ROOME & GUARRACINO, LLC

Reference: 1346 Hudson Street
 Somerville, MA

Subject: April 3rd, 2012 Site Visit

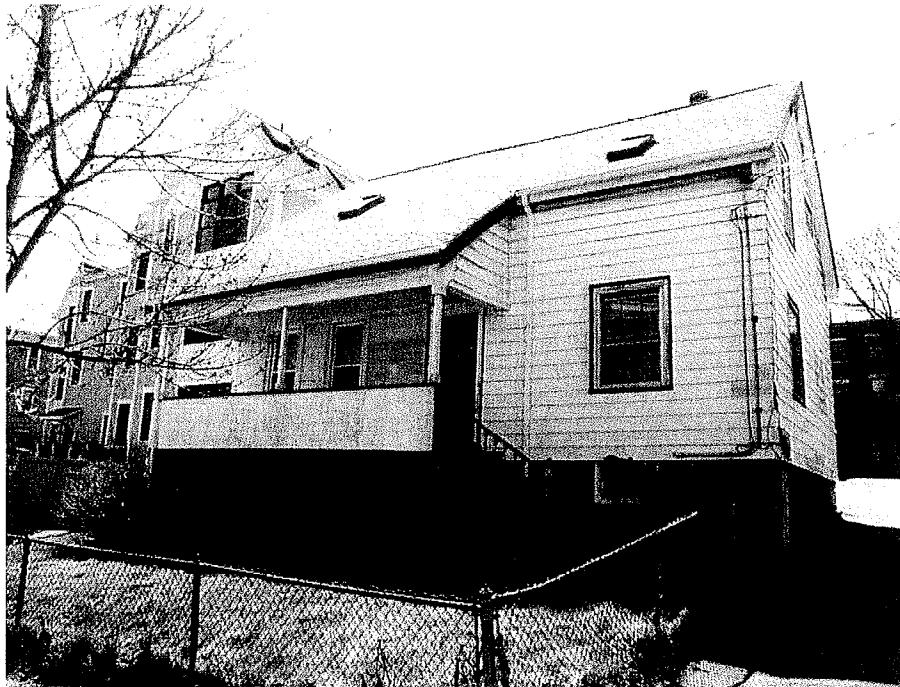
Photo 1.

The house is a wood-framed two story, timber framed structure with basement and mixed concrete and CMU block foundation walls and a basement slab on grade. I understand the house to be constructed circa 1910. See photo 1.

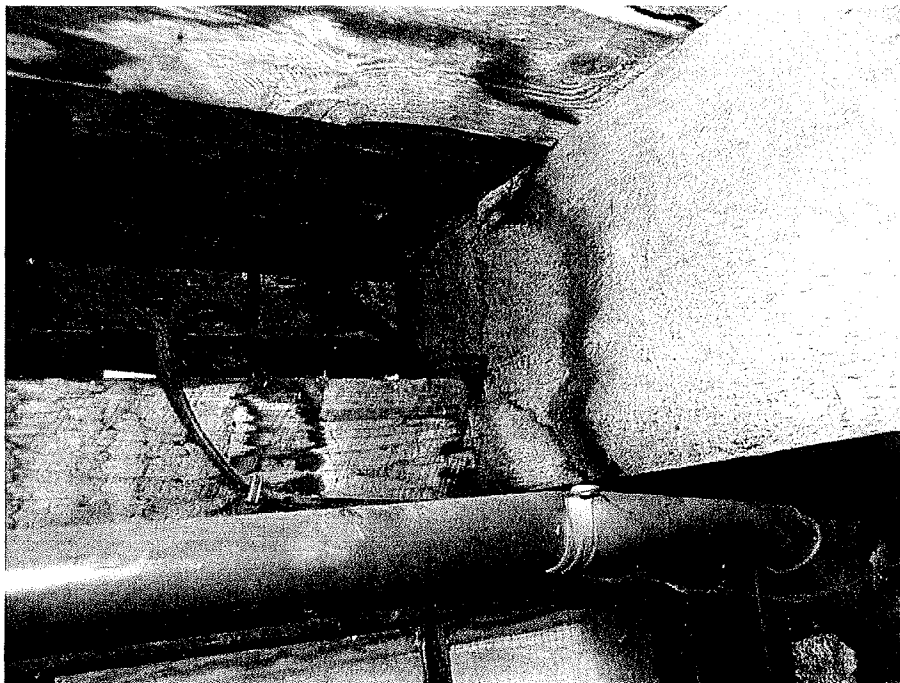
Photo 2.

I proceeded downstairs and into the basement where areas of the framing are exposed. I noted the original timber framing which spans from the sills at the outside foundation walls to interior timber beams. I noted evidence of moisture and wood deterioration and rot in the wood joist ends and sills. See photo 2.

All wood which has been damaged from intrusion of moisture needs to be removed and replaced. This will include rotted sills, studs bearing on sills and joist ends as noted in photo 2.

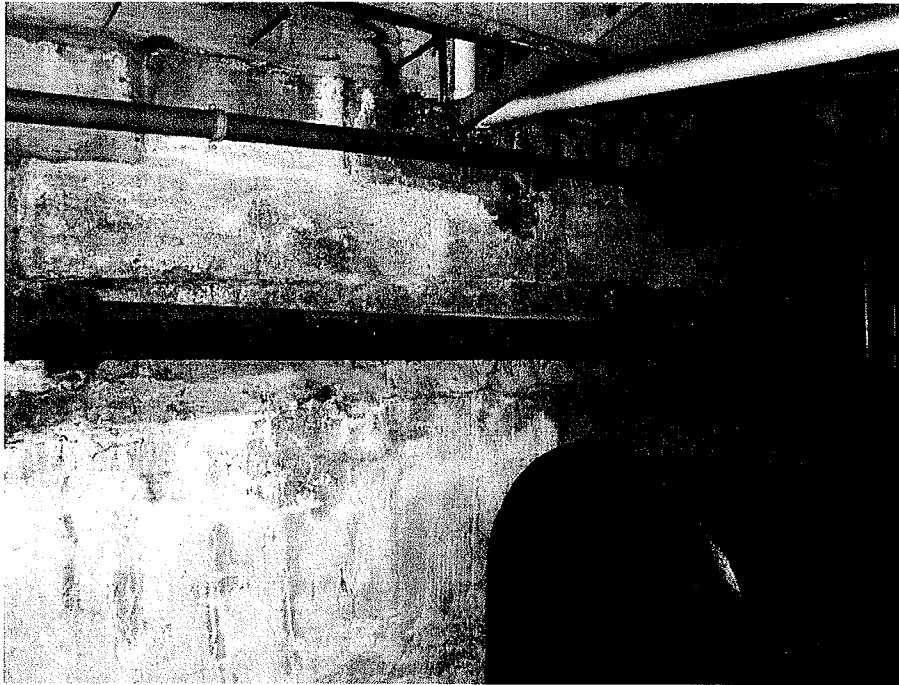
Photo 3.

I noted the perimeter foundation walls consisting of cast concrete for the lower portion and CMU blocks above. See photos 3. and 4. Various levels of deterioration and spalling was noted in the CMU, the CMU mortar joints and the concrete. Areas of light could be seen coming through the CMU mortar joints from within the basement.

The condition of the damaged areas of the foundation wall viewed is such that replacement is necessary. Re-pointing mortar which has deteriorated more than half the thickness of the wall is not effective and therefore not recommended. The existing foundations are in poor condition. This is certainly evident when observing the foundation wall from outside.

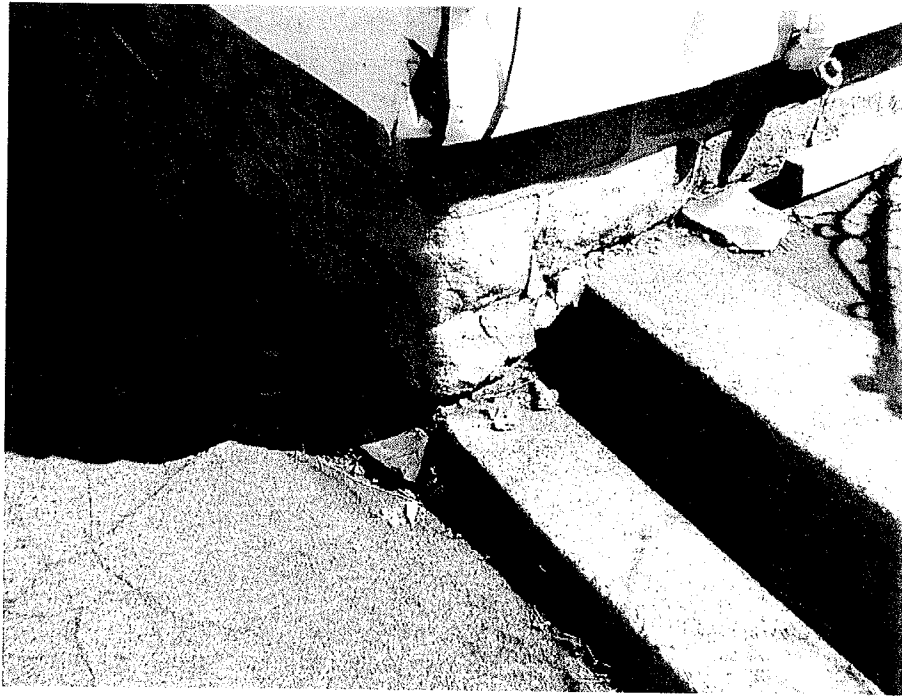
Photo 5.

I proceeded outside to view the condition of the foundations and the upper half of the CMU block is noted. Several areas of spalled and damaged CMU was noted around the perimeter of the house. See photo 5. I proceeded to review the remainder of the house, which was mostly covered by finishes and plaster. I noted several areas at the second floor with cracks in the plaster finishes and sloping floors. This is indicative of movement and possible distress due to loads and age of the structure, and foundation movements.
