RE: Covino Project 14.00046
Hazardous Building Materials Inspection Report-Revised
Former Powderhouse School
1060 Broadway
Somerville, Massachusetts

Hazardous Building Materials Inspection Report

**Former Powderhouse School
1060 Broadway
Somerville, Massachusetts**

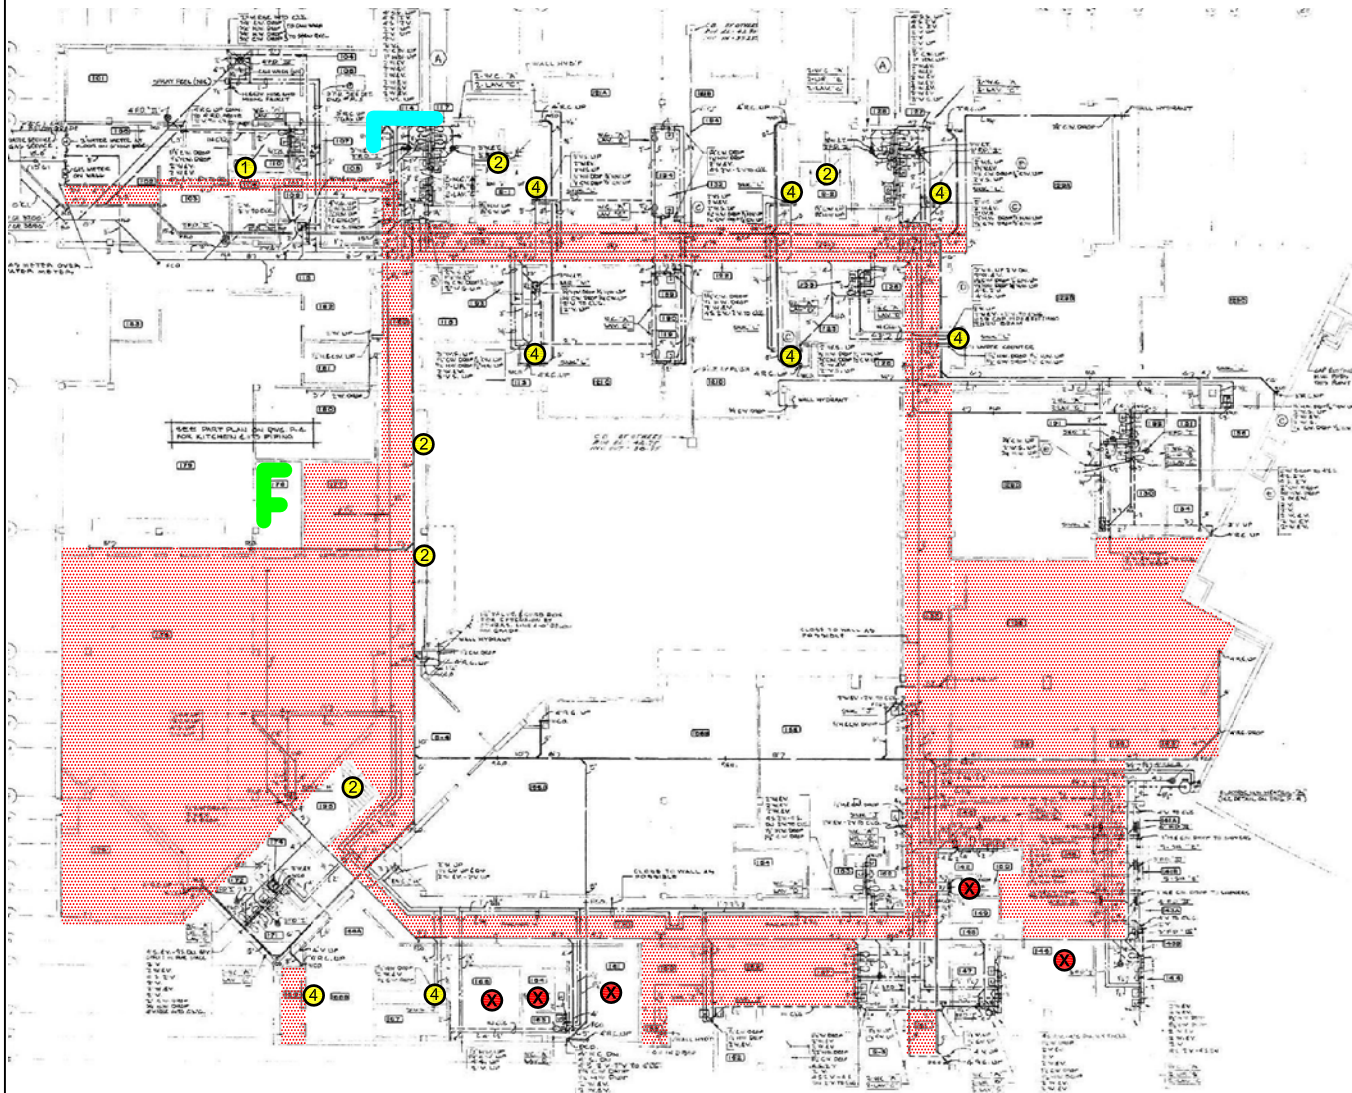
- Brown duct seam sealant
- 6" diameter pipe insulation
- ▨ 12" x 12" Brown floor tile and associated mastic
- ① Radiator caulk compound
- ② Coating on underside of cement stairs
- ③ Duct rope-like insulation/sealant
- ④ Sink basin coating (black and pink)
- ⓧ Inaccessible areas

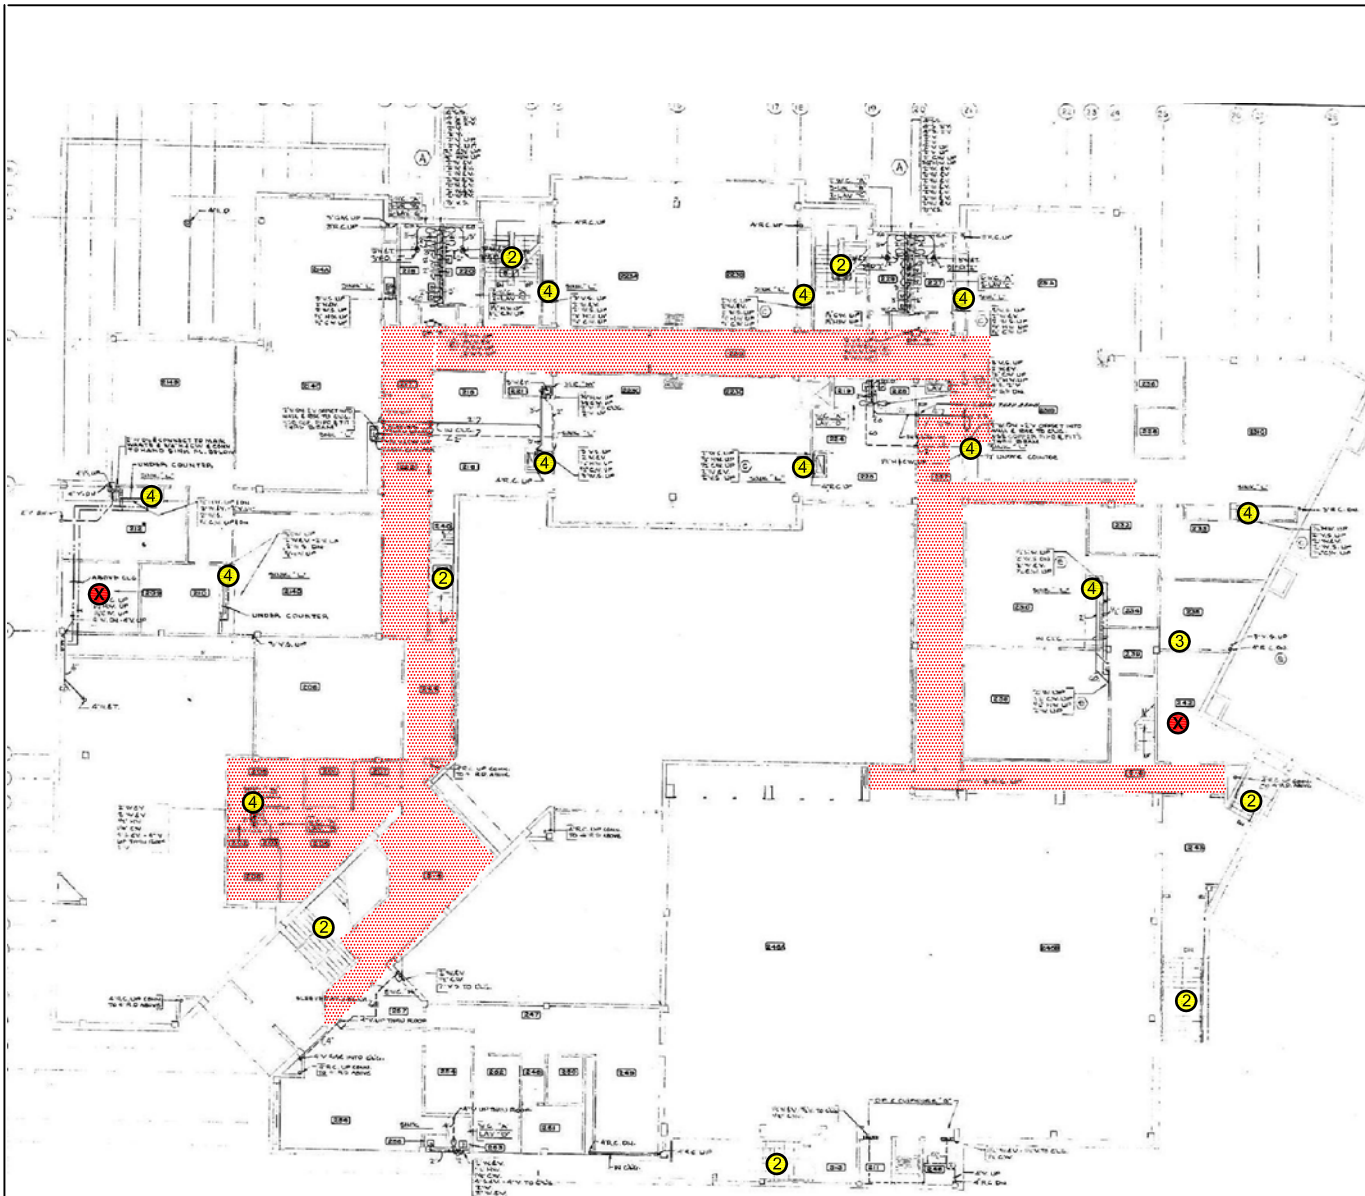
Second Floor

- Brown duct seam sealant
- 6" diameter pipe insulation
- 12" x 12" Brown floor tile and associated mastic
- ① Radiator caulk compound
- ② Coating on underside of cement stairs
- ③ Duct rope-like insulation/sealant
- ④ Sink basin coating (black and pink)
- ✗ Inaccessible areas

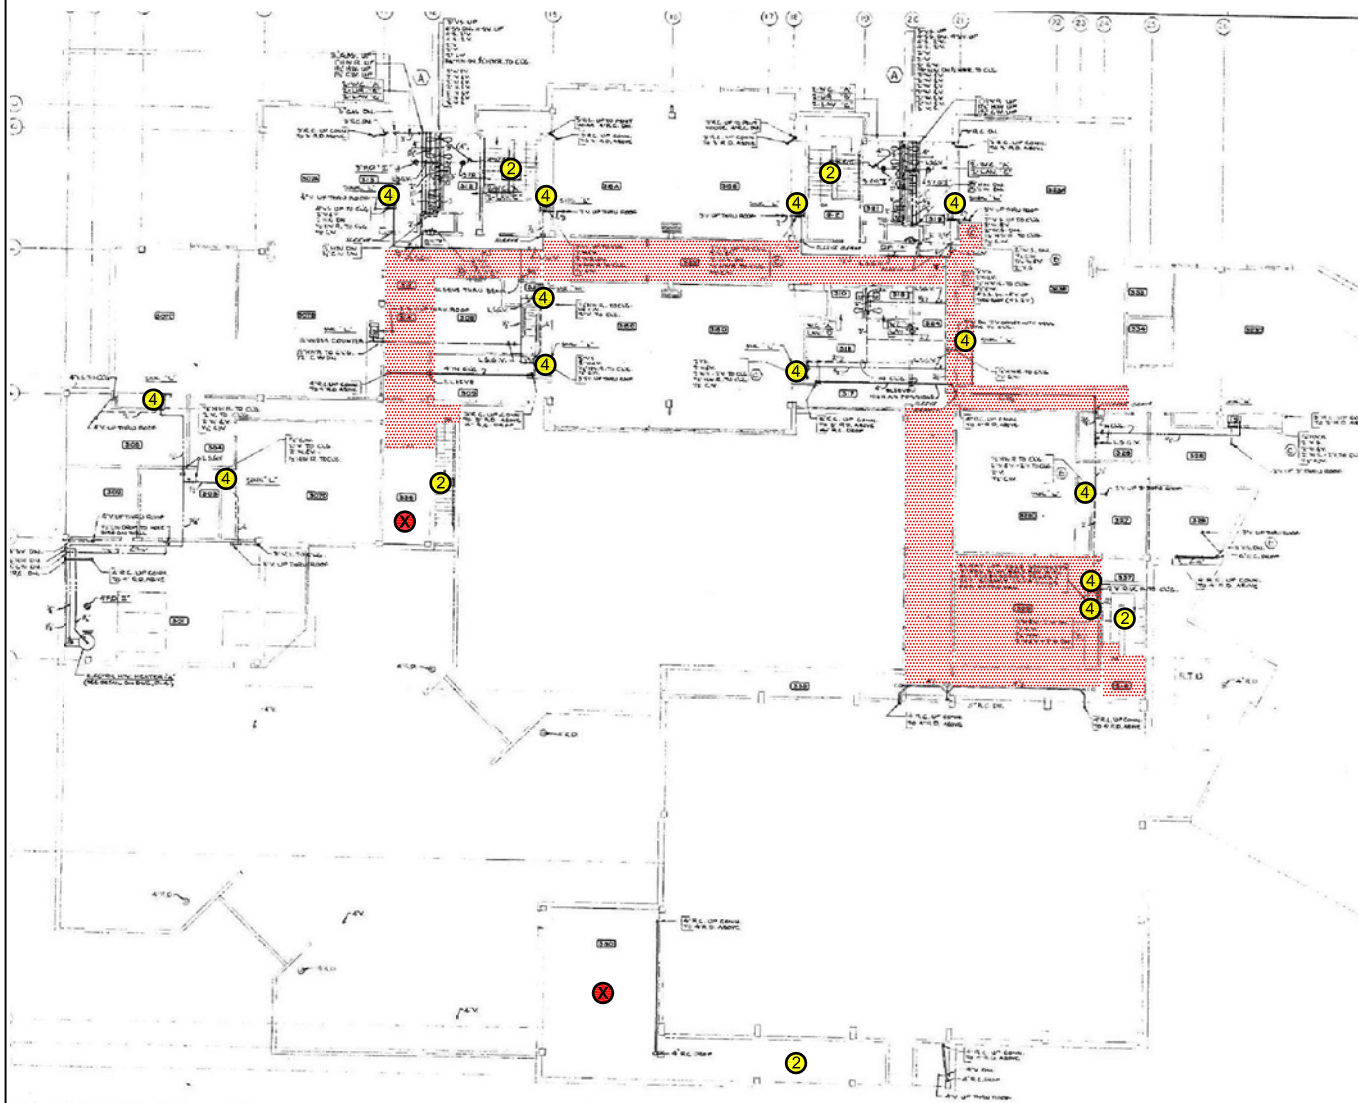
- Brown duct seam sealant
- 6" diameter pipe insulation
- 12" x 12" Brown floor tile and associated mastic
- 1 Radiator caulk compound
- 2 Coating on underside of cement stairs
- 3 Duct rope-like insulation/sealant
- 4 Sink basin coating (black and pink)
- X Inaccessible areas
