**ASBESTOS-CONTAINING MATERIALS, LEAD-CONTAINING PAINTS  
AND HAZARDOUS BUILDING MATERIALS SURVEY, FORMER POWDER HOUSE SCHOOL,  
1060 BROADWAY, SOMERVILLE, MASSACHUSETTS**

***PREPARED BY:***  
**AXIOM PARTNERS, INC.**  
**545 SALEM STREET**  
**WAKEFIELD, MASSACHUSETTS 01880**

**MARCH 18, 2014**

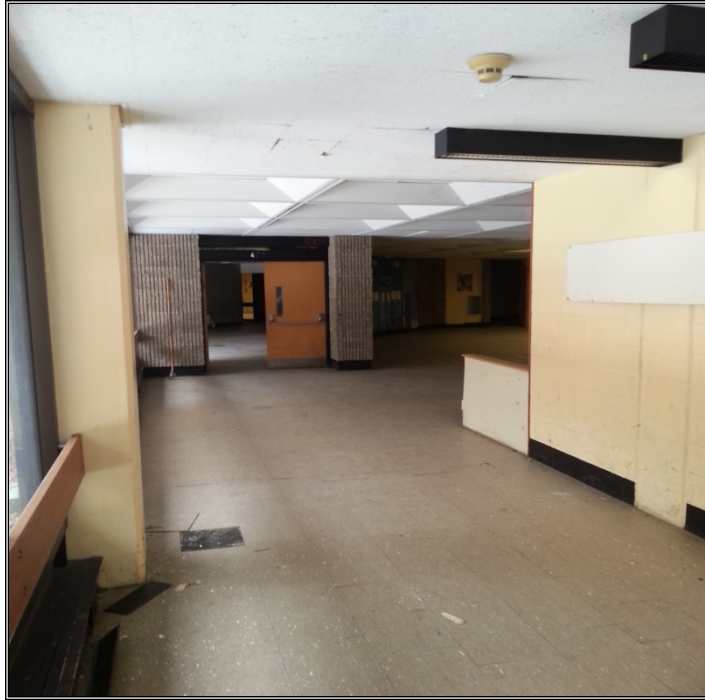
**12"x12" Brown Asbestos-Containing Floor Tile and Mastic Located Throughout School**

All confirmed and presumed ACMs that will be impacted by the demolition activities must be removed by a Massachusetts-licensed Asbestos Removal Contractor. Removal of ACMs must be clearly defined in a project specification which is used to obtain competitive bids for the work.

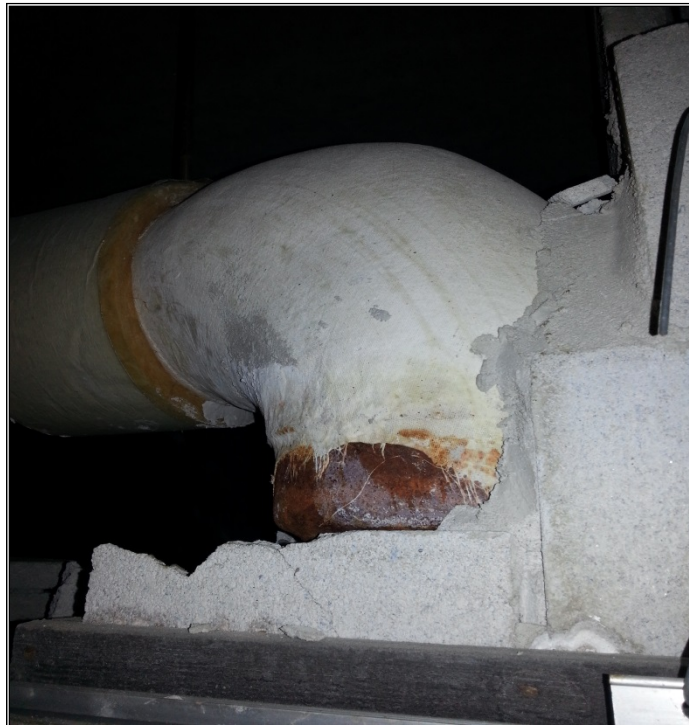
**NON-Asbestos-Containing Roof Drain Insulation Above Suspended Ceilings Throughout School**

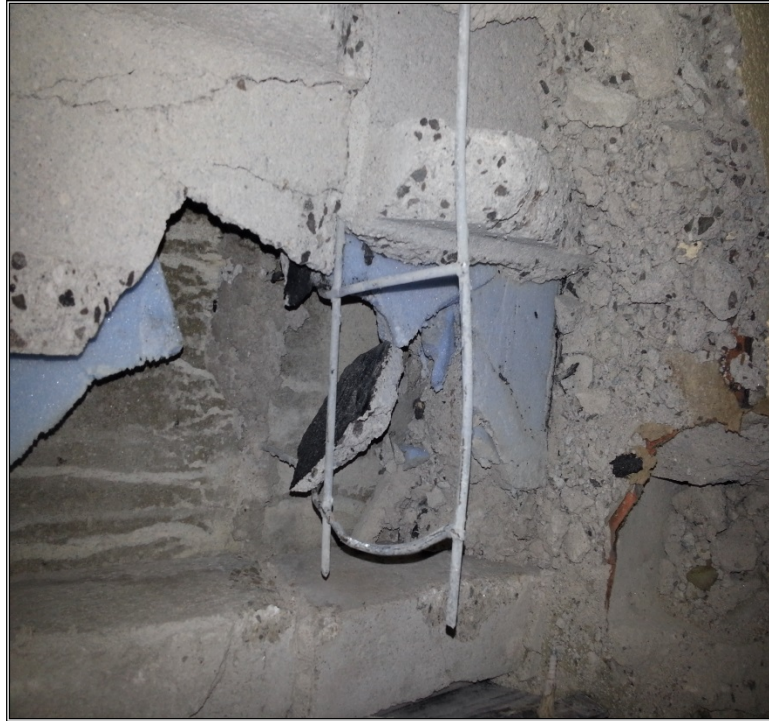
**Asbestos-Containing Damp Proofing on Blue Foam in Insulation Board on Interior CMU Walls**

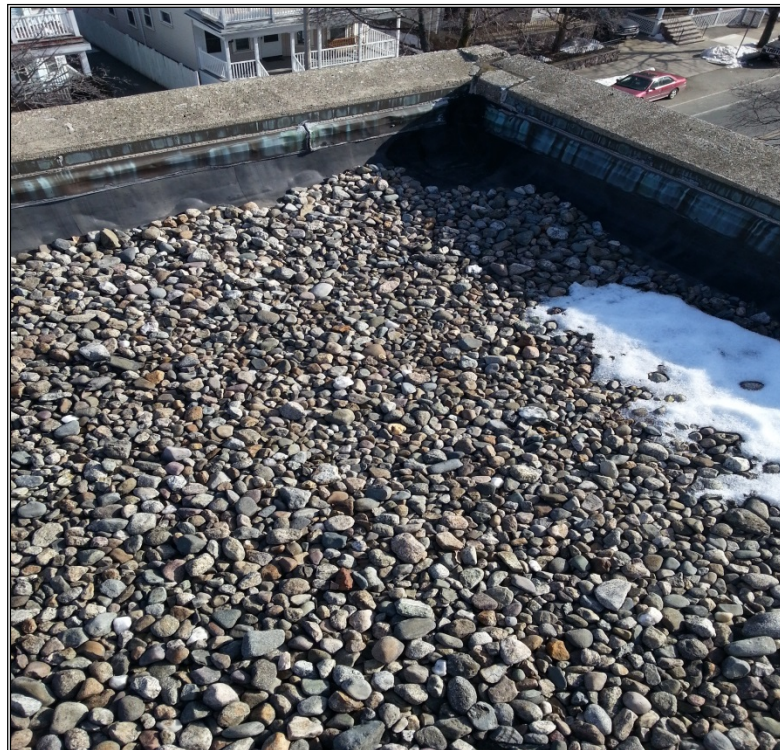
**Typical Stone Ballasted Rubber Roof Over Multi-Layer Asbestos-Containing Roofing**
