Re: Request for Qualifications (RFQ) #15-05 Design and Construction Administration Services for Renovations to the West Branch Library

**Addendum #1 – Response to Questions**

# Historic Structure Report

## West Branch Library

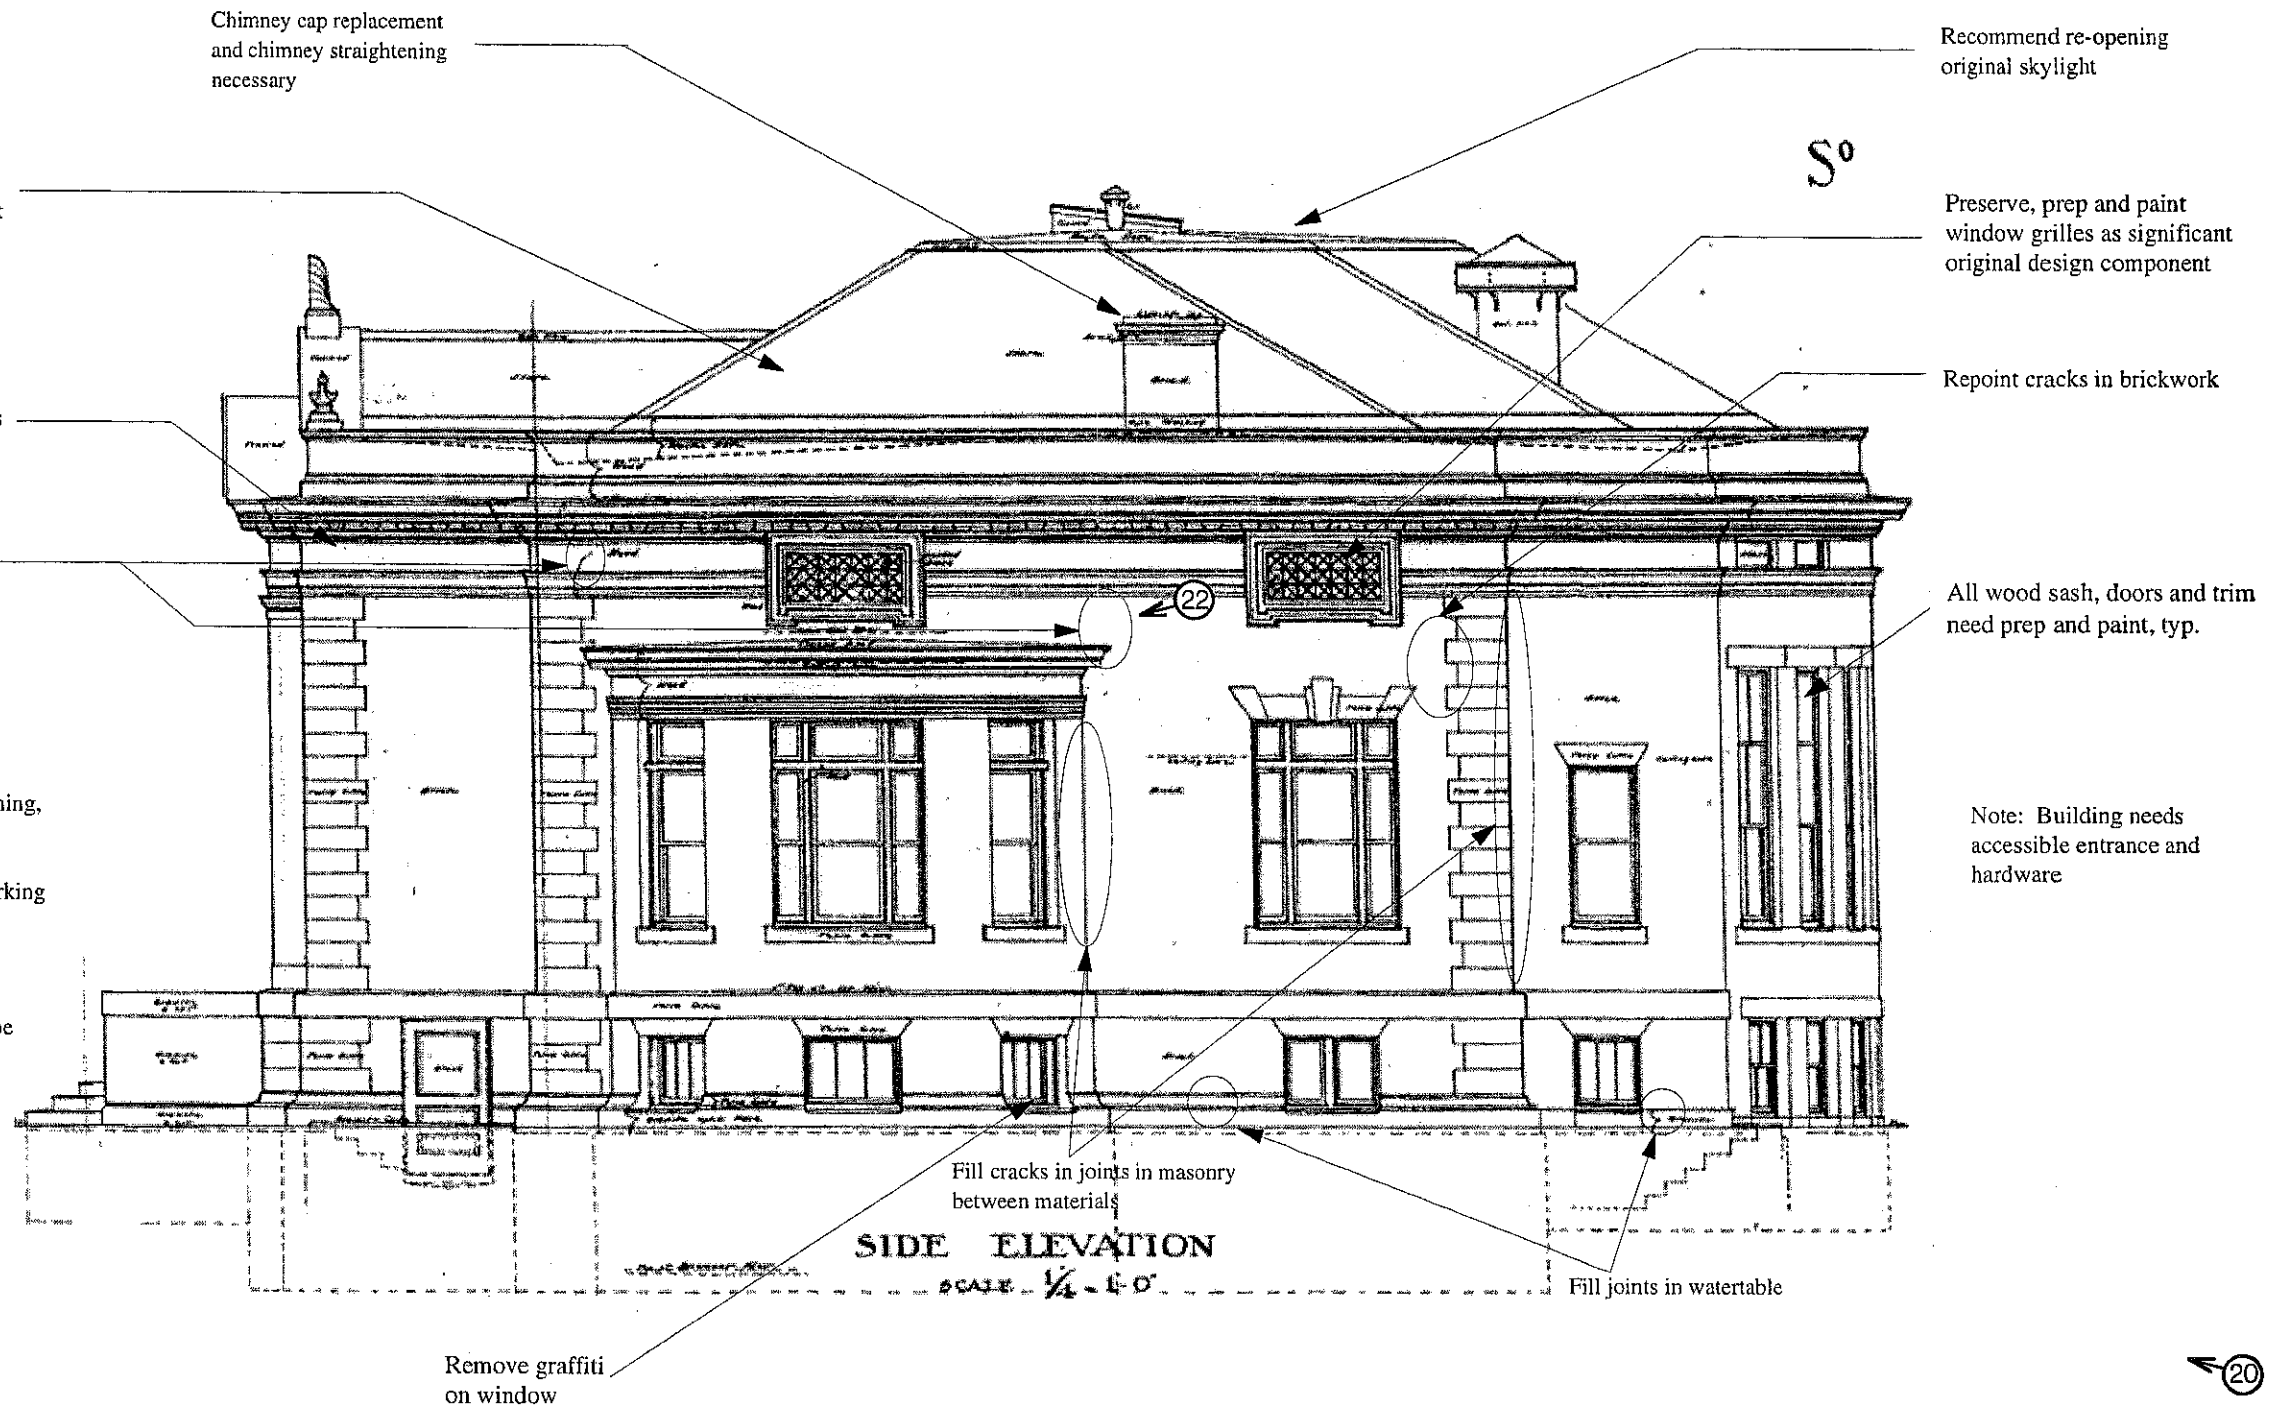
Dentil cornice soffit needs to be repaired to fix sag, joints need to be filled or caulked

Roof structure inspection and analysis recommended; suggest slate roof restoration if feasible

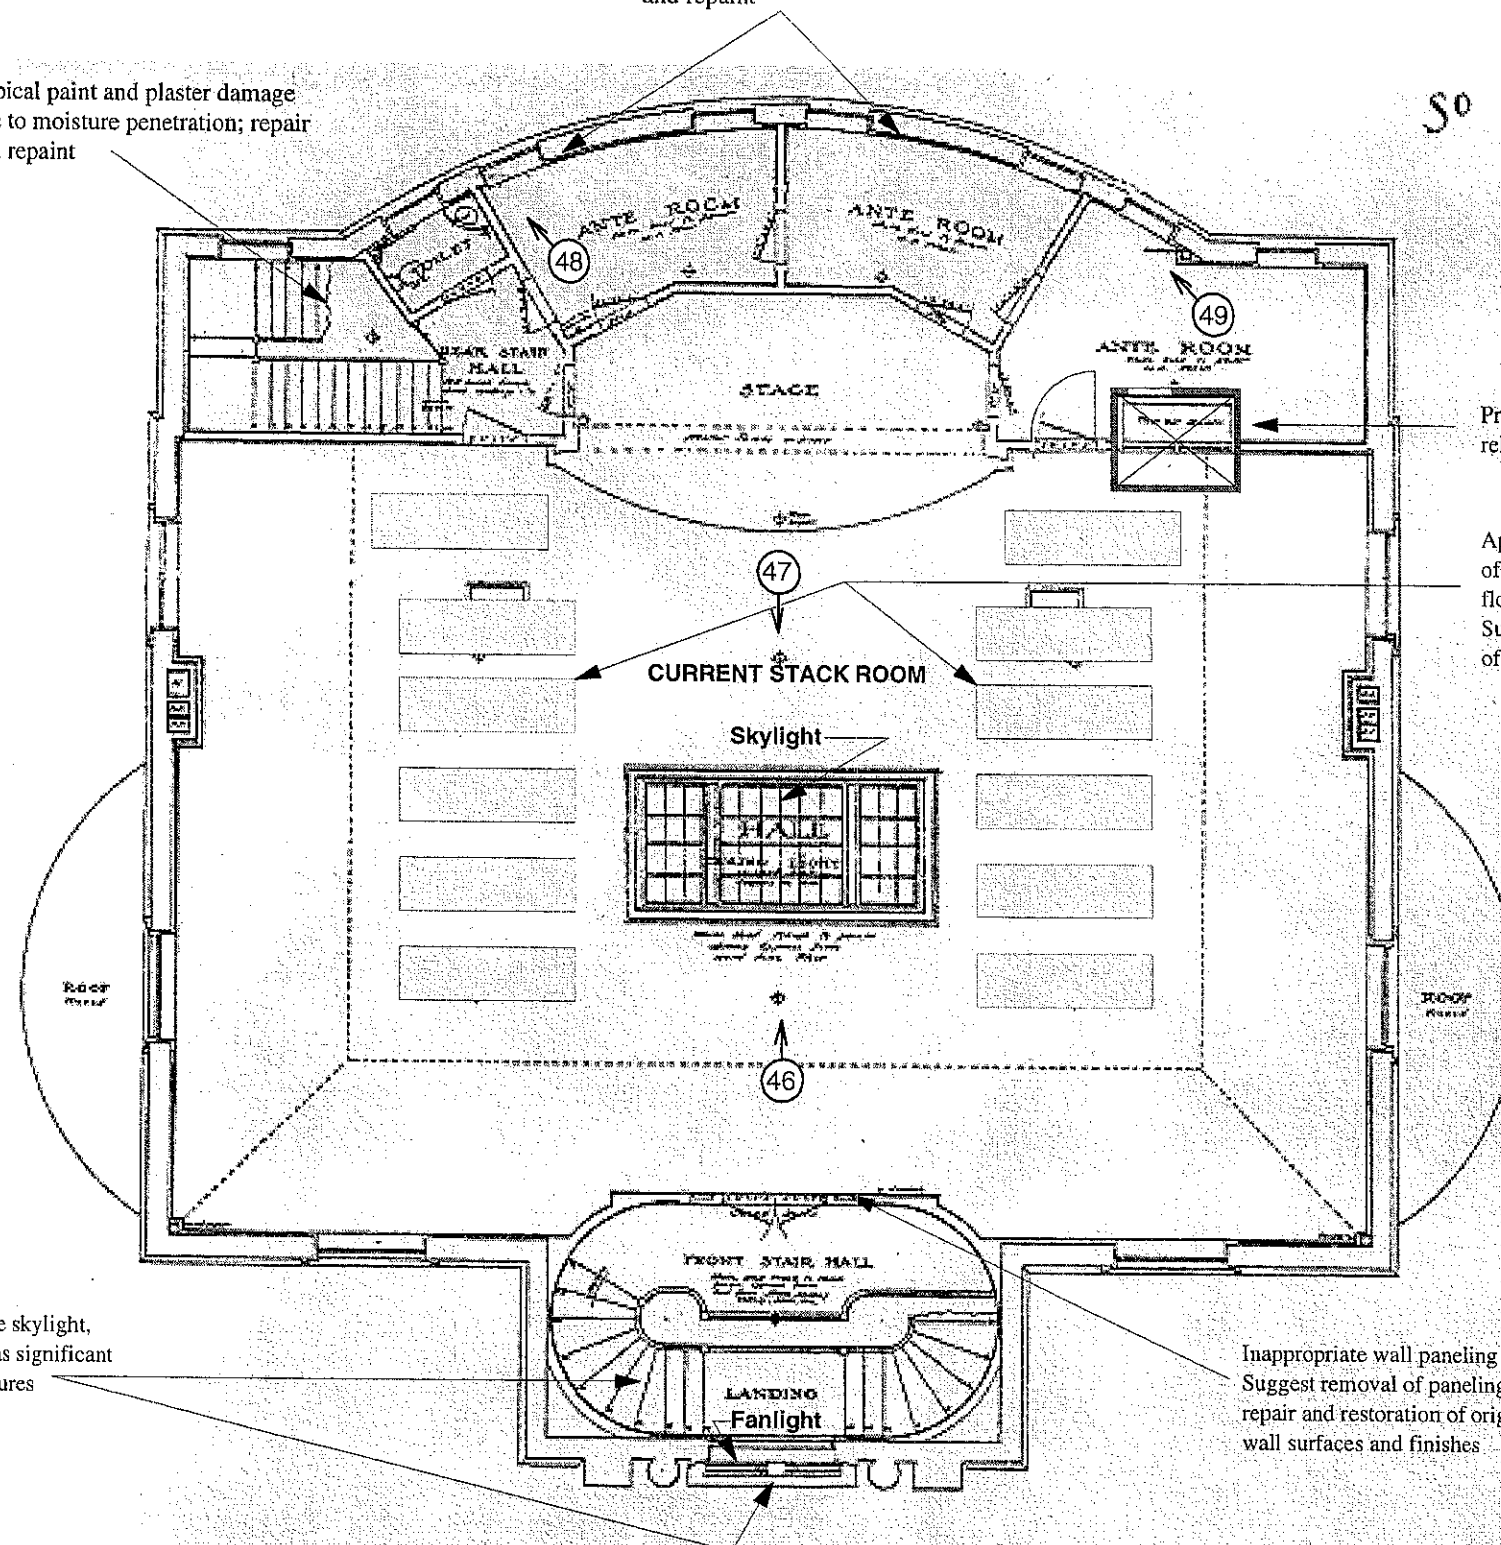
Typical paint and plaster damage  
due to moisture penetration; repair  
and repaint

Typical paint and plaster damage  
due to moisture penetration; repair  
and repaint

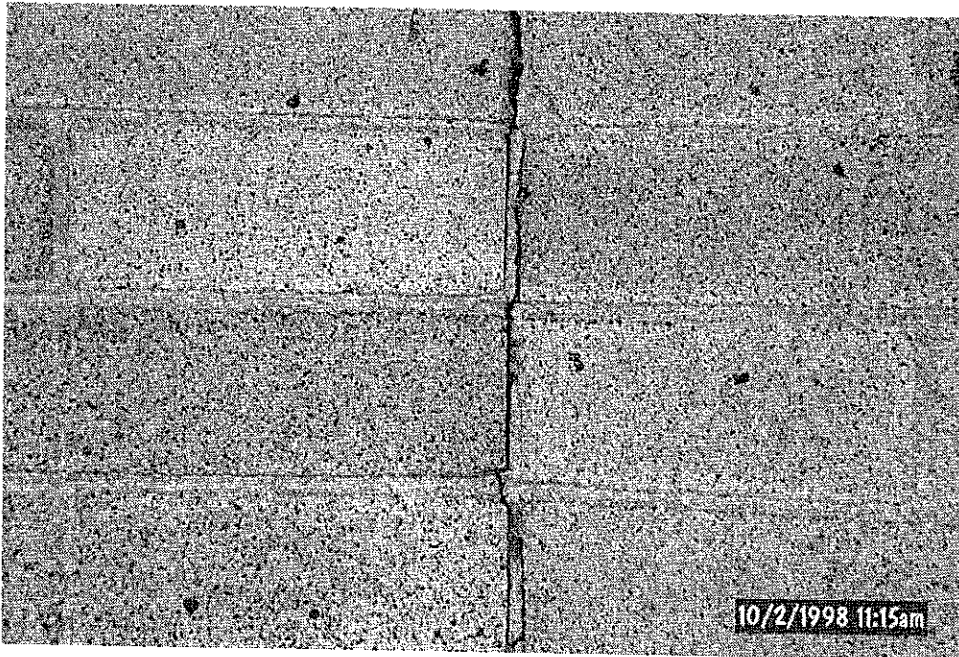
**Figure 13**

Detail of Roman brick. Note staining on brick and cracking in mortar joint.

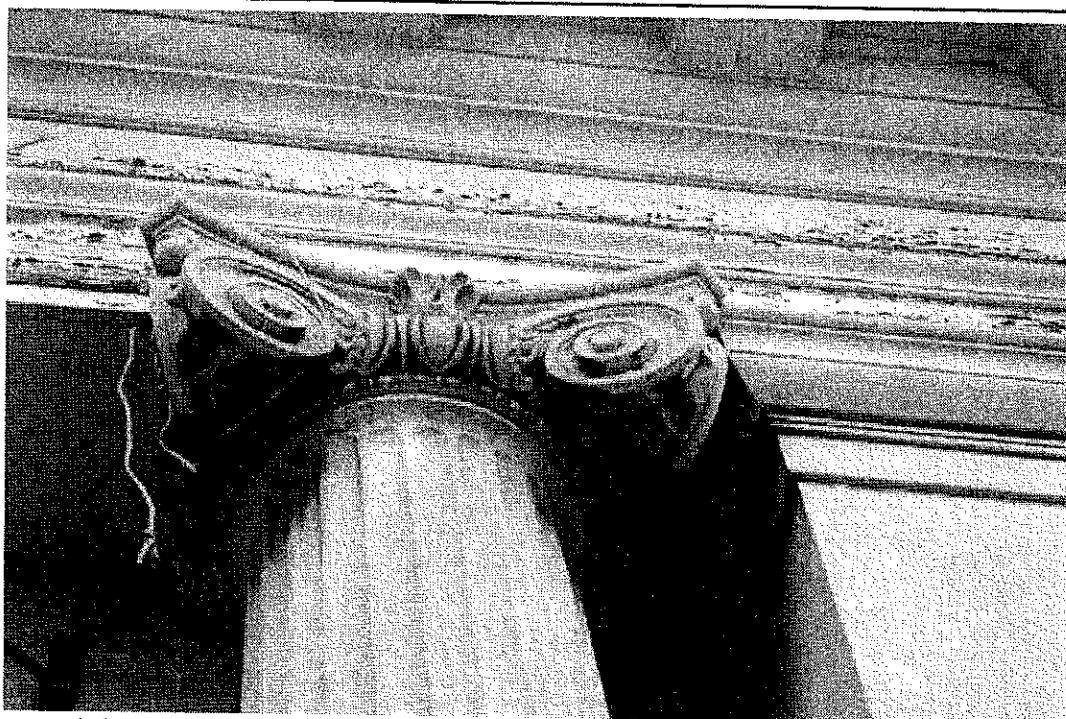
**Figure 16**

Staining underneath column capitals.

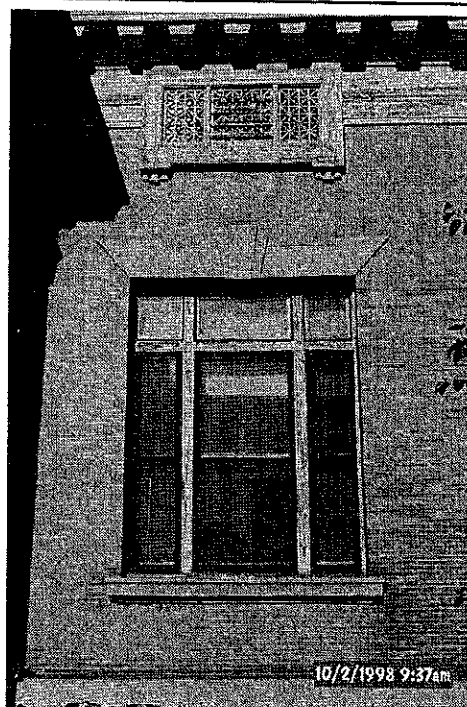
**Figure 19**

The symmetrical facade has large double-hung windows with limestone lintels and sills on either side of the entrance (Fig. 19). Above these windows are the small, second floor windows with decorative wood grilles that are surrounded by painted wood frames. The paint around these windows is also peeling. The small window frames at the basement need to be repainted. According to the engineer's report, there has been limited outward movement at the cornice line and diagonal cracks over the windows, beginning at the top of the keystones and ascend to the bottom of the window grilles on the second floor. Due to the spreading of the wall, the southern window keystone and entire northern window arch have dropped vertically. Additional vertical cracks appear in the joints between the walls of the main facade and entrance, at the southeast corner quoins and a switchback crack between the northern first floor window and the top of the basement window below it. The engineer's report suggests that this cracking may be due to an overall forced outward movement (horizontal growth) of the wall near the top.

Detail of windows with limestone lintel and wood grilles. Note peeling paint.

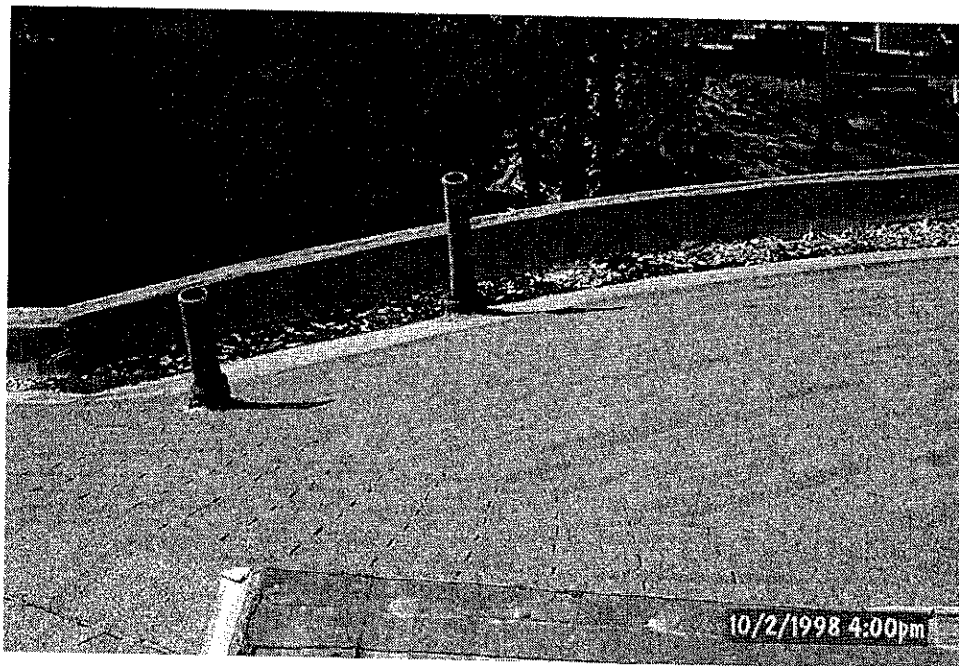
**Figure 28**

View of roof at rear bay window. Note debris gathered behind parapet.

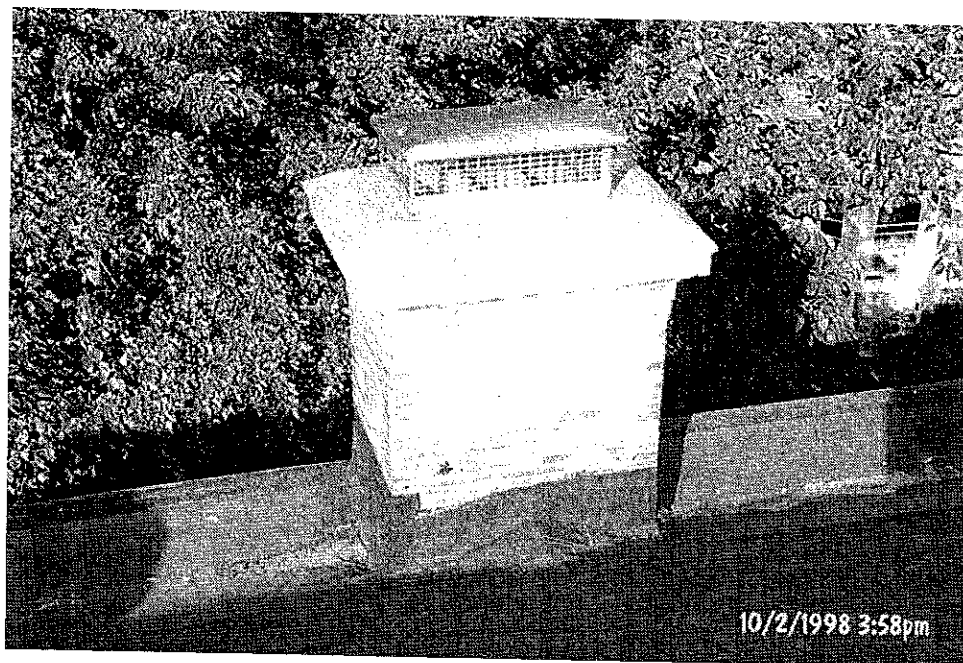
**Figure 29**

According to the engineer's report, the low-hipped roof is self-supporting with no interior supports, so that each roof surface was designed to intersect at angles to support the whole structure (See Section, Dwg. A-5 & Roof Plan, A-9). The engineer's report notes that there is some wall deflection and cracking that are related to an improper roof design. The hipped roof was redone in the early 1990's, retaining the original configuration, but replacing the slate with modern materials (Figs 26-28). The large chimneys on the south and north sides have a radical outward lean, which may, according to the engineer, follow the actual lean of the top portions of the supporting walls. The stone chimney caps have severely weathered and crystalline growth around each chimney (Fig. 29).

View of chimney, flashing and cap.

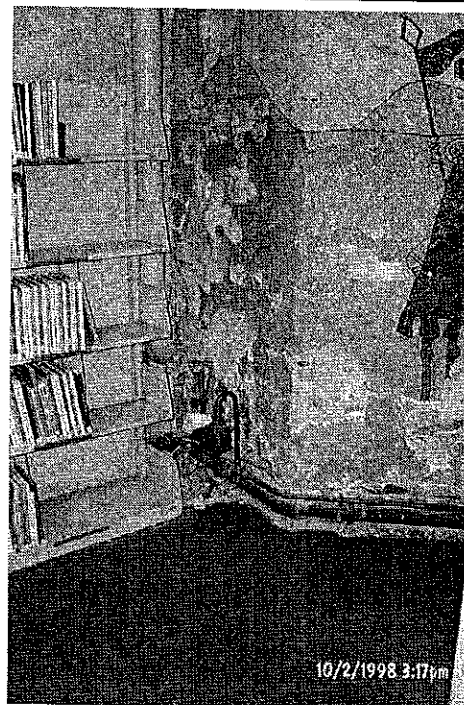
**Figure 31**

Detail of deteriorating plaster in basement in south corner.

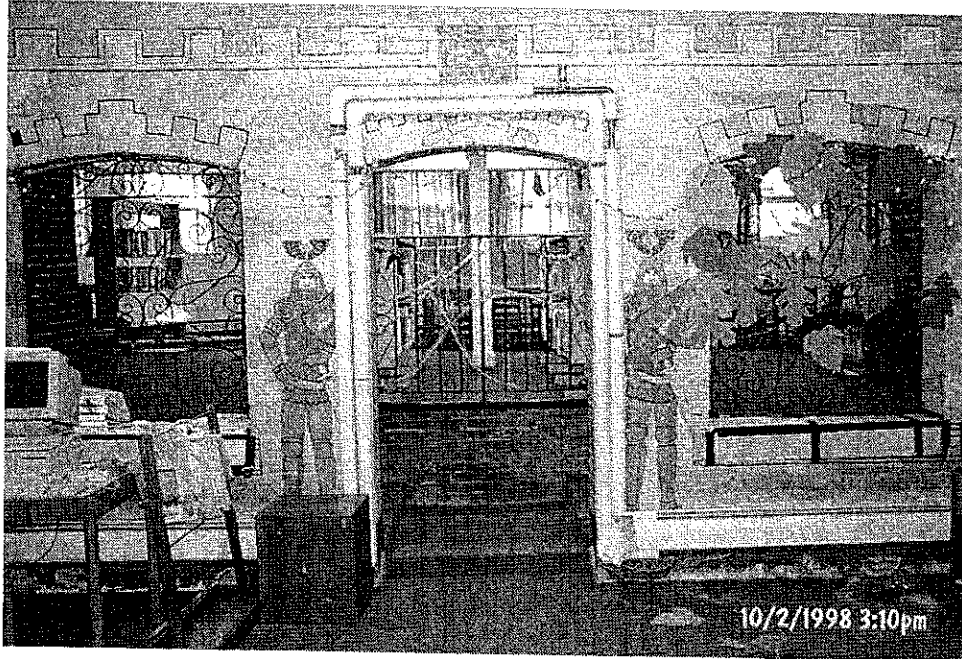
**Figure 32**

Original door and window openings into slightly raised room of Periodical area.  
Note inappropriate wall murals. View looking northwest.

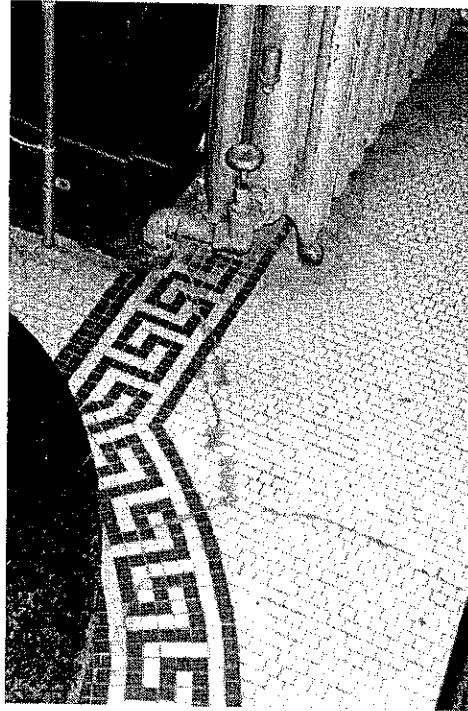
**Figure 36**

White and green tile in vestibule area near north stairs. Note cracking and missing tiles.

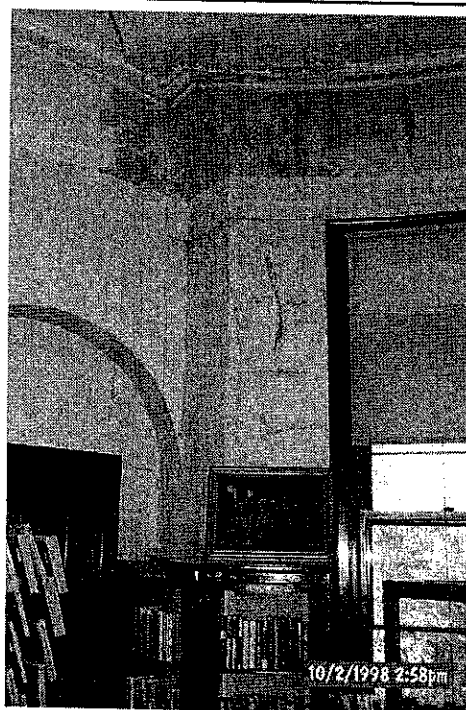
**Figure 43**

Interior deterioration due to water infiltration at ceiling and walls in north reading room.

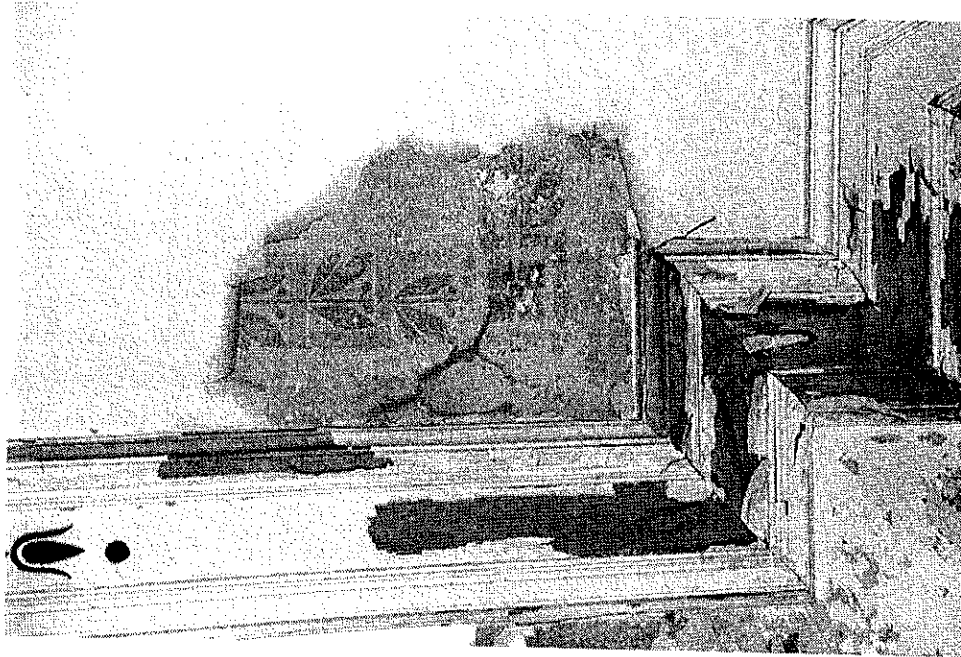
**Figure 44**

Original ceiling stenciling in southwest reading room. Stenciling with restoration potential exposed due to water damage affecting later painting.

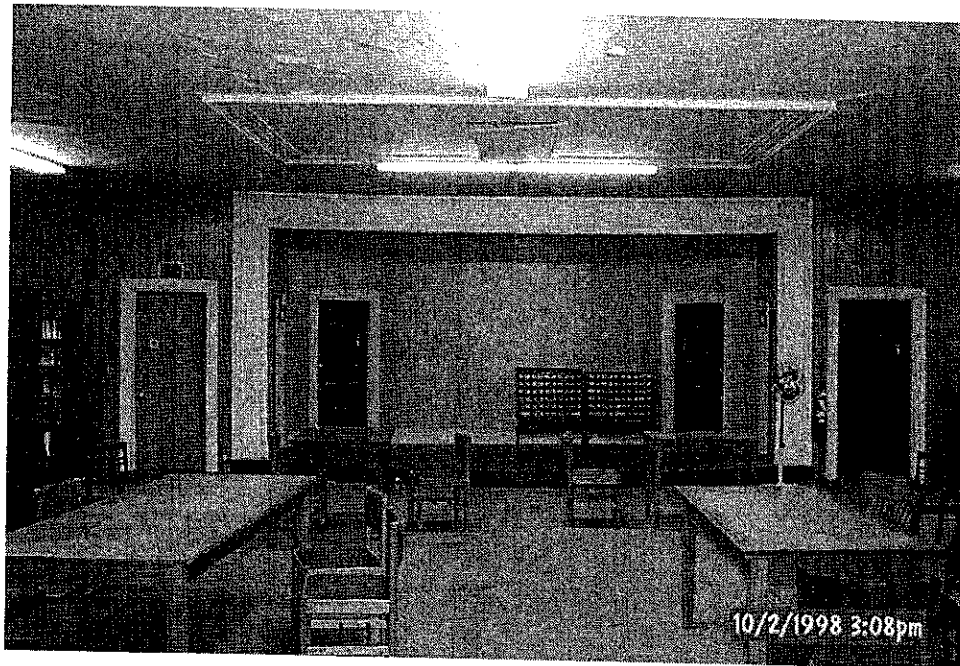
**Figure 46**

Original Hall, currently used for additional book stacks and reading area. Note inappropriate carpet and covering of original skylight. View looking northwest.

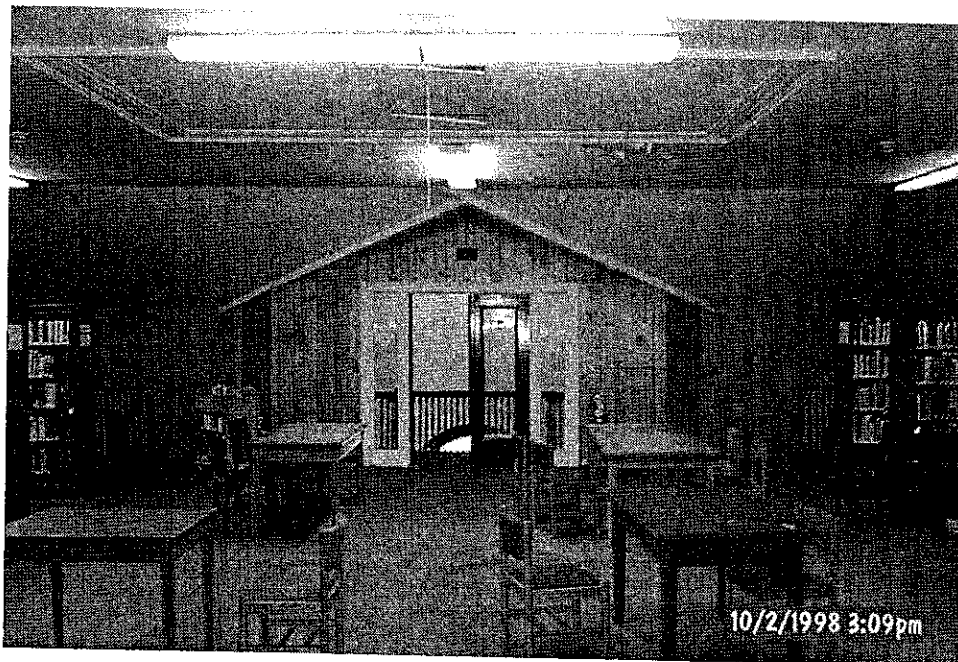
**Figure 47**

Upstairs reading room. Note inappropriate wall covering surrounding the original door. View looking southeast.

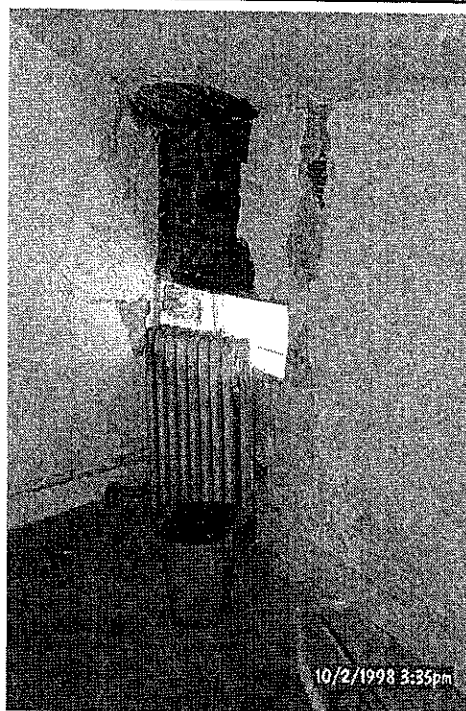
**Figure 48**

There are diagonal cracks in the walls separating the Ante-Rooms and cracks on the inside surfaces of the exterior walls (Figs. 48 & 49). According to the engineer's report, these cracks suggest either a backward shear of the roof with respect to the floor, and/or a downward deflection of the inner floor with respect to the adjacent wall. The ceiling also has numerous scattered cracks in the plaster suggesting some structural movement. The ceiling of the stage area has deflected and cracked and the north and south walls have an outward lean of more than 1" in 4 feet. The engineer also states that the floor of the Hall would have been built to support live loads of 100-150 pounds per square foot (psf) and that with the installation of stacks, there has been an increase in floor load that may exceed current code limits. Stack loads should be moved to the perimeter rather than concentrated at the middle of the structure. Currently the code contains provisions that require certain upgrades and changes in the current configurations, particularly stairs, door sizes and hardware. These are primarily the egress requirements and are discussed below under code issues.

Original Ante Room behind stage, currently unused. Note severe deterioration of plaster on ceiling and walls.
