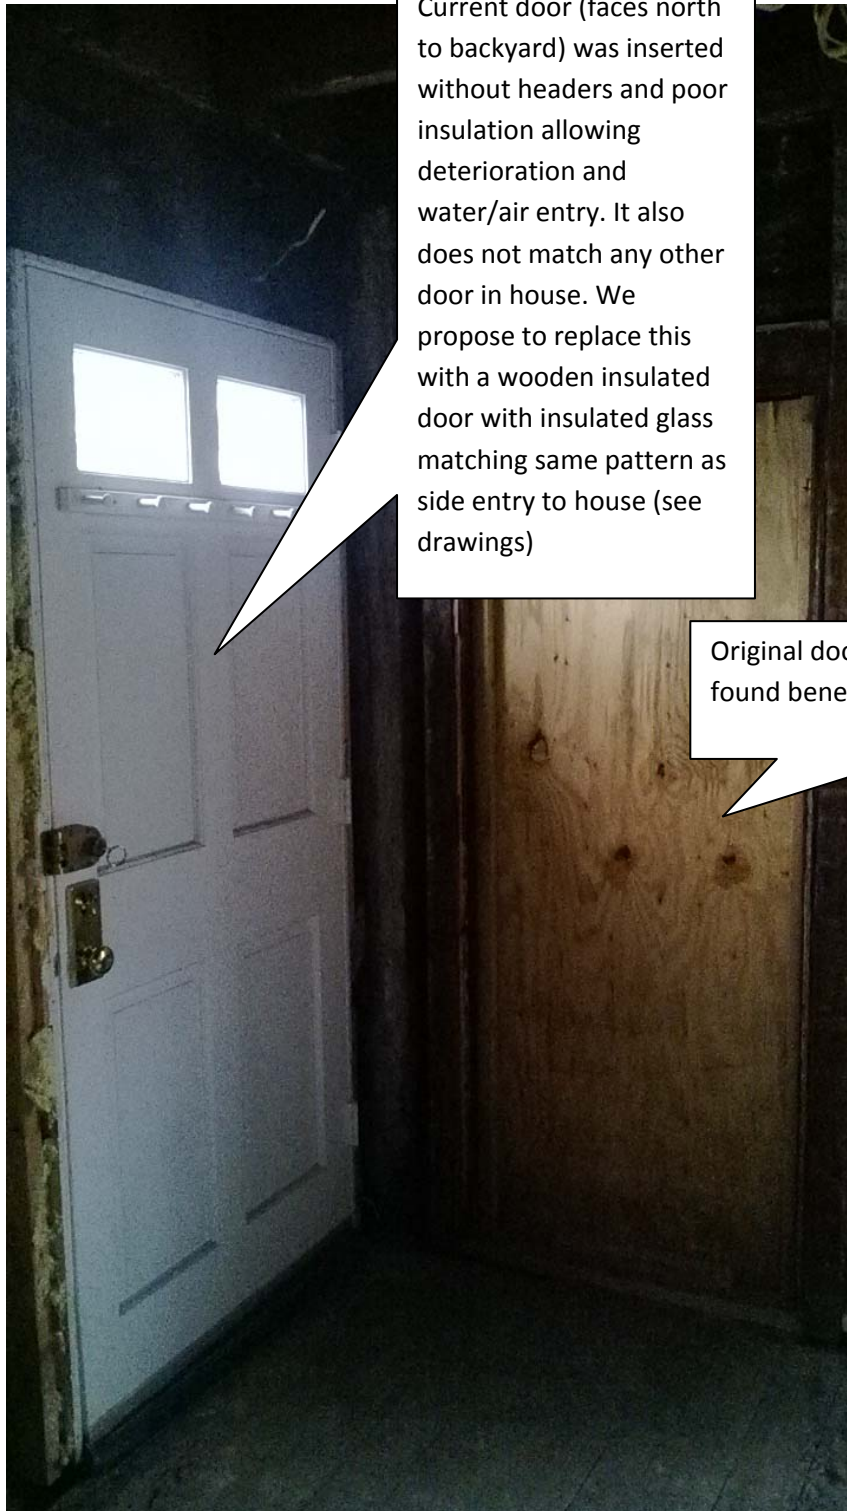
Current door (faces north to backyard) was inserted without headers and poor insulation allowing deterioration and water/air entry. It also does not match any other door in house. We propose to replace this with a wooden insulated door with insulated glass matching same pattern as side entry to house (see drawings)

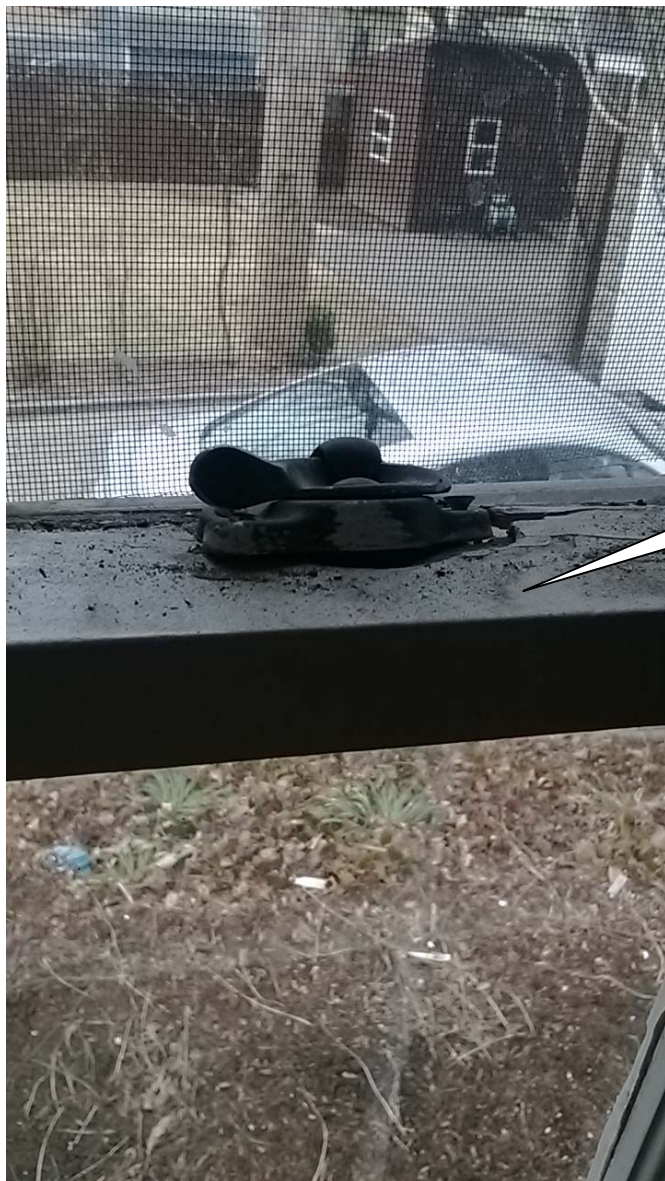
East facing window is rotted, and will not open and close and has significant air entry. The wood is too rotten to repair

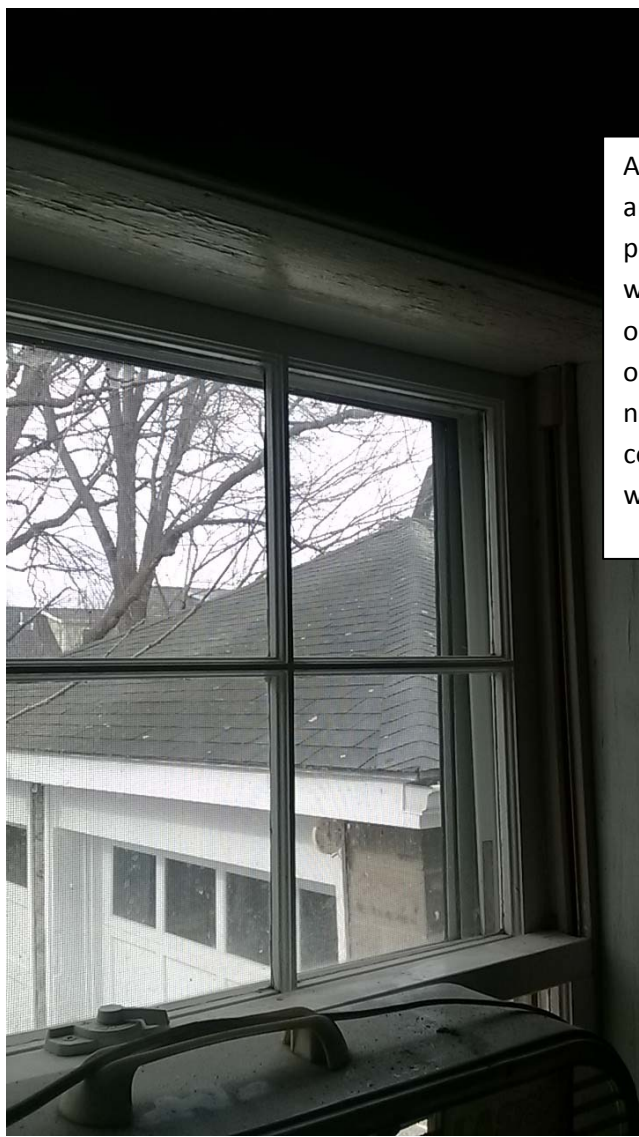
West facing windows (along driveway)
have rotten sashes
