CITY OF SOMERVILLE, MASSACHUSETTS
OFFICE OF STRATEGIC PLANNING & COMMUNITY DEVELOPMENT
JOSEPH A. CURTATONE
MAYOR

HISTORIC PRESERVATION COMMISSION

ALTERATION TO A HISTORIC PROPERTY STAFF REPORT

Site / District(s): 25-35 Atherton Street Carr School LHD, Spring Hill NRDIS, NRIND
Case: HPC 2013.037

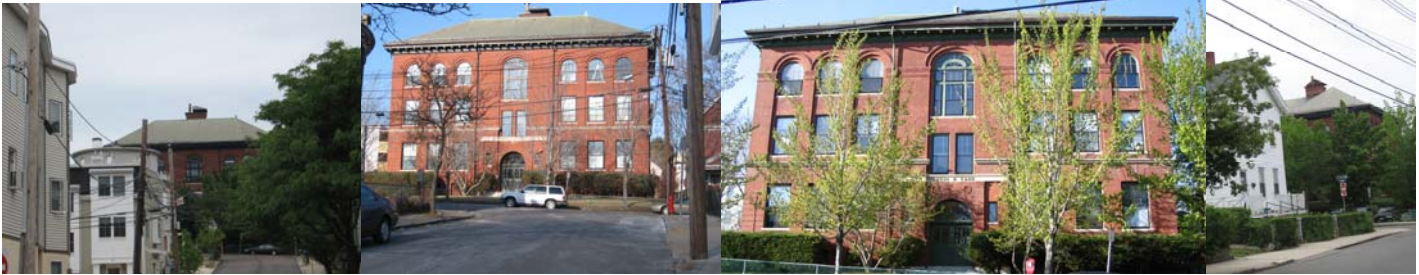
- *What is the visibility of the proposal?* The roof of this building is visible from all near-by streets and at a distance as the building is located on Spring Hill a couple of short blocks from Somerville Avenue. It should be noted that due to the pitch of the roof, it becomes less visible, the closer one stands to the building.

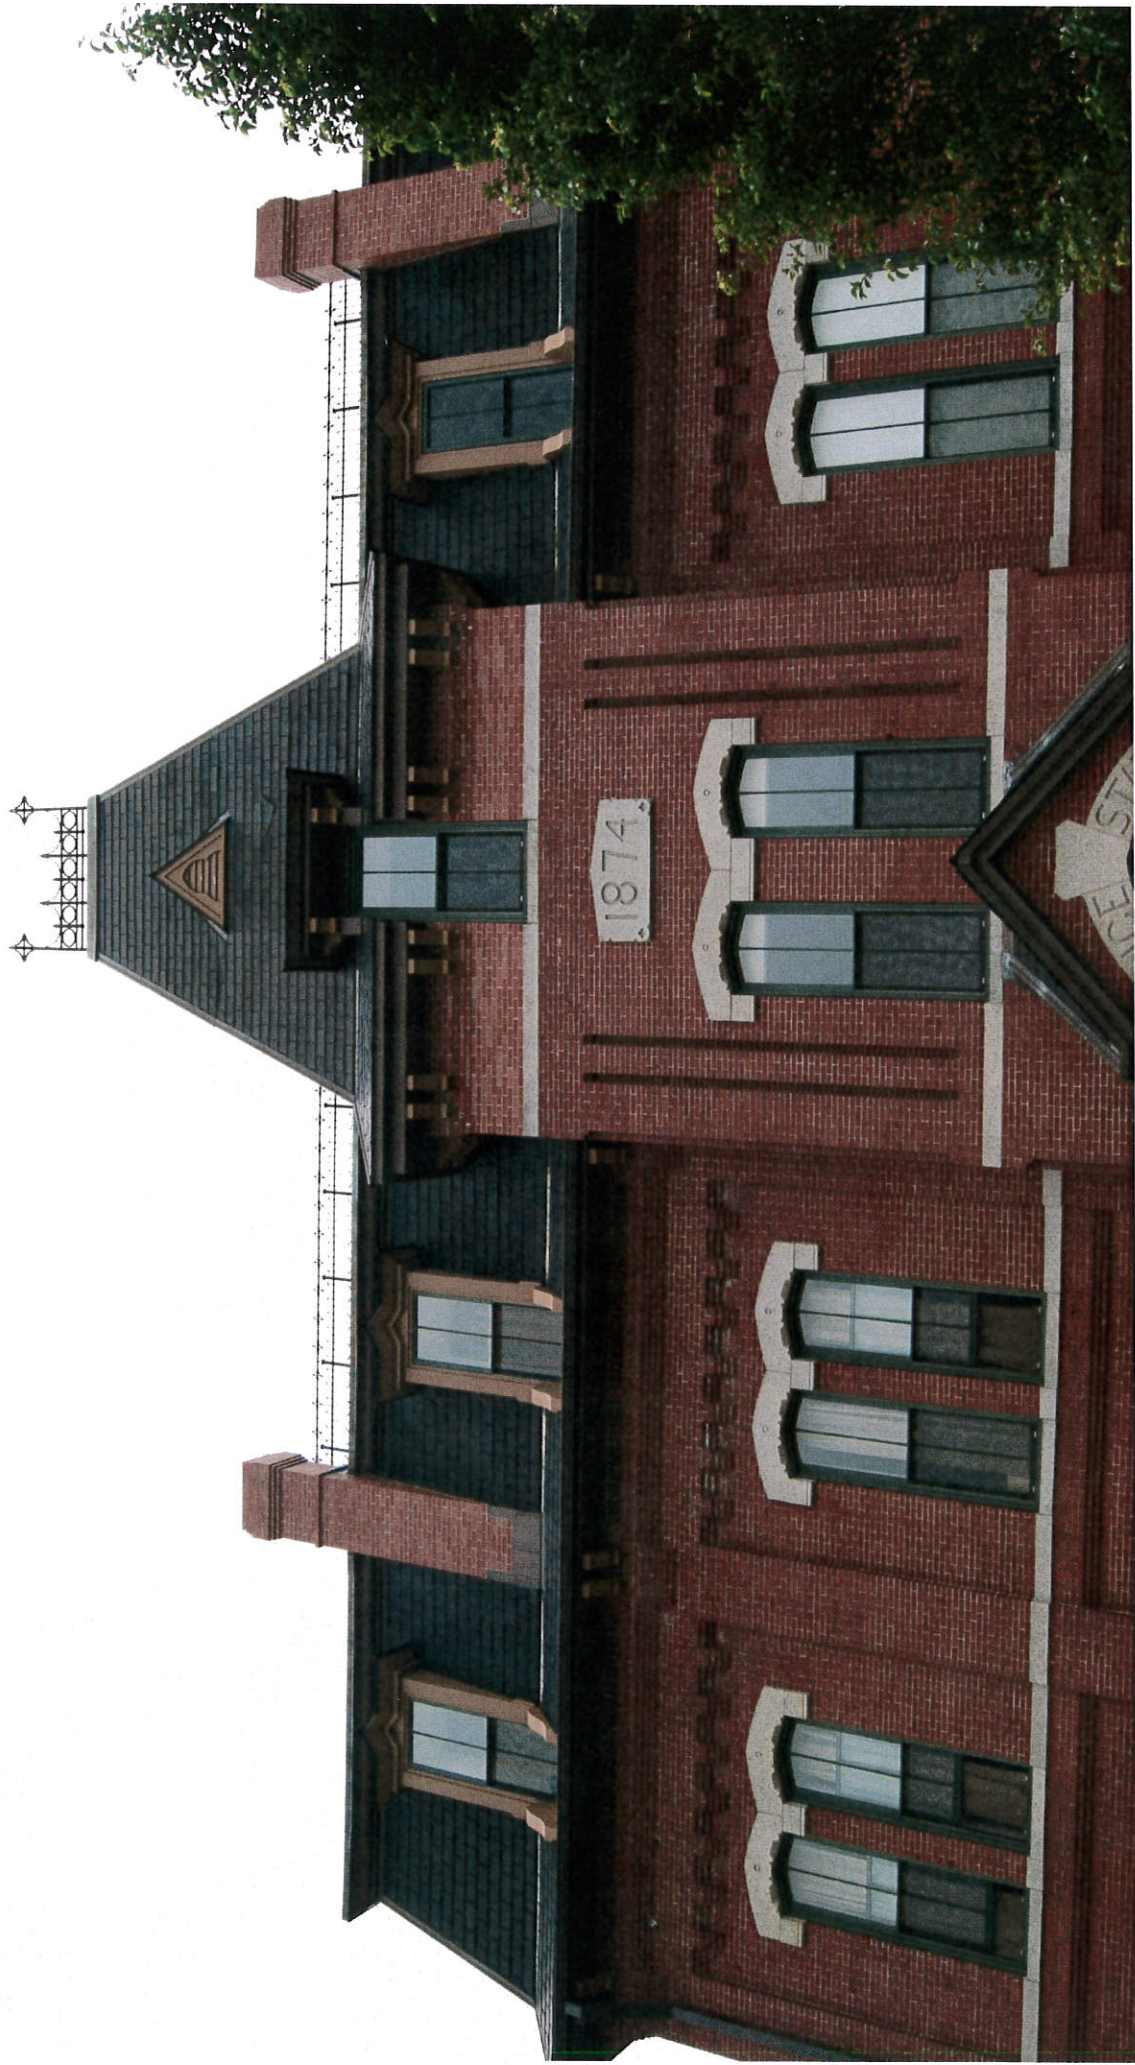
50 Bow St.

The only use of EcoStar Majestic slate has been on the **Bow Street Police Station at 50 Bow Street**. *This was for new construction*. Its use was to give indication that this was not the historic roof but a modern reconstruction similar to the roof that had originally been there. In this case, the roof is slightly lower than the original, the brick was of similar but not identical color to the original, the chimneys are shorter, and the cresting was not a replication of the original.
