ALTERATION TO A HISTORIC PROPERTY STAFF REPORT

Site: 359-365 Broadway
Case: HPC 2015-043

Historic Name: Langmaid Terrace
District(s): Single Structure LHD at the border of the Winter Hill and Ten Hills neighborhoods and within the Somerville Multiple Resource Area

Legal Notice: Alter siding, and window on ells; replace and install decks.

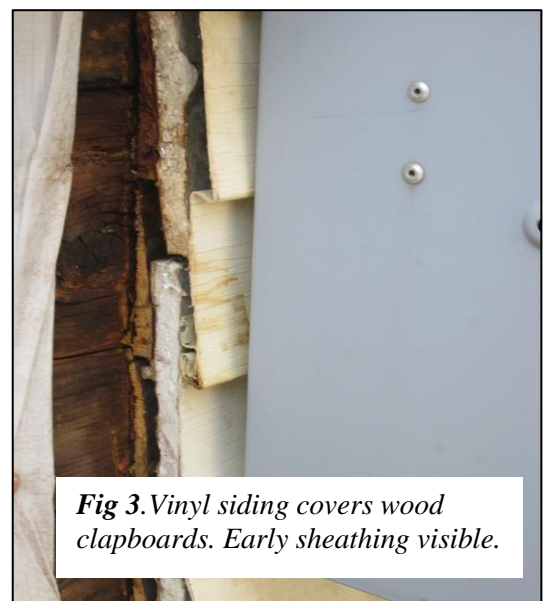
At one time, the rear extensions had vinyl siding placed over existing wood clapboards (see Fig. 3). Current windows are not original and new openings have been created to accommodate them. Openings have been created in the exterior walls for air conditioning units.

Fig 3. Vinyl siding covers wood clapboards. Early sheathing visible.

- a. Remove cement board siding and replace with wood clapboarding
- b. Remove composite trim and replace with wood trim

Condition 3 – Applicant shall use wood clapboarding that is similar to late 19th century wood siding in reveal, thickness and contour. Pine will not be considered an acceptable siding material.

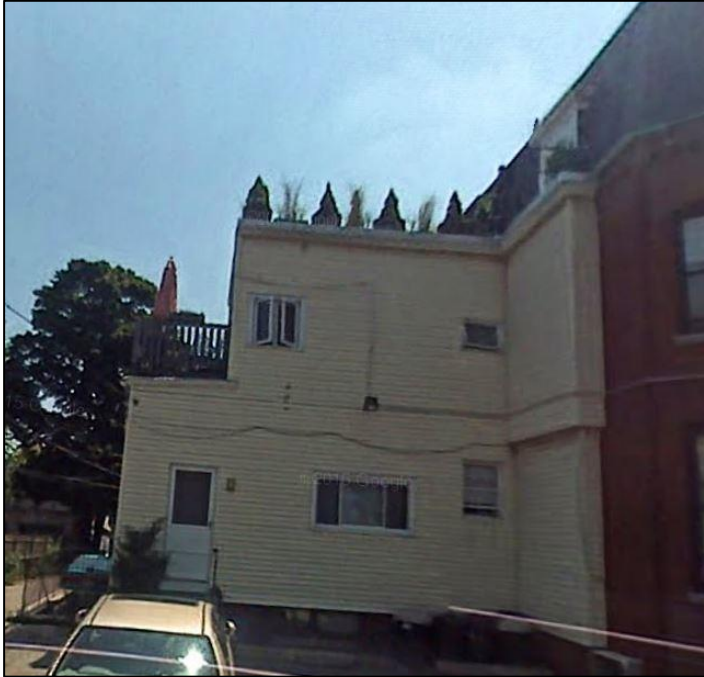
Fig. 4 Image from 2007. Vinyl siding extant and there is not opening in the façade for a/c unit and the opening for the large first floor window is smaller and of different shape than that shown in 2015 in Fig. 5.

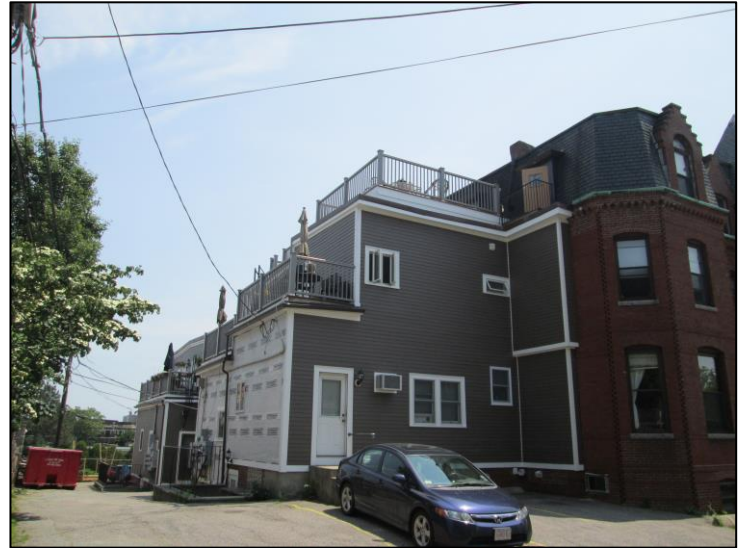
Staff comments: By performing the work described, the applicant has violated, at a minimum, items C, D, E, and F as described in the General Approach above. The application of fiber cement and composite trim, are in violation of LHD guidelines and standards as are the creation of new façade openings for a/c unit and change of windows.

Fig. 5 Image from summer, 2015 shows project in-process with vinyl siding and wood clapboards removed and large portions of extension covered with cement board and composite trim. A/c unit opening, and large first floor window opening are new and altered in size and shape respectively.

Condition 4 – Applicant shall use wood trim that is similar to late 19th century wood trim in terms of thickness and contour. Pine will not be considered an acceptable trim material.

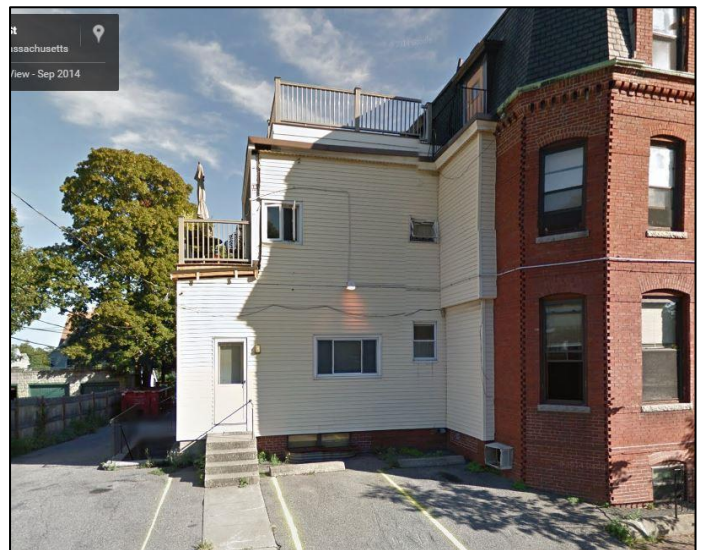
Fig. 7 Image from 2014 shows the construction of one of the unpermitted roof decks.

- a. Construction of roof decks
- b. Removal of vinyl siding
- c. Removal of clapboard siding
- d. Enlargement of window openings
- e. Creation of wall opening for a/c units

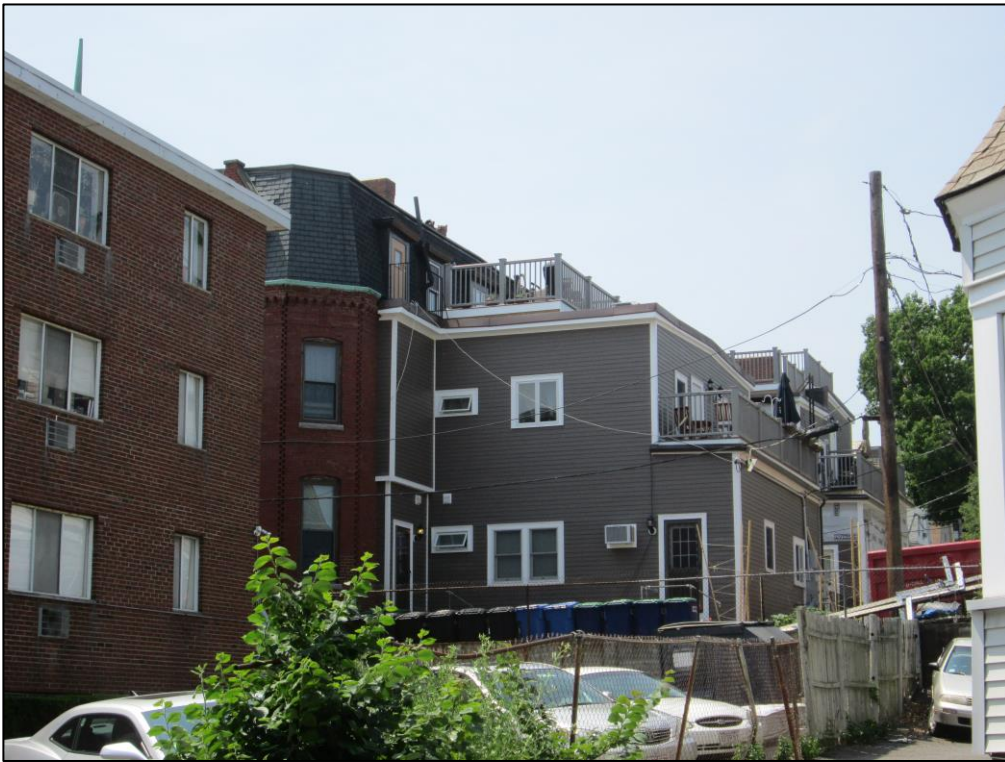
Fig. 7 Rear portion showing new window and a/c openings, new roof decks and newly-applied cement board and composite trim.

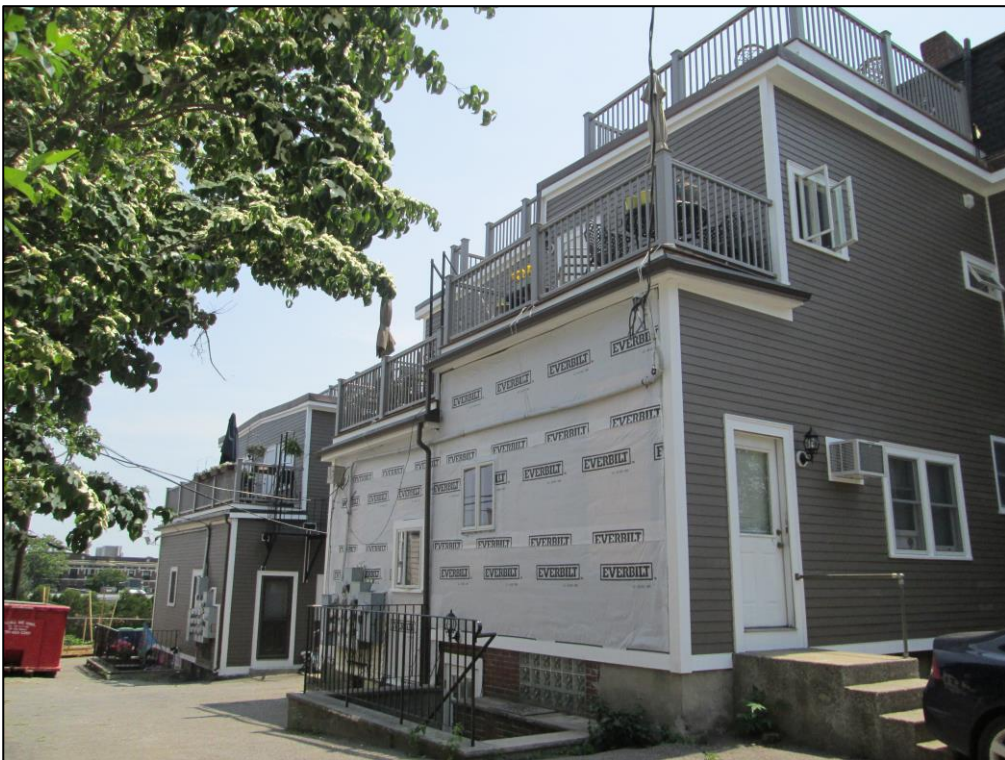
Fig. 8 View of rear extensions from Fenwick Street showing new window and a/c openings, roof decks, and in-process installation of cement board and composite trim.
