CITY OF SOMERVILLE, MASSACHUSETTS OFFICE OF STRATEGIC PLANNING & COMMUNITY DEVELOPMENT JOSEPH A. CURTATONE MAYOR

ALTERATION TO A HISTORIC PROPERTY STAFF REPORT

Site: 178 Central Street c.1840 Adams-Locke House

Case: HPC 2016.027 Single Building Local Historic District

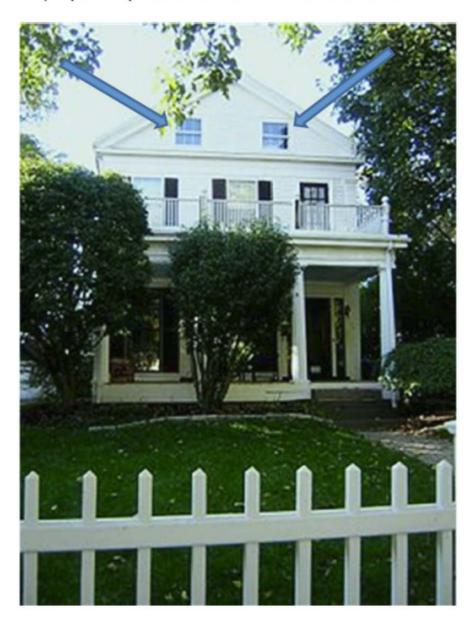
(Proposed replacement of attic windows indicated below

Front view of house facing sidewalk at 178 Central Street Page 7 of 9

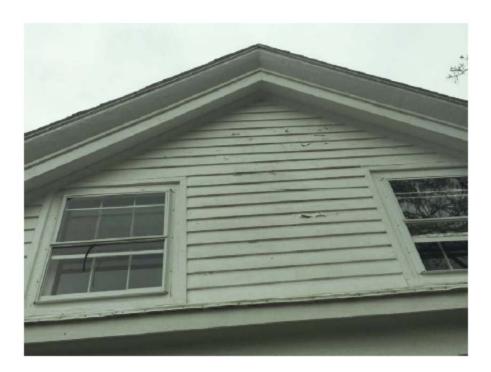
Close up of exterior attic windows from front of house facing Central Street. The replacement windows will be of exact same proportions and we will match the trim to rest of house. There will also not be any aluminum storm windows which should improve the historic character of the front of the house.

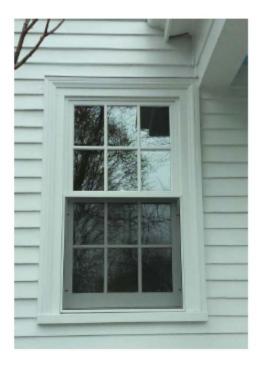
This is what the new replacement windows will look like (two photos above) from exterior and interior. These were taken from our kitchen project last year and represent the Marvin windows that were approved by the historic commission for that project. We will use the same windows except they will be 3 over 3 double hung. Below is a photo showing how well the new windows match the existing windows on rest of house
