**CITY OF SOMERVILLE, MASSACHUSETTS**  
**OFFICE OF STRATEGIC PLANNING & COMMUNITY DEVELOPMENT**  
**JOSEPH A. CURTATONE**  
**MAYOR**

*HISTORIC PRESERVATION COMMISSION*

**ALTERATION TO A HISTORIC PROPERTY STAFF REPORT**

Site: 178 Central Street c.1840 Adams-Locke House  
Case: HPC 2014.014 Single Building Local Historic District

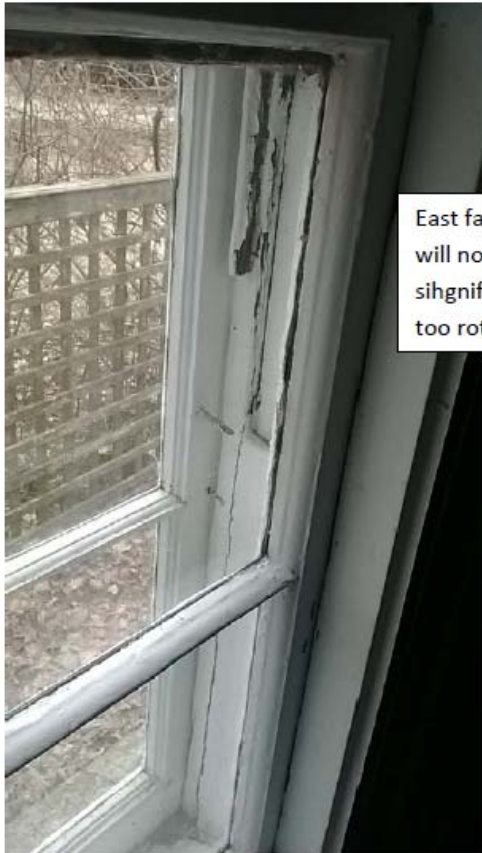
East facing window is rotted, and will not open and close and has significant air entry. The wood is too rotten to repair

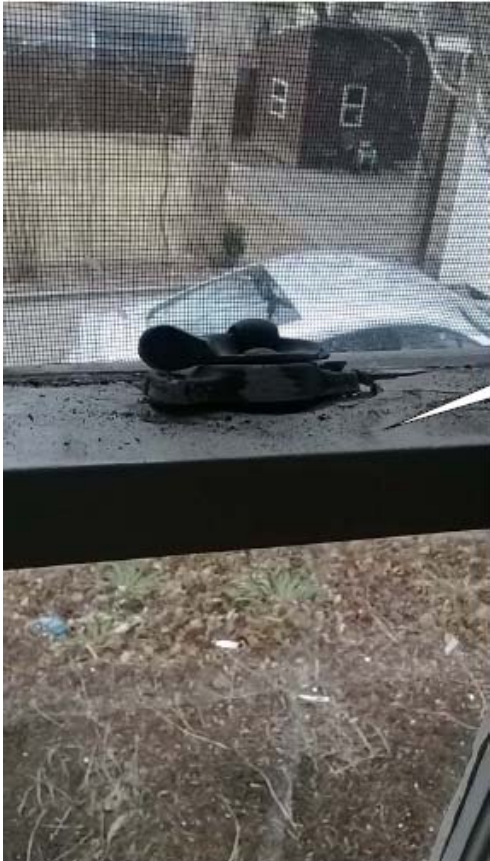
West facing windows (along driveway)  
have rotten sashes

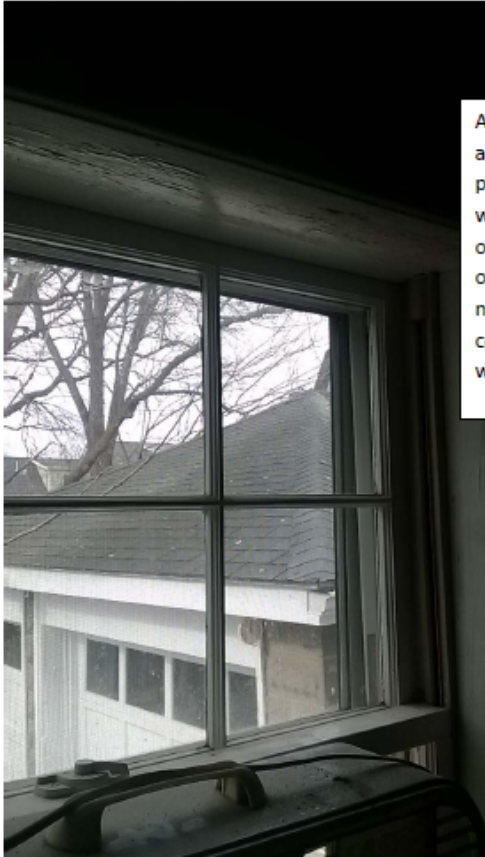
Another west facing window with indication of water damage and rot from water leaking through exterior fascia board. The picture also shows that these are old replacement sash windows and are not original to house. There are no headers on this window...it was just cut into wall and its location is not original to house. We are asking to replace these sashes with new wooden ones that offer double pane glass and better construction and better protection to house from rain and wind.
