CITY OF SOMERVILLE, MASSACHUSETTS
OFFICE OF STRATEGIC PLANNING & COMMUNITY DEVELOPMENT
JOSEPH A. CURTATONE
MAYOR

HISTORIC PRESERVATION COMMISSION

ALTERATION TO A HISTORIC PROPERTY STAFF REPORT

Site: 140 Highland Avenue c. 1890 – Barnes-Luce House
Case: HPC 2013.095 Single Building LHD, NRIND, NRMRA

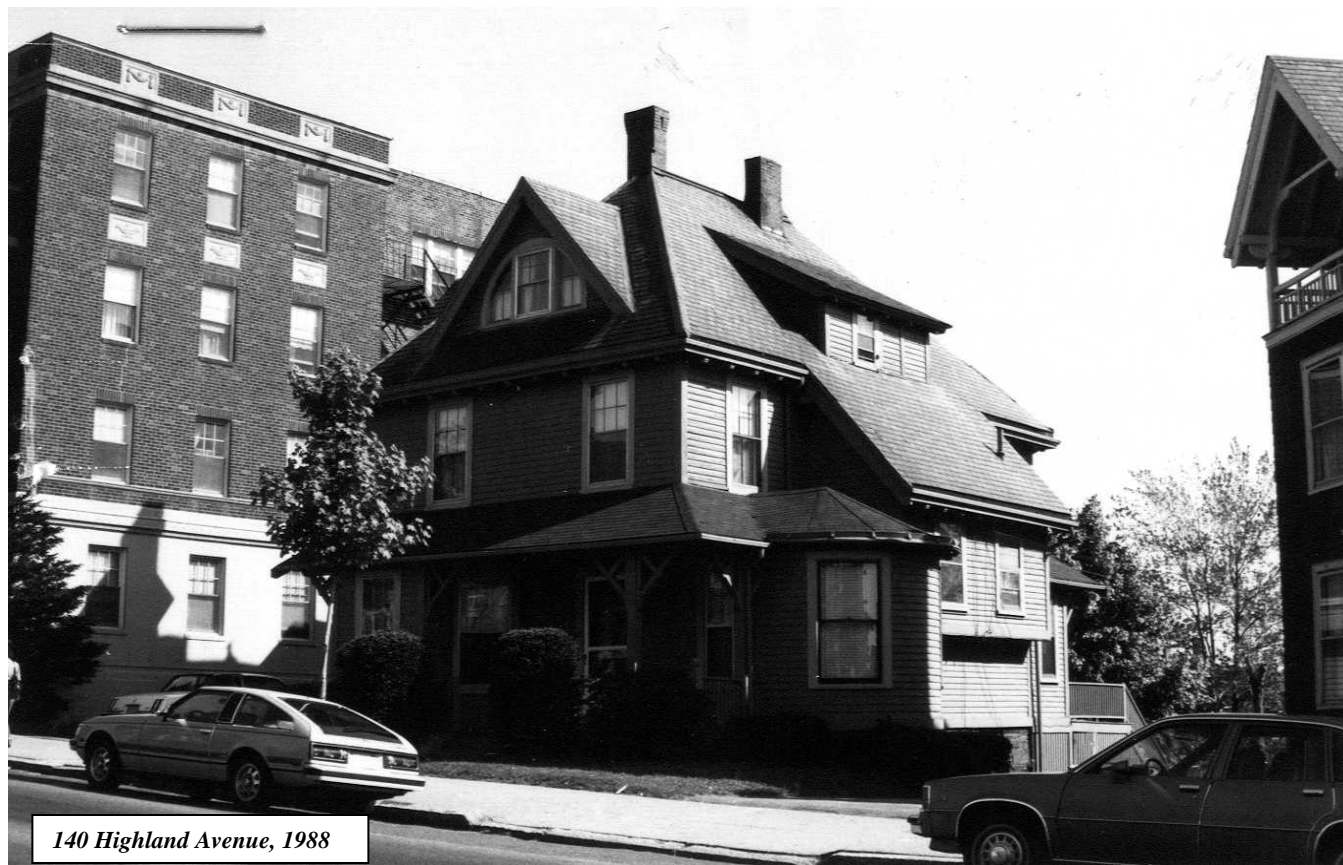
140 Highland Avenue, 1988

The chimney is clearly visible on the photo accompanying the Form B which was written in 1985 and included less architectural and historical information than today's requirements.

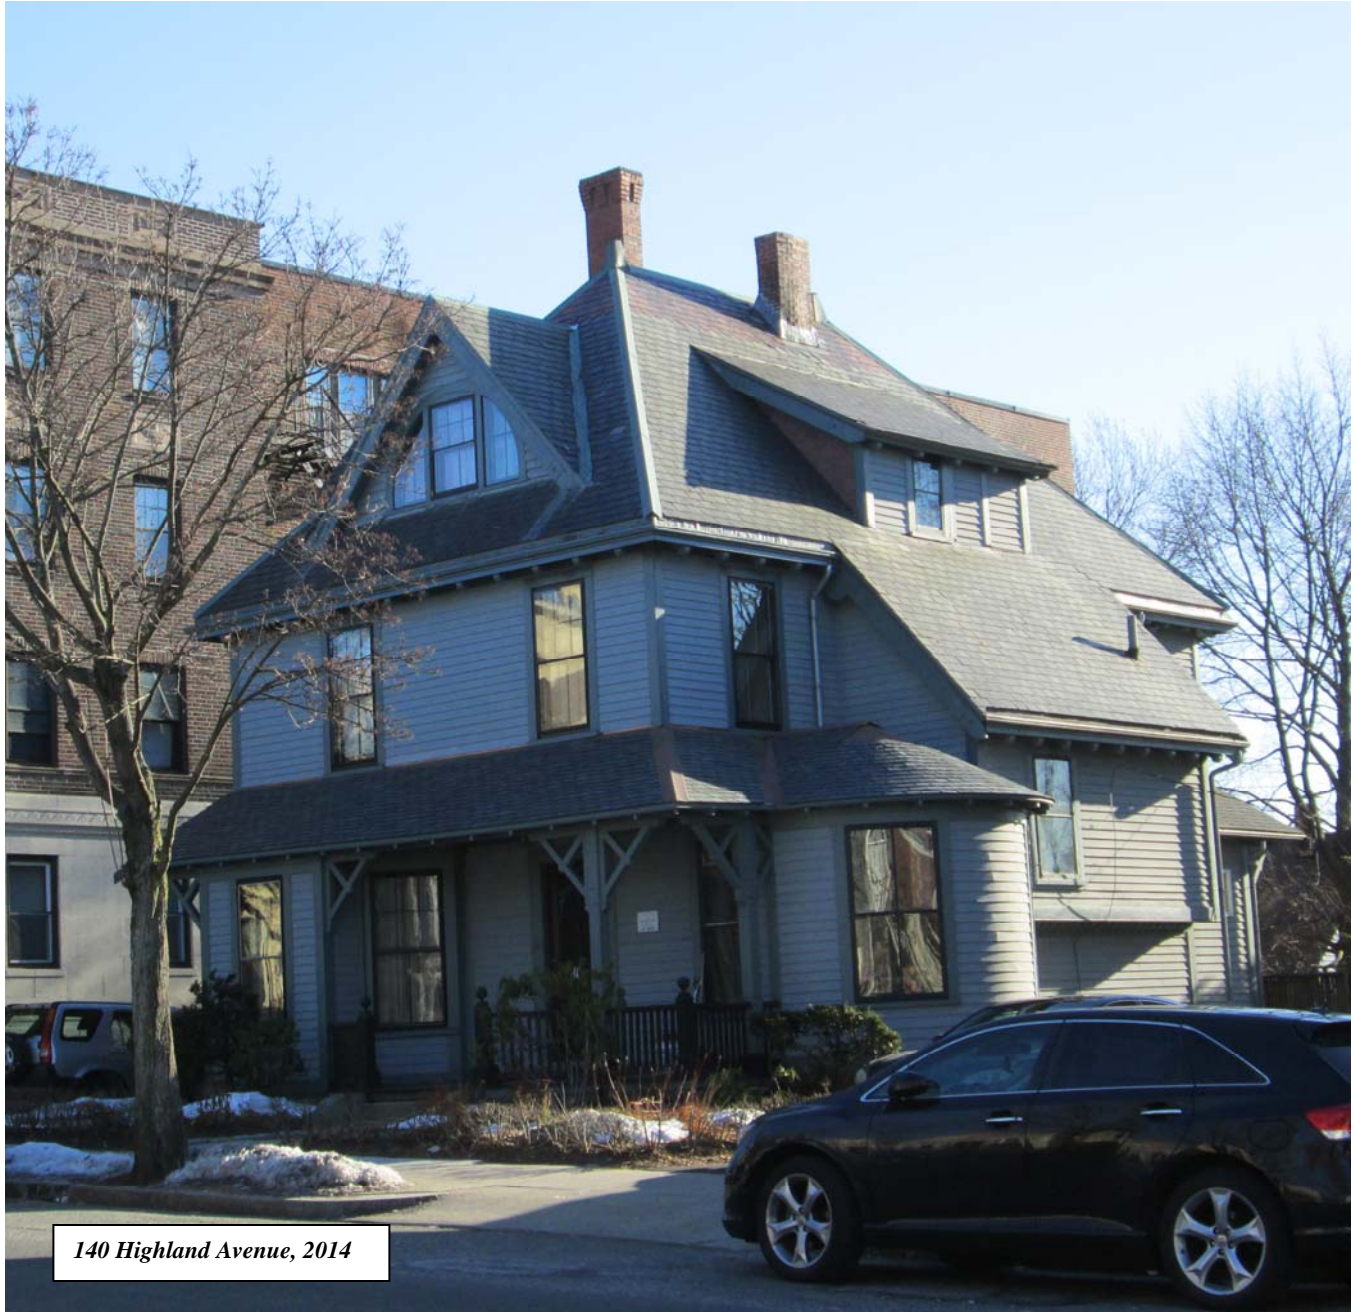
140 Highland Avenue, roof and chimney detail 2014

The chimney is visible from Highland Avenue.

The chimney and roof are visible from the public right of way.

Chimneys are a major element in the visual cues of the history and use of a building. The elaboration or simplicity of a chimney, where it is located tells a lot about the building and its inhabitants. The original

chimneys were both ornate, indicating that they were intended to be admired and were not merely utilitarian.

Staff determines that the alteration for which an application for a Historic Certificate has been filed is not appropriate for and compatible with the preservation and protection of the **140 Highland Avenue Local Historic District**; therefore **Staff recommends that the Historic Preservation Commission do not grant Michael Guigli a Certificate of Appropriateness** for the removal of a prominent chimney because it does not meet the above Guidelines. However, based on precedent, a replicated chimney in lighter weight materials that match the existing in size, color and texture with appropriate structural support could receive a Certificate of Appropriateness as there would be no visible change to the Historic District. **Staff recommends that the Historic Preservation Commission grant Michael Guigli a Certificate of Appropriateness** to *replicate the original intact chimney either with interior supports or in a lighter weight veneer to match in size, shape and texture.*
