CITY OF SOMERVILLE, MASSACHUSETTS
OFFICE OF STRATEGIC PLANNING & COMMUNITY DEVELOPMENT
JOSEPH A. CURTATONE
MAYOR

HISTORIC PRESERVATION COMMISSION

ALTERATION TO A HISTORIC PROPERTY STAFF REPORT

Site: 222 Morrison Avenue c.1873 William Shedd House
Case: HPC 2014.012 Morrison Avenue Local Historic District

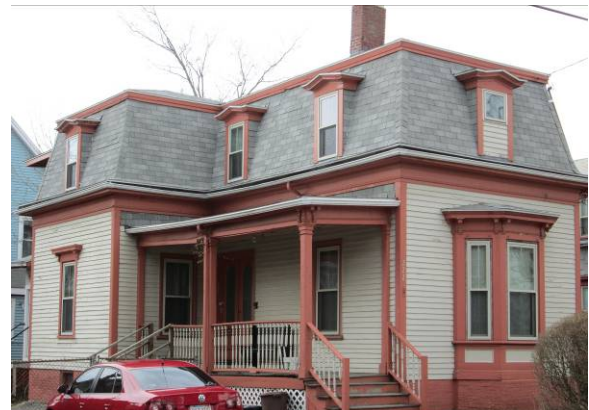
222 Morrison Avenue, 2014 photo

The porch is in poor condition with unsafe decking and broken balusters. The balusters had been replaced with tall interior stair spindle style balusters that are now breaking. Hand rails are constructed with 2 x 6 lumber. A second stairway to the back yard is constructed with pipe rails. The porch floor is buckling and needs replacement soon. Porch posts have rotting and damaged bases. The porch skirt is vinyl lattice.

Staff determines that the alteration for which an application for a Historic Certificate has been filed is appropriate for and compatible with the preservation and protection of the Morrison Avenue Local Historic District; therefore **Staff recommends that the Historic Preservation Commission grant Dorr Woodward a Certificate of Appropriateness for 222 Morrison Avenue to replace the existing porch rails and railings with simple wood railings, ~~turned~~ simple square balusters of a heavier weight than the existing, and newel posts consistent with the existing porch balusters and rails shown on the examples below** because they meet guidelines noted above.

1. The new railings and balusters shall *exactly match those on the front of 45 Vinal Avenue in construction, size, shape, proportion, detail and material.*
2. The 6" newel posts shall be detailed to match the existing historic porch posts.

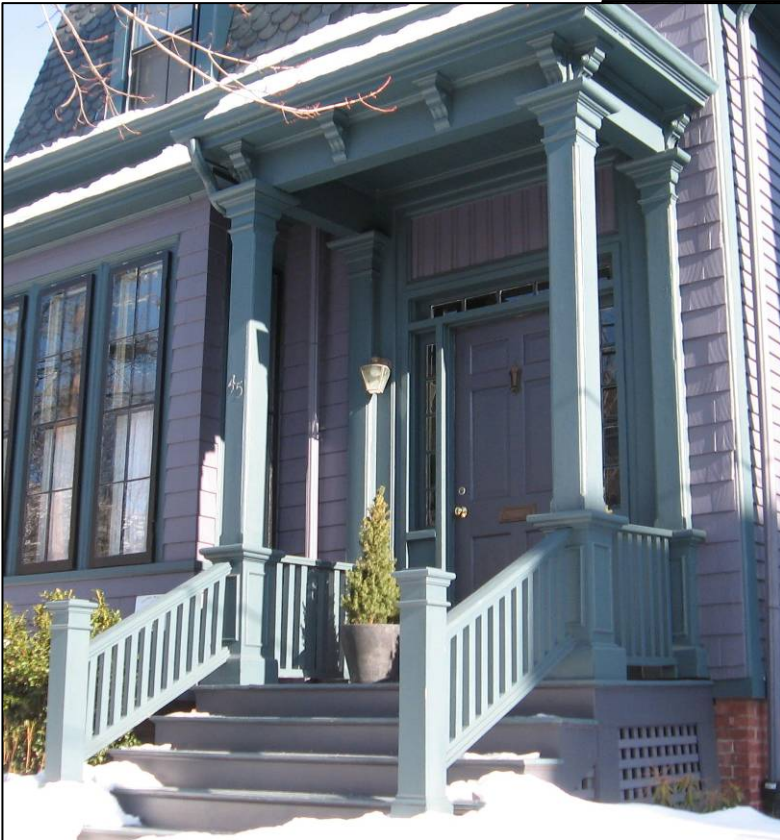
45 Vinal Avenue circa 1875 Mansard with modern balusters, railings at modern height and posts.

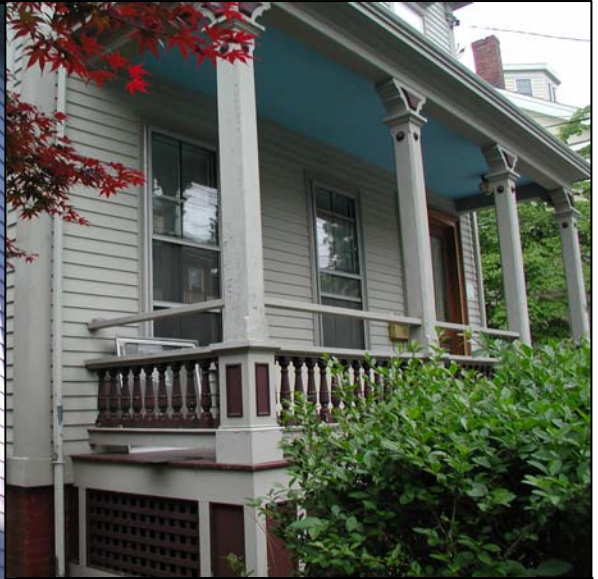
54 Atherton circa 1870 Italianate with turned balusters, railings at historic height and 'view panel'.

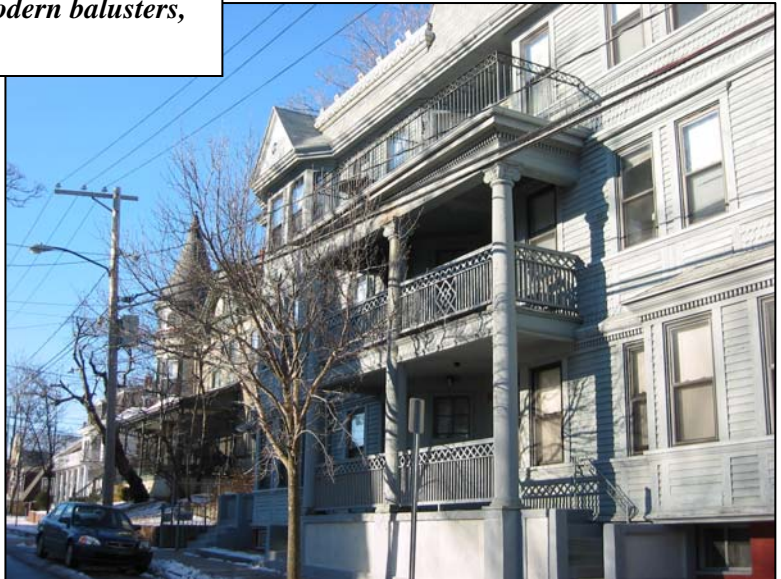
- Staff found only one case where the porch railings were raised to meet building code and insurance requirements. A Certificate of Hardship was issued in 2002 for 58 Walnut Street and 4-6 Pleasant Avenue because the buildings had many rental units; the work was done to comply with safety requirements set by the Insurance Company; and the additional height had been approached in a manner sensitive to the historic character of the building. In that case, considerable historic fabric was retained. See photos below.

58 Walnut Street circa 1890 with decorative rail height extender based on second floor latticework pattern.
