HISTORIC PRESERVATION COMMISSION

ALTERATION TO A HISTORIC PROPERTY STAFF REPORT

Site: 222 Morrison Avenue c.1873 William Shedd House
Case: HPC 2014.012 Morrison Avenue Local Historic District

Date of Application: February 9, 2016
Legal Notice:
Revisions to porch design, and driveway and walkway paving.

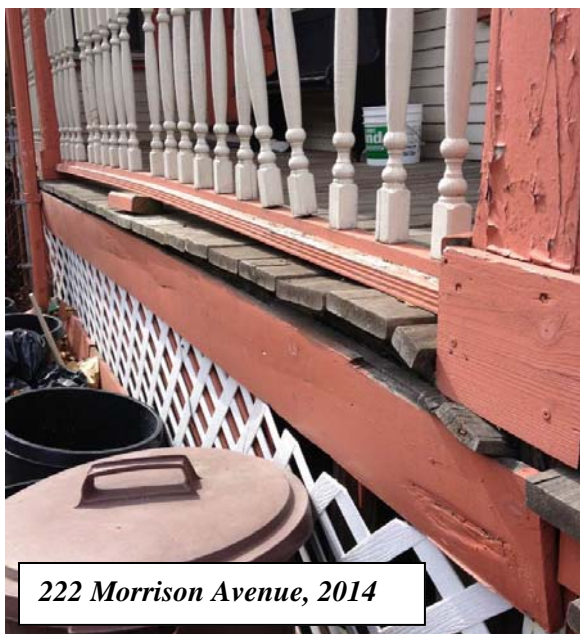
222 Morrison Avenue, 2014

The porch was in poor condition with unsafe decking and broken balusters. As can be seen from the photos, the break in the porch floor and the sinking corner post coincided with the location of the original stairway. The walkways were uneven with broken asphalt. The driveway was dirt. The current fence at the end of the driveway is chain link.

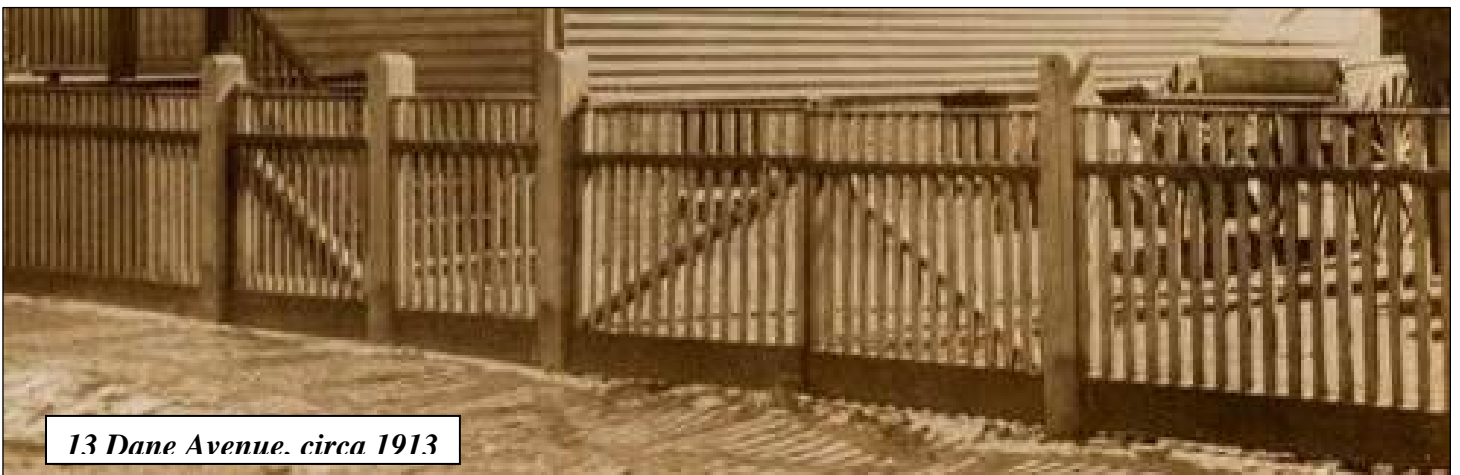
13 Dane Avenue. circa 1913

He also would like to replace the chain link fence at the end of the driveway and install a new wood fence based upon a fence and gates found on Dane Street as seen in a *circa* 1913-14 photograph by Eugene H. Jones.

The location of the stairs is based upon physical evidence of their previous location. The style of the fence is based upon an historic photograph and relates stylistically to the modern porch railings.

1. If the approval differs from the plans, new plans shall be submitted to Historic Staff prior to commencing the work;
2. The porch may remain as constructed;
3. The path and driveway may remain as constructed;
4. The chain link fence at the end of the driveway shall be replaced with a fence and gate with simple pickets top by a flat rail, a wide bottom rail at the base and a third rail near the top as shown on the photos below.
5. Historic Staff shall issue a sign-off upon completion of the project that this was done in accordance with the Certificate and approved plans.
