HISTORIC PRESERVATION COMMISSION

HISTORIC DISTRICT ALTERATION STAFF REPORT

Site / District(s) 8-10 Walnut Street / Single-Building LHD/NR
Case: HPC 2012.122

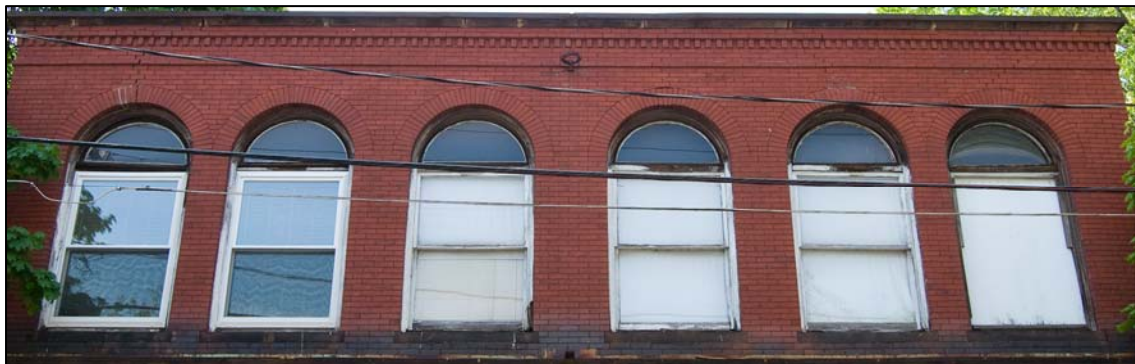
The prior existing conditions were very poor and only three of the original six wood windows were still in existence (see image below). The two left windows had already been replaced with vinyl and the right window opening has components of the upper sash that remain but there is no glass or bottom sash. The remaining three wood double hung windows are clearly in disrepair as well as the six fanlights above. Additionally, the tenant states that the wood sashes disintegrated upon the removal of the three remaining wood windows.

The existing conditions were poor. Two of the six windows had already been replaced with vinyl; one window is only left with components of the upper sash, and the three remaining windows are in such bad condition that the wood components of the windows turned into dust as they were removed.

For three (3) of the six (6) windows, two of which were previously vinyl and are located on the left side and one of which was previously plywood and located on the right side, Staff determines that the alteration for which an application for a Historic Certificate has been filed is reasonably appropriate for and compatible with the preservation and protection of the Local Historic District; **therefore, Staff recommends that the Historic Preservation Commission grant 8-10 Walnut Street a Certificate of Appropriateness.**

For the remaining three (3) windows, originally wood and located in the center, Staff determines that the alteration for which an application for a Historic Certificate has been filed is not reasonably appropriate for or compatible with the preservation and protection of the Local Historic District; therefore **Staff recommends that the Historic Preservation Commission deny 8-10 Walnut Street a Certificate of Appropriateness.**

Since the replacement windows have already been purchased and installed at the expense of the building owner, who thought the correct procedure had been followed, and since the previous windows were in such a poor condition that safety was an issue, **Staff recommends that the Historic Preservation Commission issue a Certificate of Hardship for the remaining three (3) windows that were originally wood. Staff also recommends a condition that upon the future replacement of these three aluminum windows, the Applicant shall replace them with Commission approved wood windows.**
