HISTORIC DISTRICT ALTERATION STAFF REPORT

Site / District(s) 8-10 Walnut Street / Single-Building LHD/NR
Case: HPC 2012.131

Date of Application: 11/30/2012
Legal Notice: Remove three wood fanlight windows and three wood sash windows and install three white color aluminum Universal windows within the existing openings.

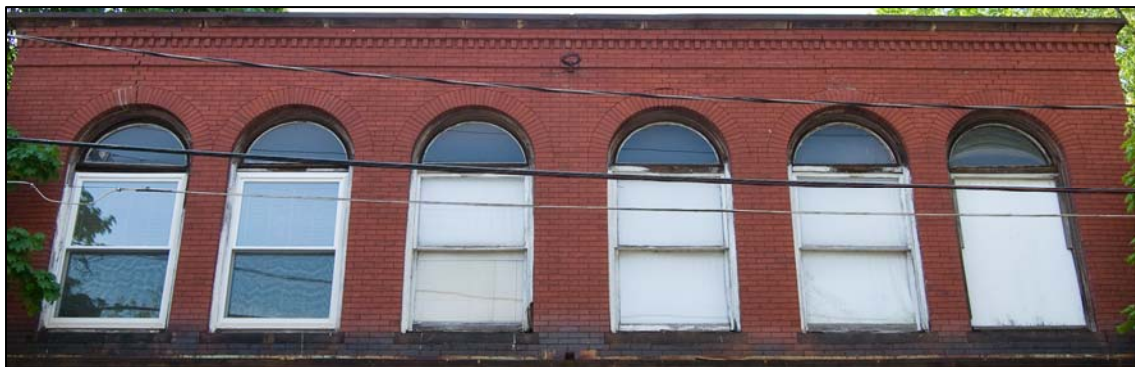
The prior existing conditions were very poor and only three of the original six wood windows were still in existence (see image below). The two left windows had already been replaced with vinyl and the right window opening has components of the upper sash that remain but there is no glass or bottom sash. The remaining three wood double hung windows are clearly in disrepair as well as the six fanlights above. Additionally, the tenant states that the wood sashes disintegrated upon the removal of the three remaining wood windows.

8-10 Walnut Street: Existing conditions before installation of aluminum windows

The existing conditions were poor (see photo). Two of the six windows had already been replaced with vinyl and one window was only left with components of the upper sash; these windows received a Certificate of Appropriateness last month. The three remaining wood windows are in such bad condition that the wood components of the windows turned to dust as they were removed.

According to photographs and statements offered by the tenant, Staff believes that the windows were likely not salvageable. Although the remaining three wood windows were replaced with aluminum, the feature itself still remains.

For the remaining three originally wood windows, Staff determines that the alteration/compromise for which an application for a Historic Certificate has been filed is reasonably appropriate for or compatible with the preservation and protection of the Local Historic District; therefore **Staff recommends that the Historic Preservation Commission grant 8-10 Walnut Street a Certificate of Appropriateness with two conditions: (1) the white aluminum windows shall be painted to match the cornice of the first story; and (2) upon the future replacement of these three aluminum windows, the Applicant shall replace them with Commission approved wood windows.**
