CITY OF SOMERVILLE, MASSACHUSETTS
OFFICE OF STRATEGIC PLANNING & COMMUNITY DEVELOPMENT
JOSEPH A. CURTATONE
MAYOR

ALTERATION TO A HISTORIC PROPERTY STAFF REPORT

Site: 137 Highland Avenue Samuel Gaut House c. 1848
Case: HPC 2016.082 Single Building Local Historic District

Date of Application: October 17, 2016
Legal Notice: *Replace windows.*

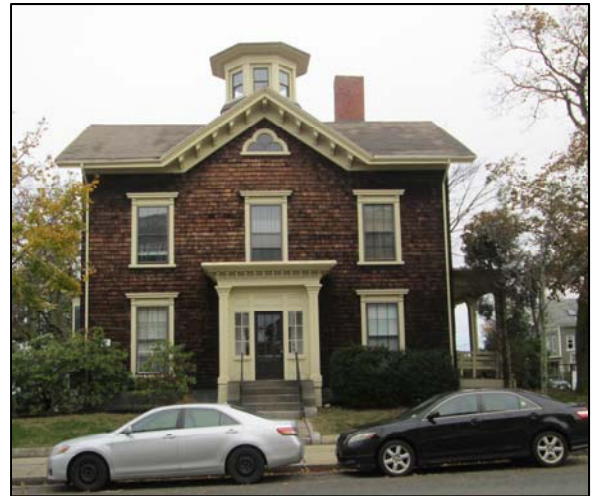
The Applicant would like to replace the original wood windows with Pella® Architect Series ® windows to match the existing configuration.

1. Remove existing original wood windows.
2. Pella® Architect Series ® windows to match the existing configuration.

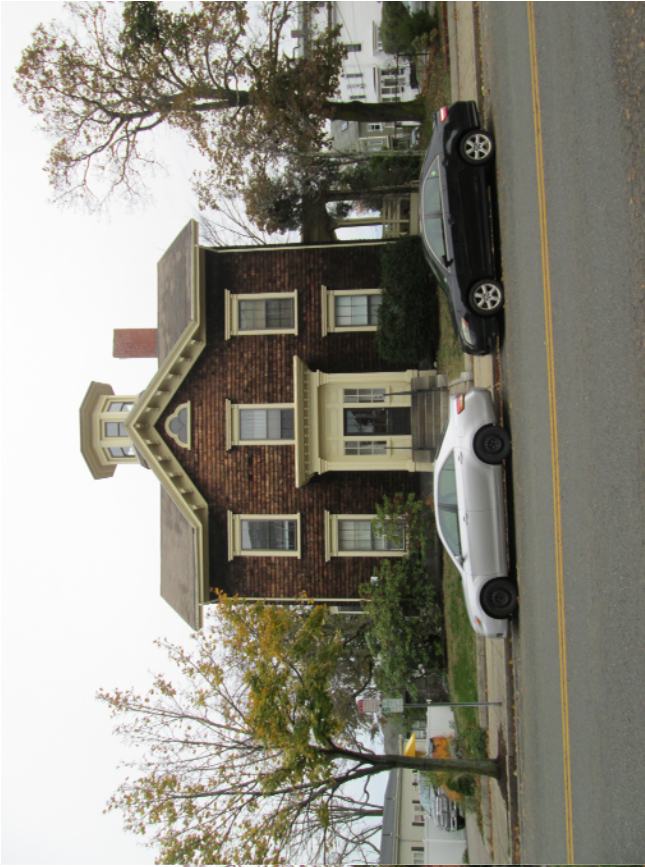
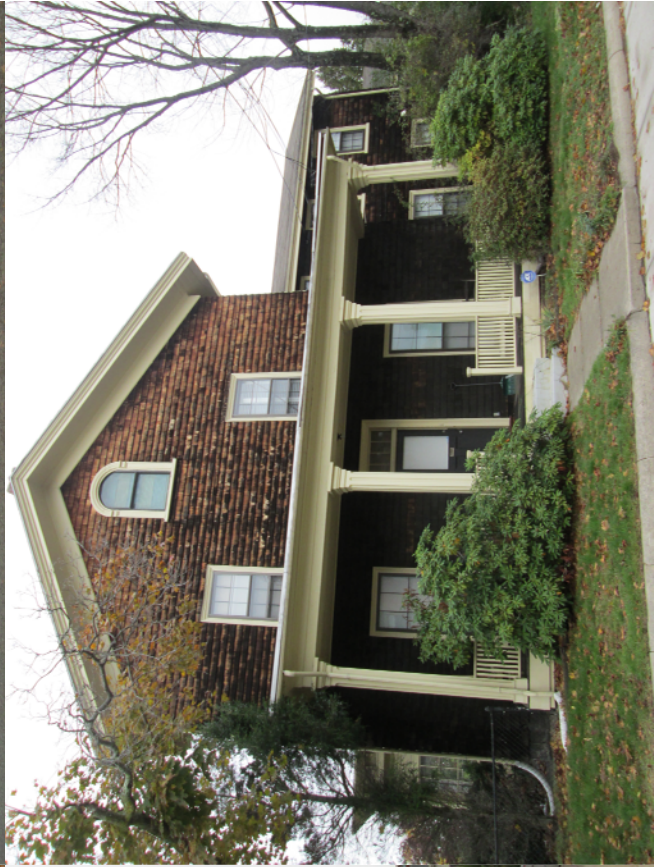
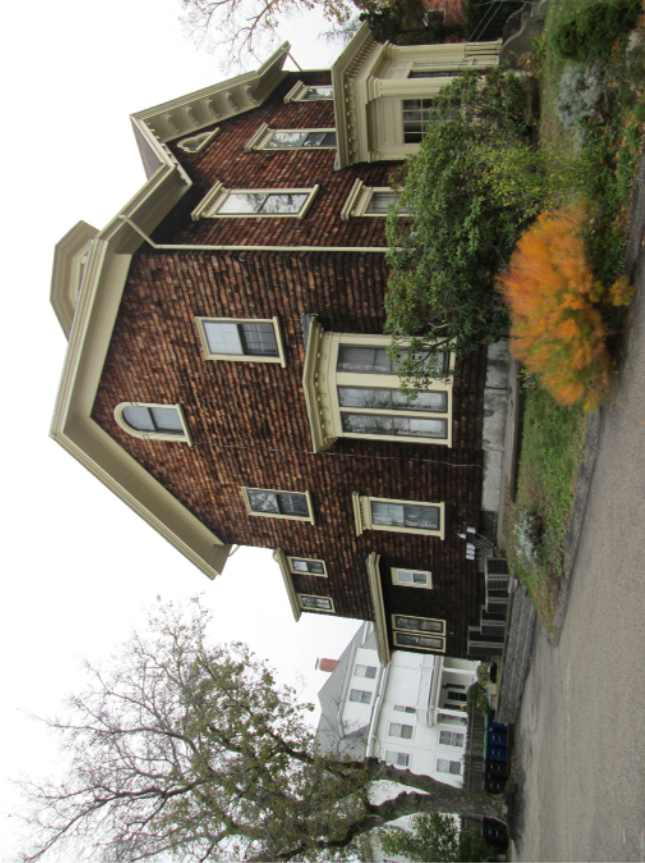
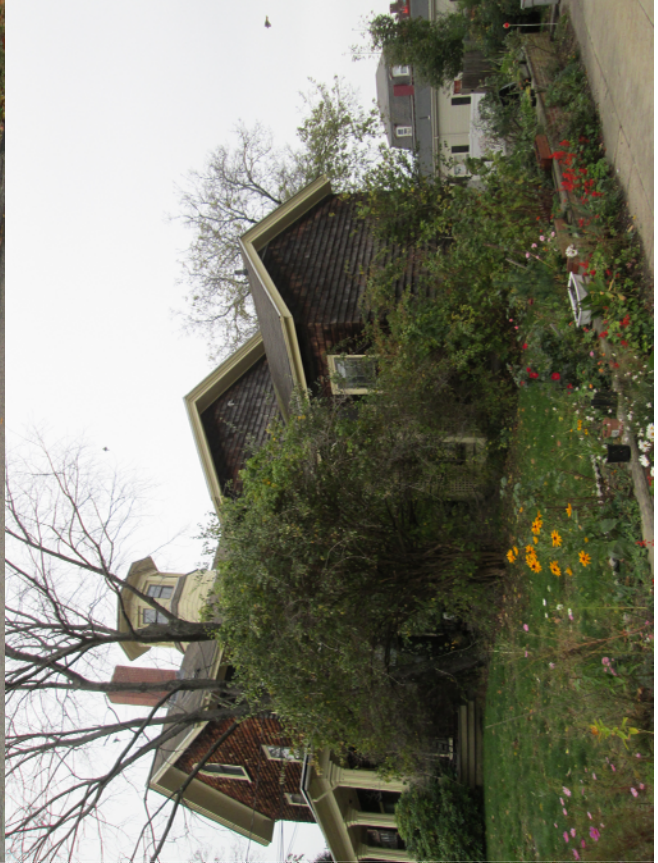
The wood-framed building is in good condition. Some of the windows have been replaced without a Certificate of Appropriateness from the HPC on the upper floors. The Applicant has stated that the windows are in poor condition and would like to replace them with windows that work. See attached photos of the meeting rails of some of the windows. Other members of the Condominium Association also complain of the drafts.

The photos submitted show that the meeting rails on some of the lower sash show signs of rot and need to be replaced.

The window openings will not be altered. The original materials will not be retained or replicated. This should only be considered as a last resort if the fabric of the window is deteriorated beyond repair. Photo-documentation of the condition of several windows without reference as to where they are located on the building has been received. At the time of writing the Staff Report (11/8/2016), It appears that neither the condominium association nor the applicant have spoken with any window repair professionals. The proposed windows will be constructed of primed wood of unknown type which may not be as durable as the old growth. The windows will have double glazing and low-E coating

A **Certificate of Non-Applicability** may be issued for the repair of the original windows and the installation of new storm windows.

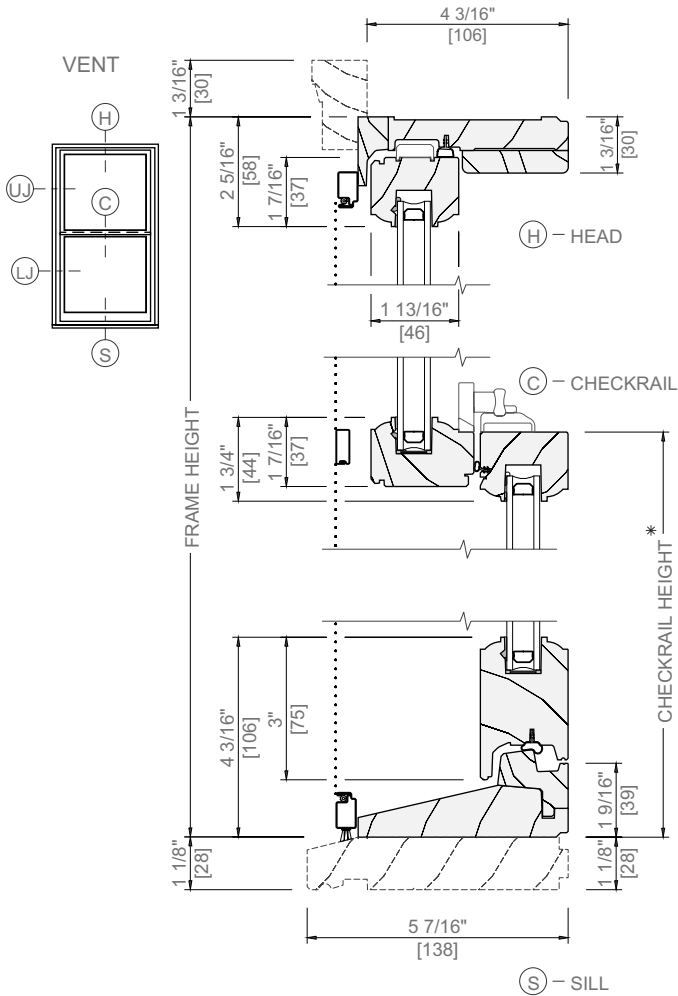
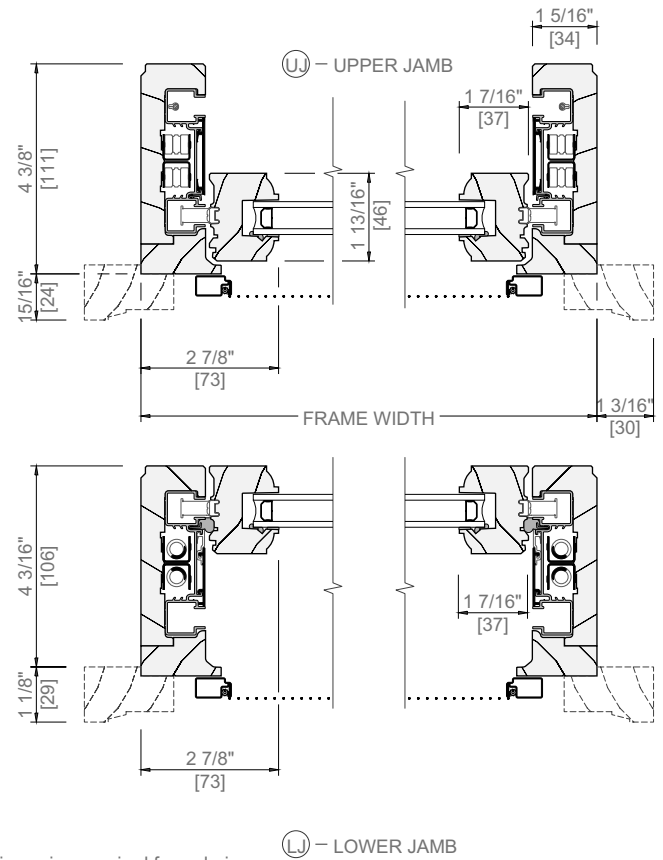
UNIT SECTIONS

LX Single- and Double-Hung

* Dimension required for ordering units with unequal sash.

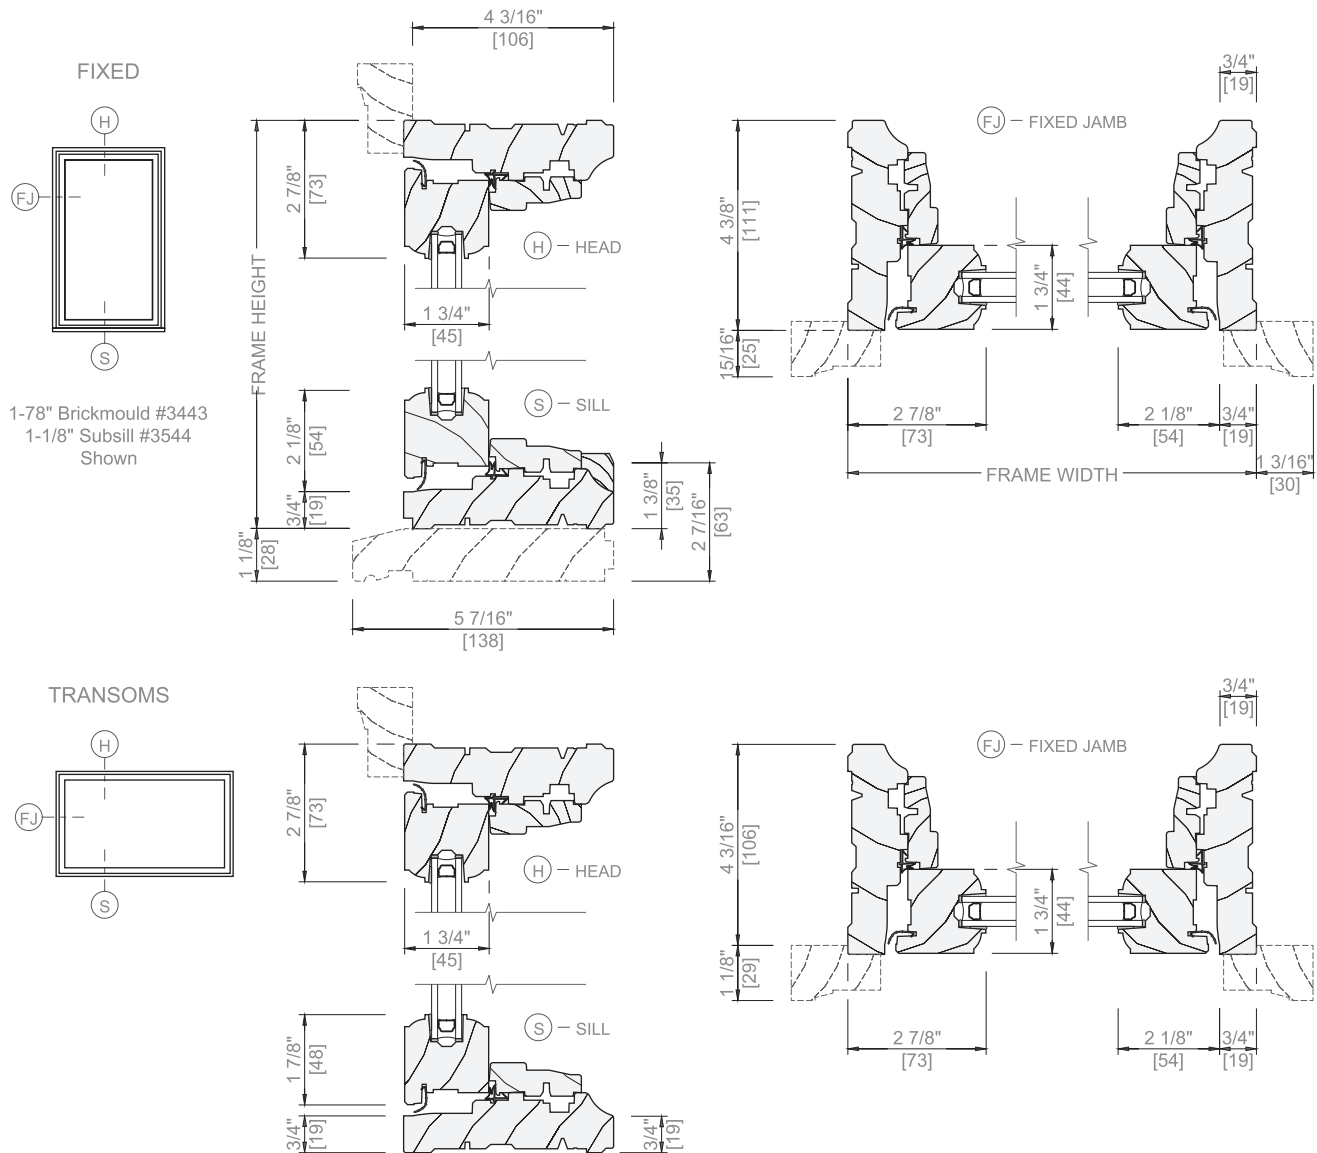
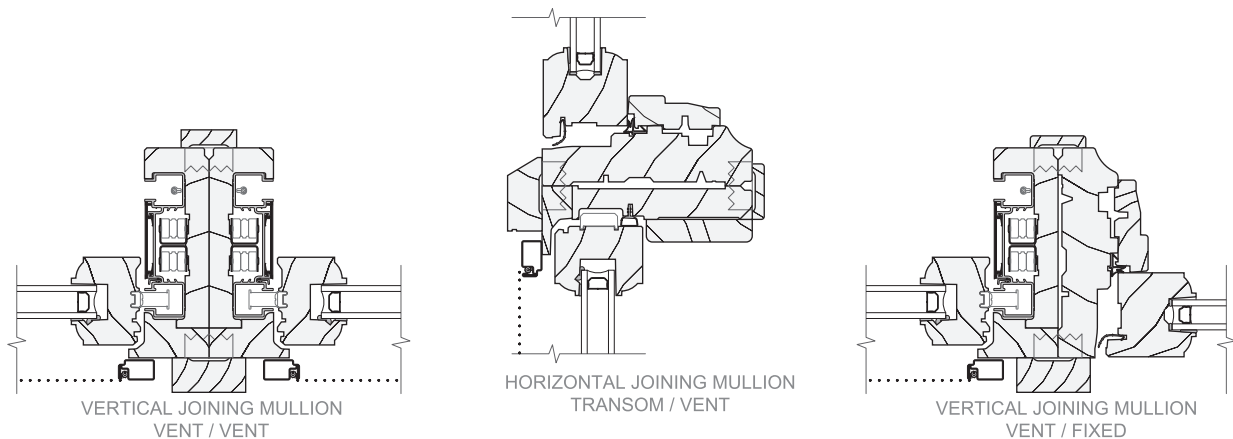
TYPICAL JOINING MULLIONS

LX Fixed and Transoms

See Installation and Performance at www.PellaADM.com for mullion limitations and reinforcing requirements.
