ALTERATION TO A HISTORIC PROPERTY STAFF REPORT

Site: 27 Columbus Avenue c.1892 Julia Gustin

Case: HPC 2016.078 Single Building Local Historic District

Legal Notice: Replace one 70's-era casement window in 2nd floor street-facing side and one 70-s era sliding glass

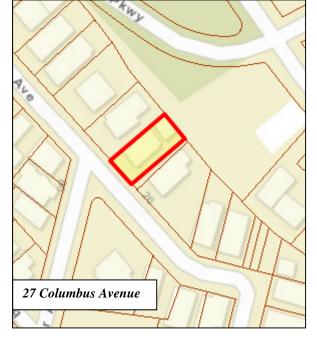
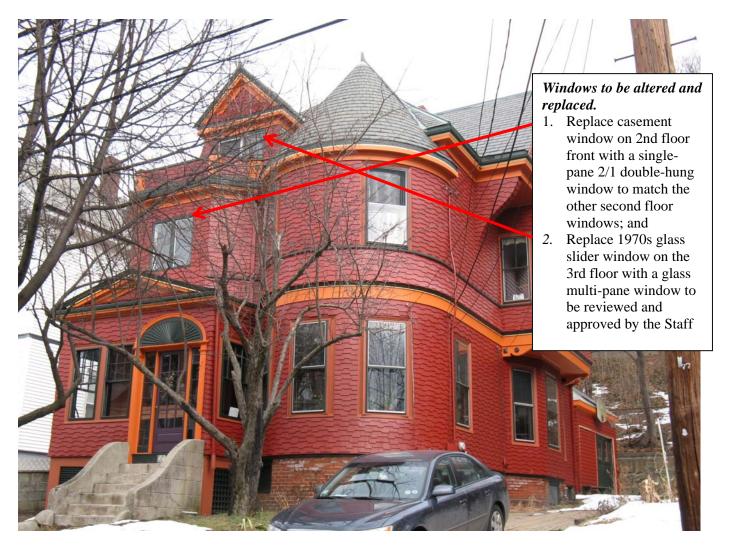
What are the Existing Conditions of the building / parcel?
 The existing windows are of a much later style inappropriate to a Queen Anne style house. The proposed windows have not been submitted to the Staff for evaluation. See photos at the end of the document.

The windows were not discussed in the Form B. The deteriorated windows are not original to the building and should be replaced with a more historically appropriate configuration. No historic features will replaced or altered. The original window styles are not known although it is likely that the sash had a 2/1 or 1/1 configuration. The windows are visible from the public right of way.

There is no intent to alter the openings. Interior photos show the bull's eye corner blocks and railroad casing to be different on each window. The second floor casing appears to be a replacement while the third floor casing appears to be original. This is a case where one original opening is unknown. If the sizing is correct, it is likely that it was a Queen Anne window. This would have had small colored panes surrounding a large clear glass pane. If the opening was made smaller to hold the existing sash, it is likely that the window was double-hung and rose to the stringcourse on the second floor similar to the other windows on that floor. The third floor window may have been a decorative Queen Anne window that fit the existing casing.

- 1. All appropriate building permits shall be obtained prior to the start of any work.
- 2. If changes are necessary to the proposed design for which this Certificate of Appropriateness was issued, new plans shall be submitted to Historic Staff prior to commencing the work.
- 3. Replace casement window on 2nd floor front with a single-pane 2/1 double-hung window to match the other second floor windows; and
- 4. Replace 1970s glass slider window on the 3rd floor with a glass multi-pane window to be reviewed and approved by the Staff.
- 5. Historic Staff shall issue a sign-off upon completion of the project that it was executed in accordance with this Certificate and approved plans.
