CITY OF SOMERVILLE, MASSACHUSETTS OFFICE OF STRATEGIC PLANNING & COMMUNITY DEVELOPMENT JOSEPH A. CURTATONE MAYOR

ALTERATION TO A HISTORIC PROPERTY STAFF REPORT

Site: 58-60 Atherton Street c.1845 Greek Revival Double House HPC 2016.059 Single Building Local Historic District Case: Spring Hill National Register District

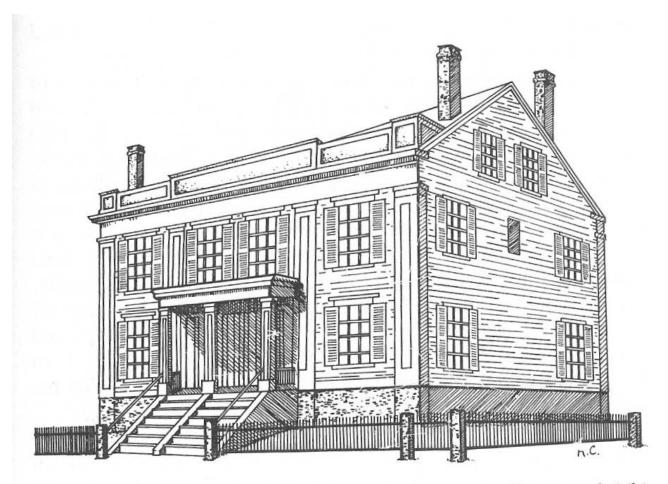
Fig. 27. Parapets, once common, have in most cases disappeared. This Portland duplex was drawn from an old photograph.

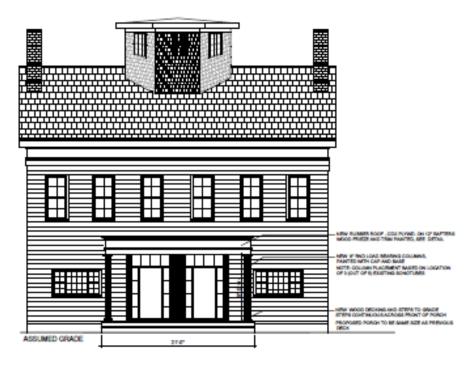
Proposed Front Elevation

- 1. Proposal of Alteration:
 - 1. Rebuild front porch to the same footprint (6' x 21') as the former porch.
 - 2. The steps would run the length of the porch.
 - 3. The porch roof will be supported by 8" round columns springing from the porch deck.
 - 4. The porch would be roofed with flat roof and have a simple entablature.
