HISTORIC PRESERVATION COMMISSION

DETERMINATION OF SIGNIFICANCE STAFF REPORT

Site:	18 Autumn Street
Case:	HPC 2012.130
Applicant Name:	Anthony Howard, ABH Services
Date of Application:	November 29, 2012
Recommendation:	Not Significant
Hearing Date:	December 18, 2012

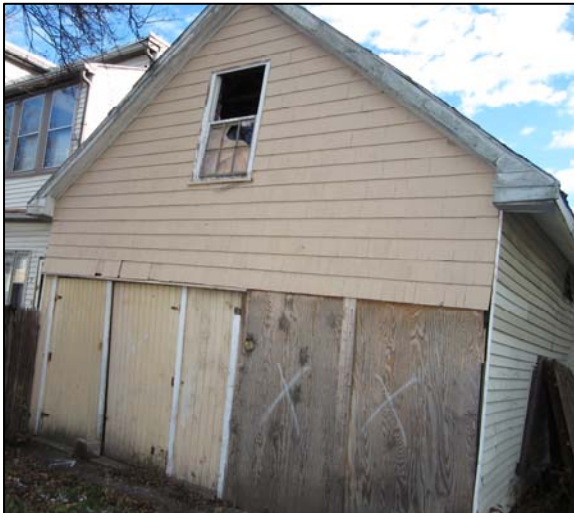
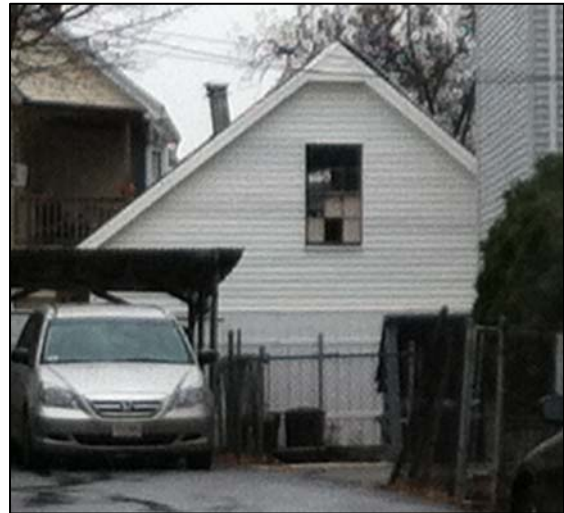
The subject structure, a c. 1895 stable/garage, is located at the back of the 18 Autumn Street parcel. This structure is a wood frame construction with a gable roof that is two bays wide. The primary façade is shingled while the remaining facades are synthetically sided. One window is located beneath both the north and south gable. The north façade no longer has the upper sash, but both windows are six over six. A six over one window is located near the ground on the right side. Although style is difficult to understand, due to the condition of the structure, the deep eaves and construction date suggest the Italianate style. This is consistent with the two-family dwelling on the lot, which is also likely to have been Italianate.

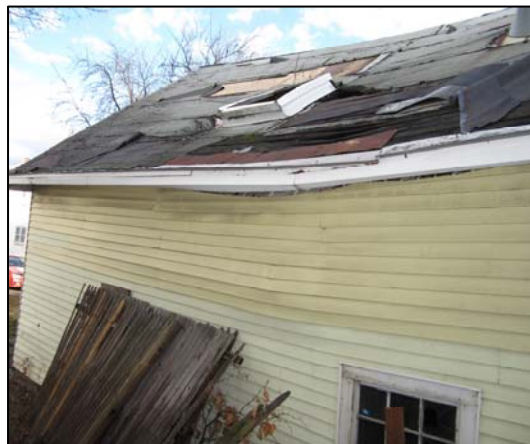
- c. Materials: Wood is the predominant material that composes this stable-type structure. Original windows exist on the rear and right side façades while only the lower sash exists on the front façade. The front façade is shingled while the remaining three facades are sheathed in synthetic siding. The roofing material is significantly deteriorated and has exposed sections of plywood, but appears to have been asphalt shingles.

- d. Alterations: Major alterations occurred in 1925 when the stable structure was expanded and given a pitch roof. Other alterations include synthetic siding, plywood on the roof and in the right side bay, and beadboard in the left side bay.

Other alterations to the structure since 1925 include synthetic siding, asphalt shingles, plywood, and beadboard. These materials have significantly altered the appearance and remaining integrity of the structure. Structurally, the building appears in extremely poor condition and is not safe. While components such as original windows still exist, the structure has been moved, significantly modified in 1925 as well as materially altered throughout the last several decades, and is most likely not currently stable.
