HISTORIC PRESERVATION COMMISSION

# DETERMINATION OF SIGNIFICANCE STAFF REPORT

Site: 2 Belmont Terrace
Case: HPC 2014.092
Applicant Name: Philip Kramer
Date of Application: October 29, 2014
Recommendation: Significant

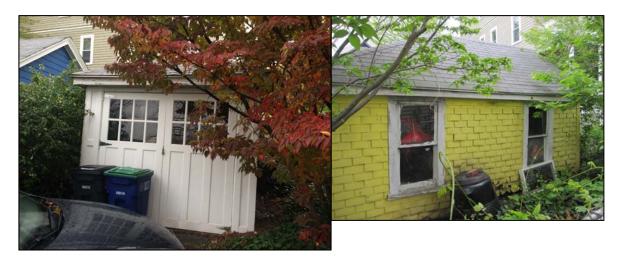
Architectural Description: The subject structure, a c.1925 garage, is located along Belmont Terrace adjacent to 2 Belmont Terrace (c. 1850). This structure is a wood frame construction one bay in width with a hipped roof. There are two windows located on the right side facade, however, the rear and left side facade are not visible due to vegetation and the adjacent buildings. The primary façade is composed of some wood panels on either side of the garage doors while the right side facade is shingled with two one-over-one windows. Although style is difficult to determine due to the lack of architectural detail, the garage doors with glazing at the top, shallow eaves, and one-over-one window glazing, along with the late date of construction, suggest an Colonial Revival style.
