**DETERMINATION OF SIGNIFICANCE STAFF REPORT**

Site: 73 Concord Avenue, barn  
Case: HPC 2013.013  
Applicant Name: Jose Vale, GS Construction

Date of Application: April 10, 2013  
Recommendation: Significant  
Hearing Date: May 21, 2013

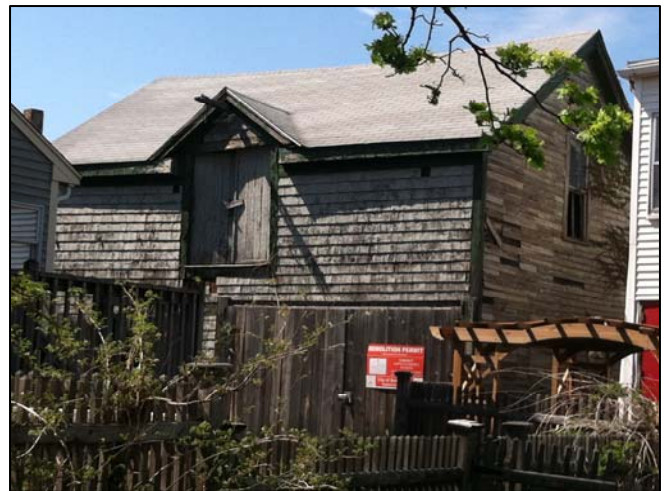
The subject structure, a c.1900 barn/stable, is located behind the dwelling at 73 Concord Avenue. This structure is a wood frame construction two bays in width with a side gable roof. The primary façade is shingled while the rear and right side façades are sheathed in clapboard and the left side façade is sheathed in synthetic siding. A hayloft door and hoist are centrally located in the half story of the primary façade; two paneled doors are located at ground level. One window (possibly original) is located on the right side façade while a boarded up window is located on the rear façade. The rear façade, at one point, also had a door. Although style is difficult to determine due to the condition of the structure, the depth of the eaves, primary façade shingles and construction date suggest a Victorian style. However, it is not clear if the possible Victorian style of the barn/stable is consistent with that of the c.1895 dwelling, due to extensive alterations.

*73 Concord Avenue, rear stable/barn*
