**CITY OF SOMERVILLE, MASSACHUSETTS**  
**MAYOR'S OFFICE OF STRATEGIC PLANNING & COMMUNITY DEVELOPMENT**  
**JOSEPH A. CURTATONE**  
**MAYOR**

*HISTORIC PRESERVATION COMMISSION*

**DETERMINATION OF PREFERABLY PRESERVED STAFF REPORT**

Site:	35 Cutter Street
Case:	HPC 2013.038
Applicant Name:	Sandra Xuyu
Date of Application:	June 26, 2013
Date of Significance:	July 16, 2013
Recommendation:	Preferably Preserved
Hearing Date:	Tuesday, August 20, 2013

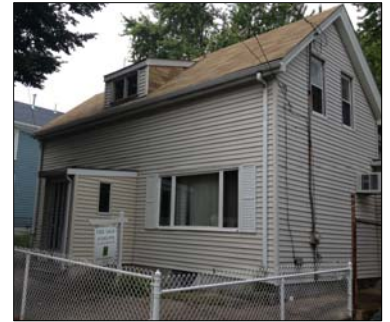
*35 Cutter Street, photos 2013*

The siting of the structure, centered on the lot, is rather uncommon by Somerville standards and does not seem to follow a pattern along the street. The original three bay fenestration pattern can be generally inferred, due to the small massing of this structure, and the center hall entry is still clearly understood; however, the level of detail for working class structures such as the subject structure is often minimal.

The Commission found that the remaining integrity of this single family dwelling is retained within the form and massing as well as portions of the fenestration pattern. As the level of detail for working class structures such as the subject structure is often minimal, integrity of such structures is often upheld by the original form and massing as well as fenestration pattern rather than the retention of architectural detail.

In accordance with the Demolition Review Ordinance (2003-05), Section 4.D, Staff find the potential demolition of the subject structure detrimental to the heritage of the City, and consequently in the best interest of the public to preserve or rehabilitate. Therefore, due to the earlier c.1858 construction date and intact existence of the original historic building context at the southern end of Cutter Street, which demonstrates early subdivision activity, and as a representative of mid 19<sup>th</sup> century working class housing, **Staff recommend that the Historic Preservation Commission find 35 Cutter Street Preferably Preserved.**

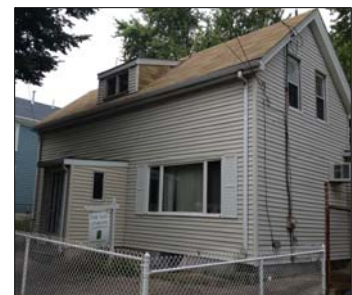
*35 Cutter Street, photos 2013*

One-story side-gable dwellings with three bays are located in certain areas throughout the City and compose a moderate portion of the residential housing stock within the City. This building type is generally constructed as a single family dwelling and often constitutes workers housing. Comparable structures along Cutter Street as well as in the Lowell Street neighborhood include:

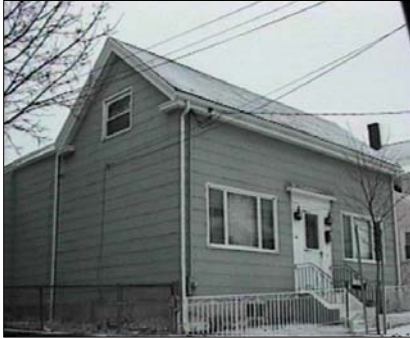
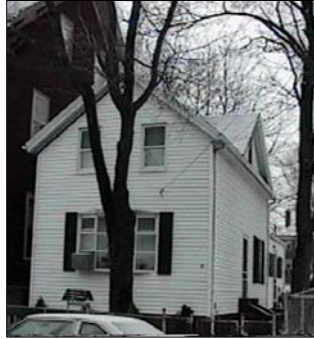
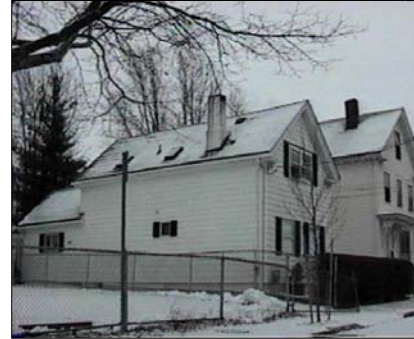
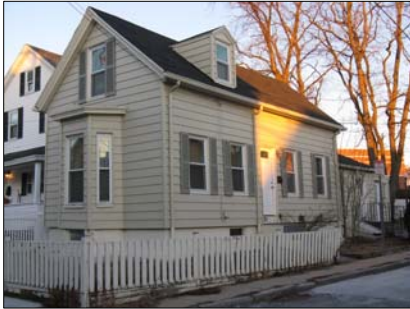
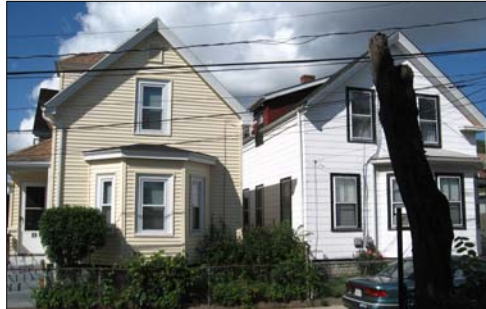
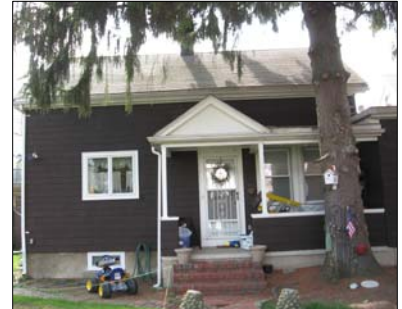
*Top: 40 Cutter Street; 18 Cutter Street; 34 Cutter Street  
Bottom: 37 Fiske Street; 23-25 Fiske Street; 283 Lowell Street*

- 40 Cutter Street (center hall entry)
- 18 Cutter Street (center hall entry)
- 34 Cutter Street (center hall entry)
- 37 Fiske Street (center hall entry)
- 23-25 Fiske Street (center hall entries)
- 283 Lowell Street (center hall entry)

Predominant differences between the comparable dwellings and the subject dwelling are the level of architectural detail, such as bay windows and eave returns, and the level of architectural integrity that remains due to alterations and the removal of historic fabric. Many of the comparable structures, as well as the subject dwelling, have an altered fenestration pattern due to enlarged windows on the primary façade. A majority of these comparative structures appear to retain more architectural integrity than the subject structure.

In addition, while all the examples present a center hall entry, several are oriented with the gable end facing the street. While this is not a predominant building type found throughout the City, as the comparable structures illustrate, other examples exist both within the Cutter streetscape and within other areas of the City.

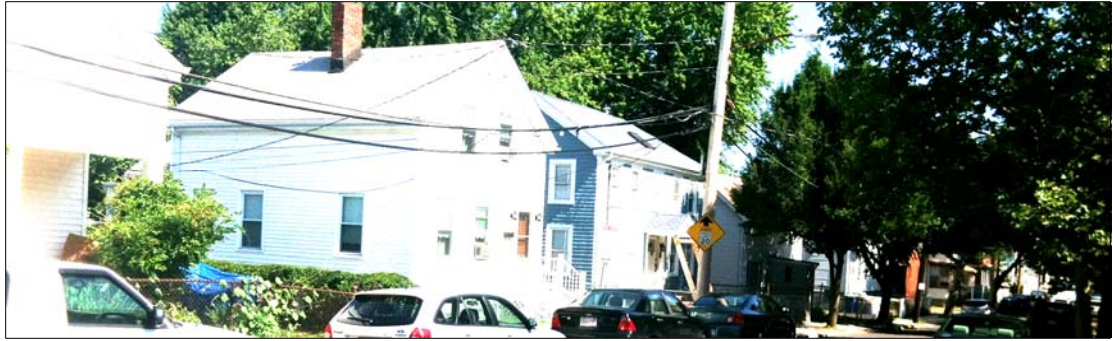
*Cutter streetscape, photo 2013*

The subject parcel is highly visible along Cutter Street and is located near the center of the streetscape, which remains predominantly intact. Cutter Street composes a mixture of 1½ and 2½ story buildings with a consistent gable form. Though the gables are oriented both to the

street and to the side of the lot, they do not necessarily correlate to front entrances which are also both oriented to the street and to the side of the lot.
