HISTORIC PRESERVATION COMMISSION

DETERMINATION OF SIGNIFICANCE STAFF REPORT

Site:	27 Dickinson Street	
Case:	HPC 2014.057	
Applicant Name:	Inman Square Development LLC	
Date of Application:	June 30, 2014	HPC received: August 1, 2014
Recommendation:	Not Significant	
Hearing Date:	September 16, 2014

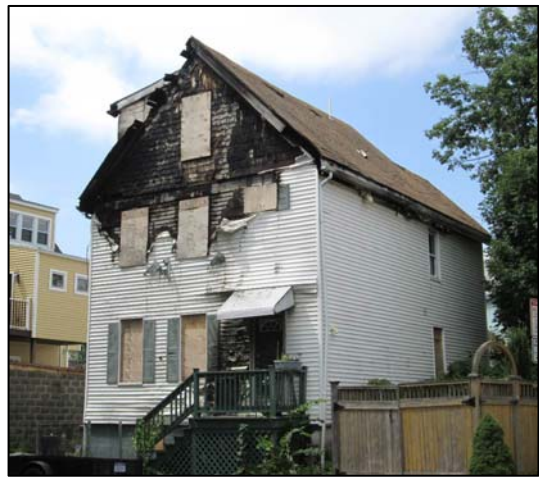
27 Dickinson Street, September 2014

Architectural Description: The house is a gable-end side-hall plan Queen Anne. The majority of the building is covered by vinyl siding. The main entry has a metal door hood on the northern edge of the main façade. The ground floor has 2 windows to the left of the door. The second floor main façade has three windows with the northern most being shortened. The fire melted vinyl siding revealed decorative shingles in the gable with a central window. None of the windows retain any casings. . A shed dormer is located on the south side of the roof. The foundation is parged and painted. There is a rear kitchen ell.

- a. Location: The building has not been moved.
- b. Design: The design has been modified by the addition of vinyl siding. While the siding was applied over the clapboards and trim, the window casings were altered for the application of the siding. The windows have been removed. A dormer was added in 1992.
- c. Materials: The original decorative wood shingles are visible in the front gable which indicates that more of the original siding may remain beneath the vinyl.
- d. Alterations: The addition of vinyl siding, a dormer, parged foundation and the altered window, the missing windows, and door hood have been noted above as alterations.

Evaluation of Integrity: The building has lost its integrity due to the alterations noted above along with the extensive damage due to a fire in the fall of 2013. The building has no individual distinction but is part of the rhythm of the street. Most of the buildings are gable front 2 ½ story Queen Anne homes with vinyl or aluminum siding. There is one 3-decker in the neighborhood.
