*HISTORIC PRESERVATION COMMISSION*

**DETERMINATION OF SIGNIFICANCE STAFF REPORT**

Site:	88 Dover Street
Case:	HPC 2013.050
Applicant Name:	Mui Sin Chow & Nam Cheung
Date of Application:	07/30/2013
Recommendation:	Significant
Hearing Date:	August 20, 2013

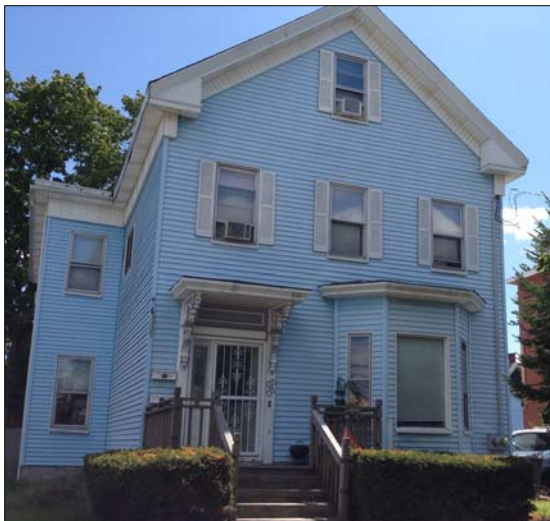
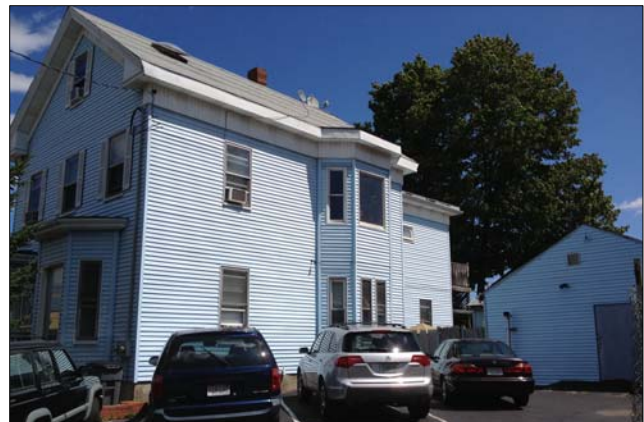
The subject property, c.1874, is a 2½ story two-family dwelling that is three bays wide with an entry door hood and polygonal bay on the primary façade, a two-story polygonal bay on the right side facade, vinyl siding, and replacement windows. The structure has a two-story rear ell and one chimney at the rear of the main massing; the foundation has been parged but appears brick in small areas. A small workshop (c.1934) is located at the rear of the lot on the right side. This dwelling represents the Italianate style, which is illustrated by the polygonal bays on the primary and right side façades, deep eaves, and the door hood.

*Front and right side façades of 88 Dover Street, photos 2013*

- b. **Design:** The current design of the building illustrates three bays in width with a side hall entry interior plan. The front façade retains a polygonal bay on the first story and an original entry door hood. The right side façade implies the main building is two rooms deep while the left side façade implies the rear ell is also two rooms deep. While the dwelling is clad in vinyl with replacement windows, the entry door and hood, eaves, and polygonal bays continue to illustrate Italianate style.

Alterations, such as replacement windows, siding, and asphalt shingles, have modified the exterior appearance of this two-family dwelling over the years; however, the form and massing and some architectural detail remains in tact and visible.

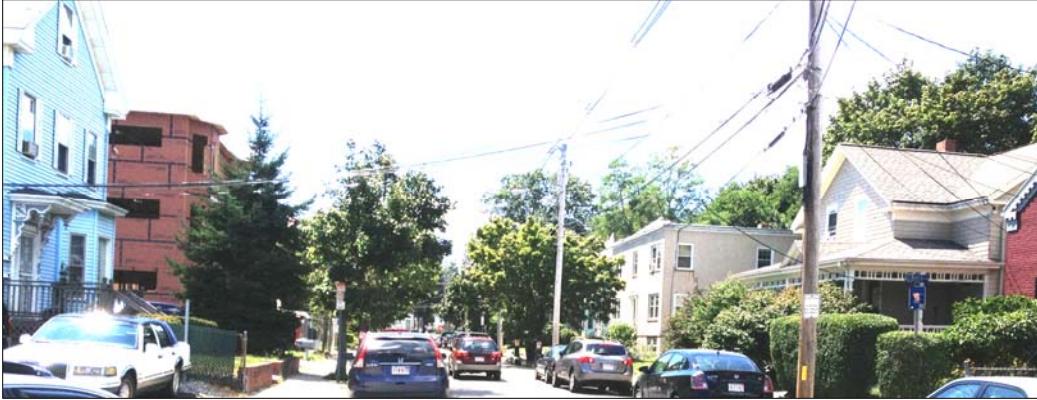
The subject building bookends the historic structures at the north end of this streetscape. While the adjacent dwelling at 82 Dover has recently been demolished and is currently being redeveloped, this subject dwelling is still located within a context of buildings and structures which reflect the development of this neighborhood as a commuter suburb. However, the subject parcel, located approximately 500 feet from Davis Square, is directly adjacent to the commercial and industrial development that encroaches into this clearly defined residential neighborhood. Additionally, a modern apartment building is located across the Street.

*Dover Streetscape looking south*
