DETERMINATION OF SIGNIFICANCE STAFF REPORT

Site:	88 Dover Street – Accessory Building
Case:	HPC 2016.028
Applicant Name:	Sing Cheung
Date of Application:	April 25, 2016
Recommendation:	Significant
Hearing Date:	May 17, 2016

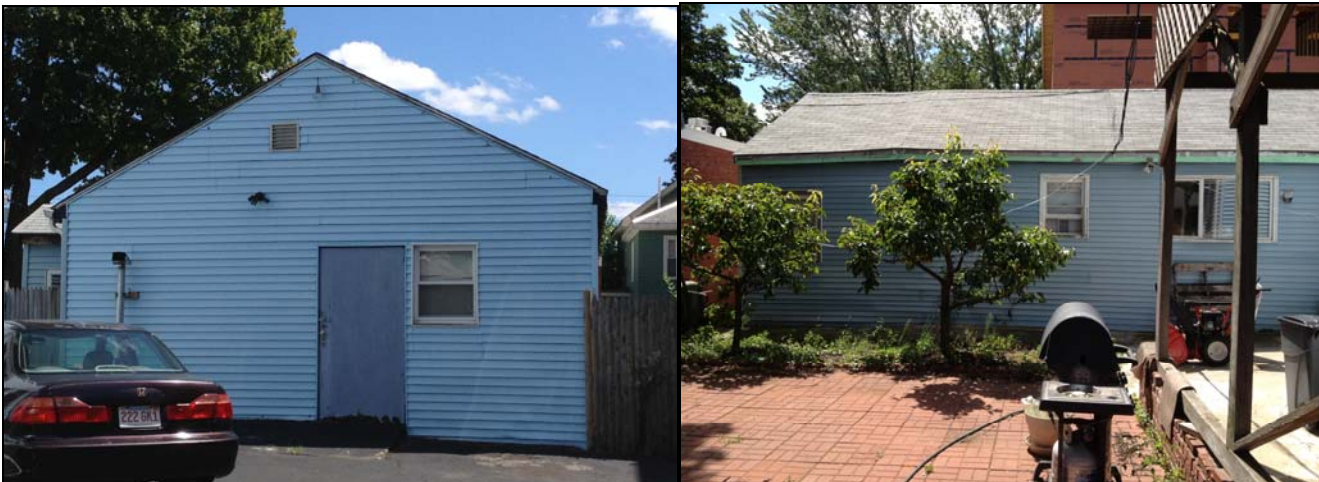
The subject property, c.1924 as found in the building permit records, is a 1 story gable-end vinyl clad accessory building that is one bay wide with an entry door and vinyl replacement window located off center on the primary façade. From the north side, the wall is punctuated by vinyl windows. A differentiation of the roof indicates that the building may have been constructed at different times although no evidence was found in the building permit records or historic maps to indicate if and when this might have occurred. There is no record of when the house and accessory building were clad with vinyl.

Front and north sides of 88 Dover Street accessory building, photos 2013

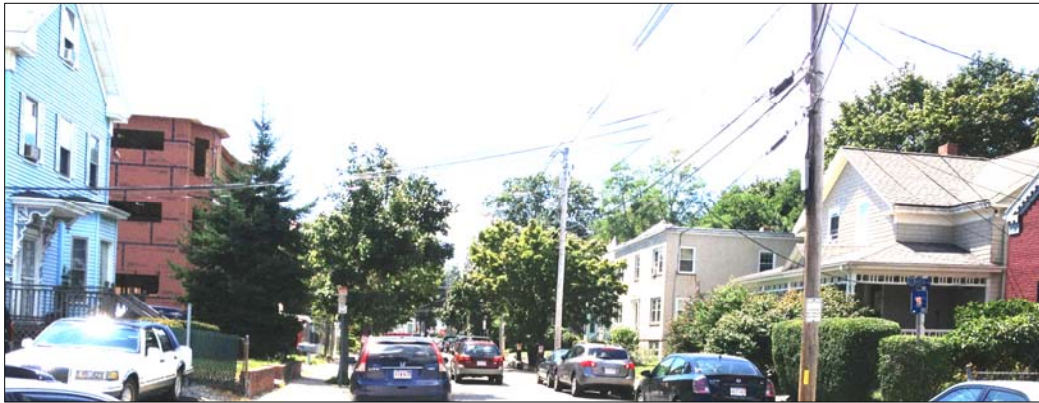
Dover Streetscape looking south
