HISTORIC PRESERVATION COMMISSION

ALTERATION TO A HISTORIC PROPERTY STAFF REPORT

Site / District(s):	80 Franklin Street	c. 1850 – Blodgett-Gee House
Case:	HPC 2014.098	Lower Franklin Street Local Historic District
Applicant Name:	Walter Jr. Moura, Contractor	
Applicant Address:	97 Winthrop Street, Medford, MA	
Date of Application:	November 24, 2014	
Legal Notice:	Remove chimney	
Staff Recommendation:	Deny Certificate of Appropriateness	
Date of Public Hearing:	December 16, 2014

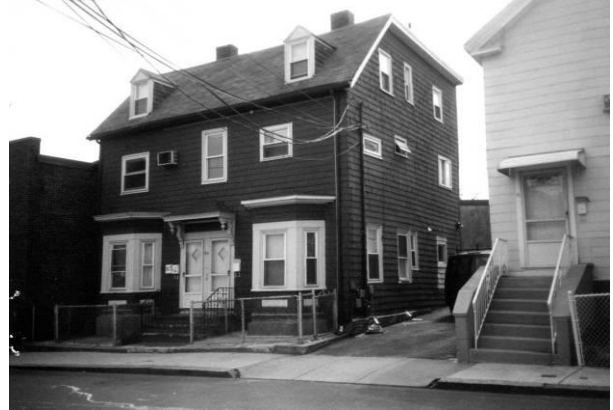
Architectural Description: The early double house at 80 Franklin Street was likely built 1848-1852 by an unknown housewright for Nathan Blodgett as the original owner, later owned by John Gee. The plan follows a Late Federal period double house form of two stories with a gable roof and two rear chimneys, set on a brick foundation. The plan is similar to 74 Franklin Street (SMV.584), also owned by Blodgett, and possibly built as a boarding house. The design is Italianate Style as seen in the bracketed entrance hood and the paneled facade bays, while the pedimented dormers show an older Federal Style form, suggesting a conservative builder. A recent remodeling has altered the second story window facade, possibly from a five bays as 74 Franklin Street (SMV.584).

- *What is the visibility of the proposal?* The chimney is visible from the public right of way.
- *What are the Existing Conditions of the building / parcel?* Two chimneys are located behind the ridge line but are clearly visible from Franklin Street. These indicate the locations of rooms and fireplaces or stoves in the rooms below, showing their relative importance as habitable spaces.

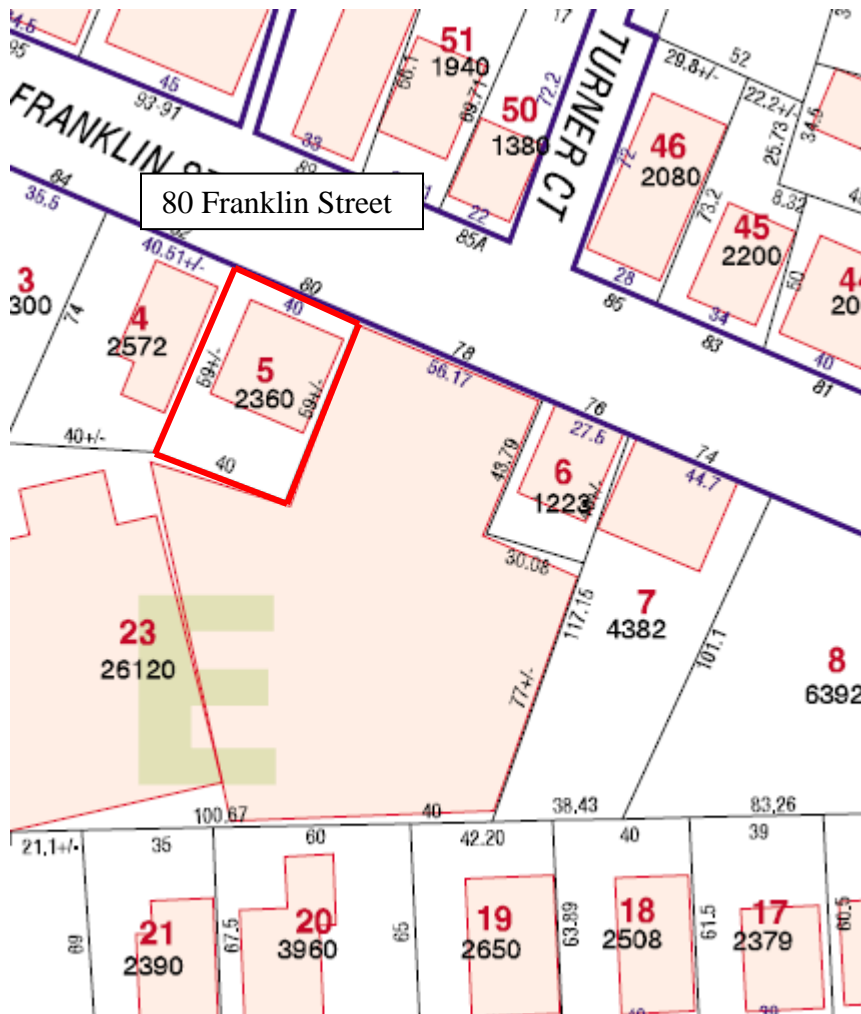
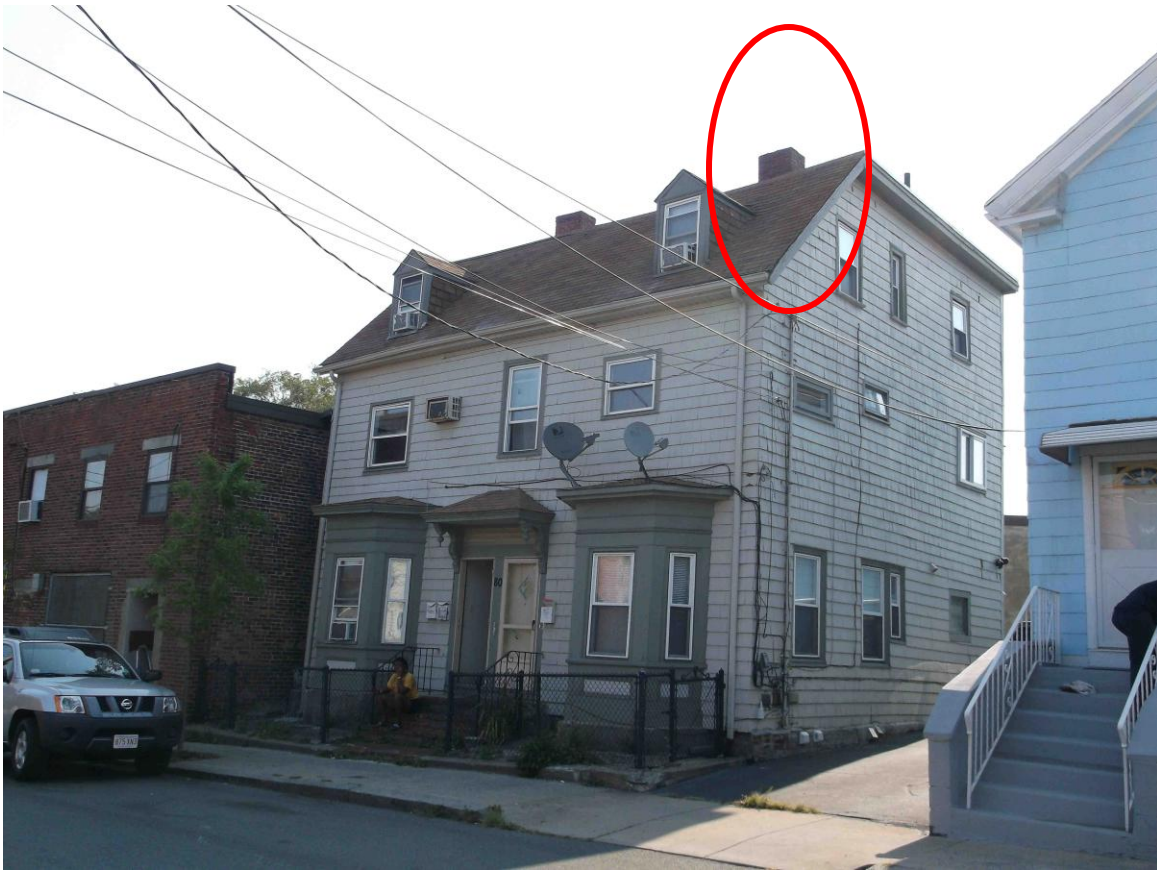
80 Franklin Street – Assessors Photo

The chimney is visible from Franklin Street.

The Staff recommends that the Applicant be granted a Certificate of Non-Applicability to repair or rebuild the existing chimney with the existing brick or in-kind to match the existing as closely as possible in size, shape, texture and color and with an appropriate mortar that is consistent with the hardness of the bricks used. New flashing should be installed to make the seal with the roof water-tight.
