**DETERMINATION OF PREFERABLY PRESERVED STAFF REPORT**

Site:	36 Horace Street
Case:	HPC 2016.016
Applicant Name:	Maria Valente
Date of Application:	March 23, 2016
Date of Significance:	April 26, 2016
Recommendation:	Preferably Preserved
Hearing Date:	May 17, 2016

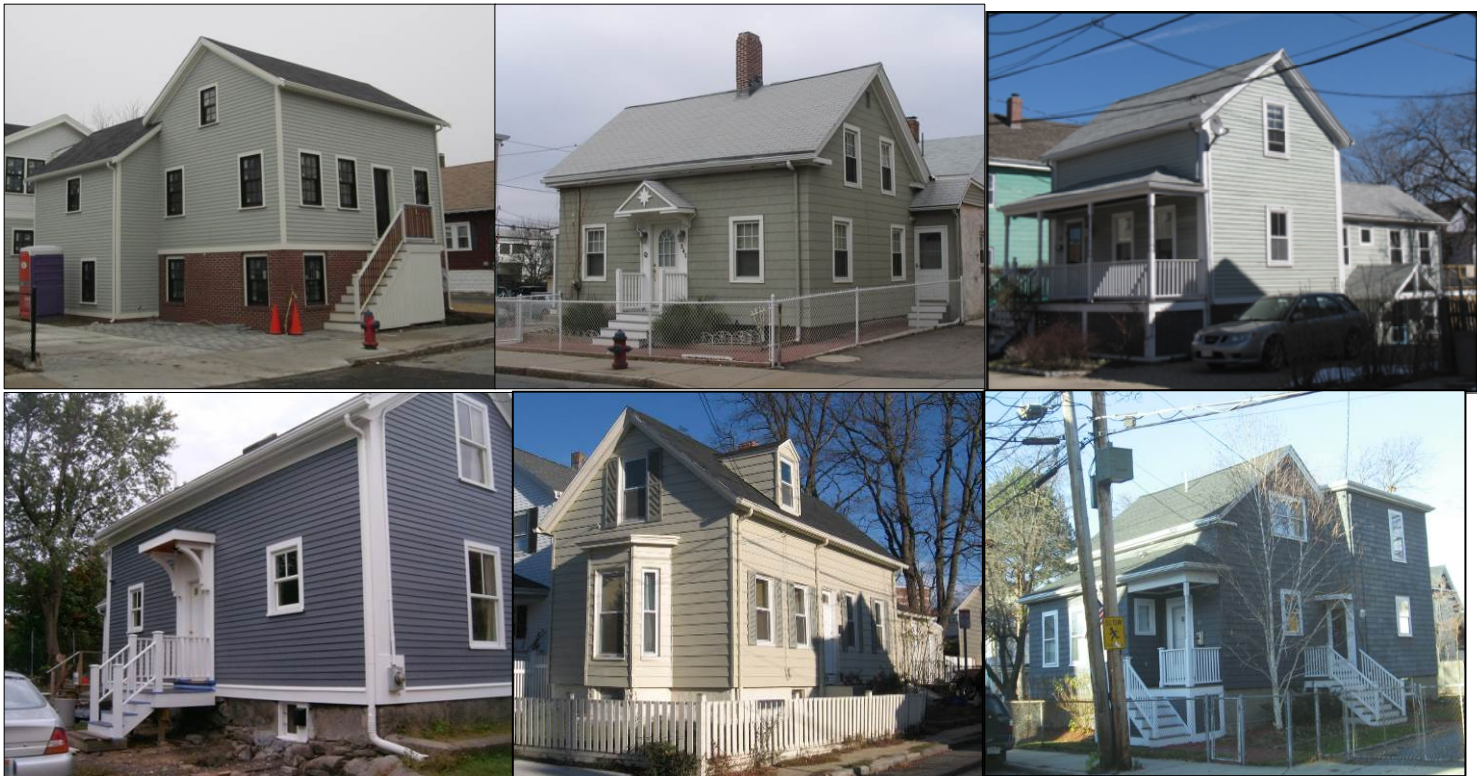
Predominant differences between the comparable dwellings and the subject dwelling are orientations toward the street, heights of basements, and the shapes and sizes of the ells. They were all constructed for workers and inhabited by families for generations. For the most part they are well-maintained and retain much of their original character, Properzi Way, Dane Avenue, and Fisk Avenue are located in existing neighborhoods of workers housing with somewhat similar and later dates than the Horace Street structures.

*Top: 25 Clyde Street (1860); 342 Lowell Street (1861); 80 Properzi Way (c.1850).  
Bottom: 27 Dane Avenue (c.1874); 37 Fisk Avenue (1866); 31 Richardson Street (c. 1850).*

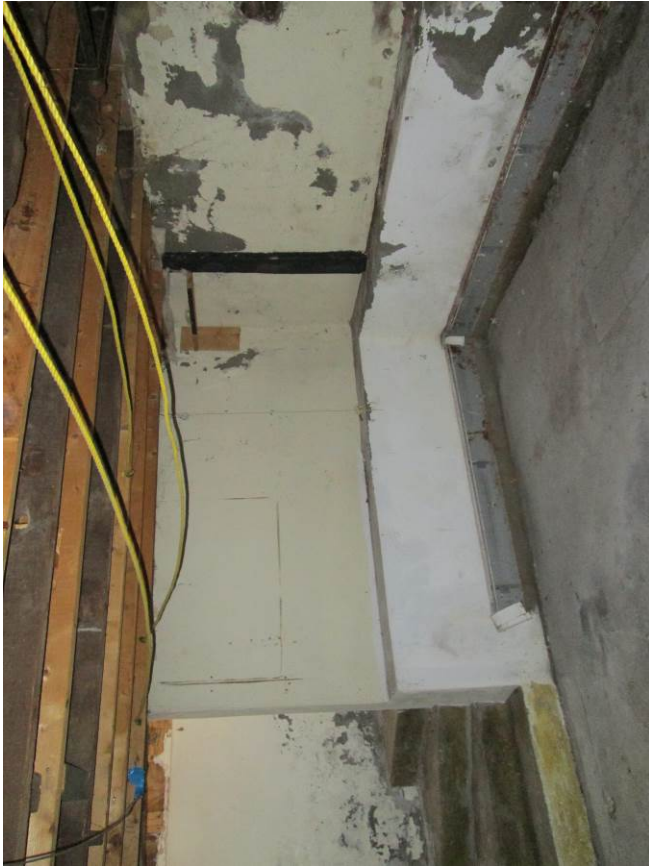
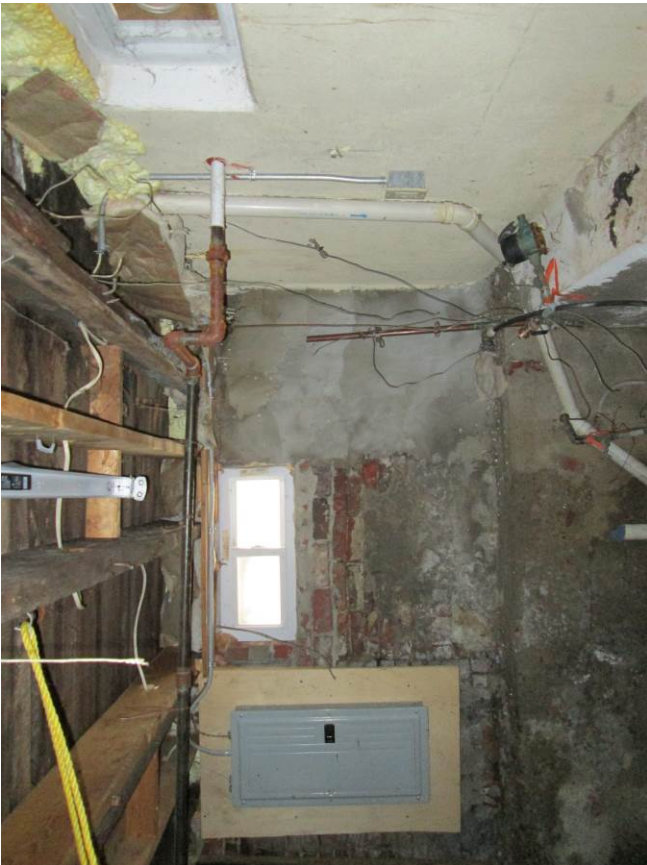
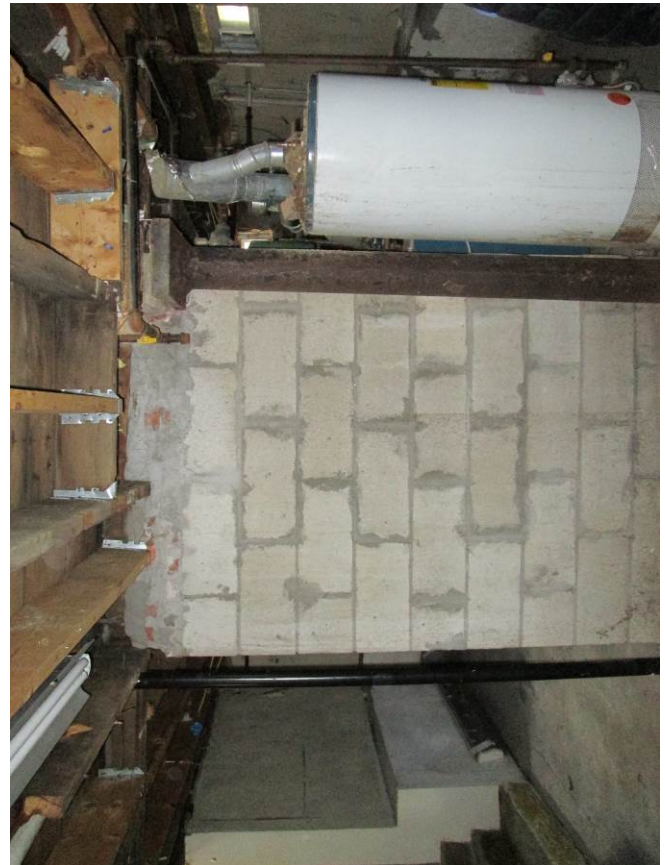
Basement

1. Exterior left (south) wall of structure does not look plumb – significant leaning;
2. The Foundation appears to be in OK shape;
3. Structure is balloon framed with a variety of approaches to sistering and reinforcement;
4. There is significant sagging in the framing on the first and second floor sandwiches; and
5. There is evidence of fire (charring of framing members) at third floor and roof rafters.
