**DETERMINATION OF SIGNIFICANCE STAFF REPORT**

Site: 4 Milk Place  
Case: HPC 2014.041  
Applicant Name: City of Somerville

Date of Application: June 19, 2014  
Recommendation: Not Significant  
Hearing Date: July 15, 2014

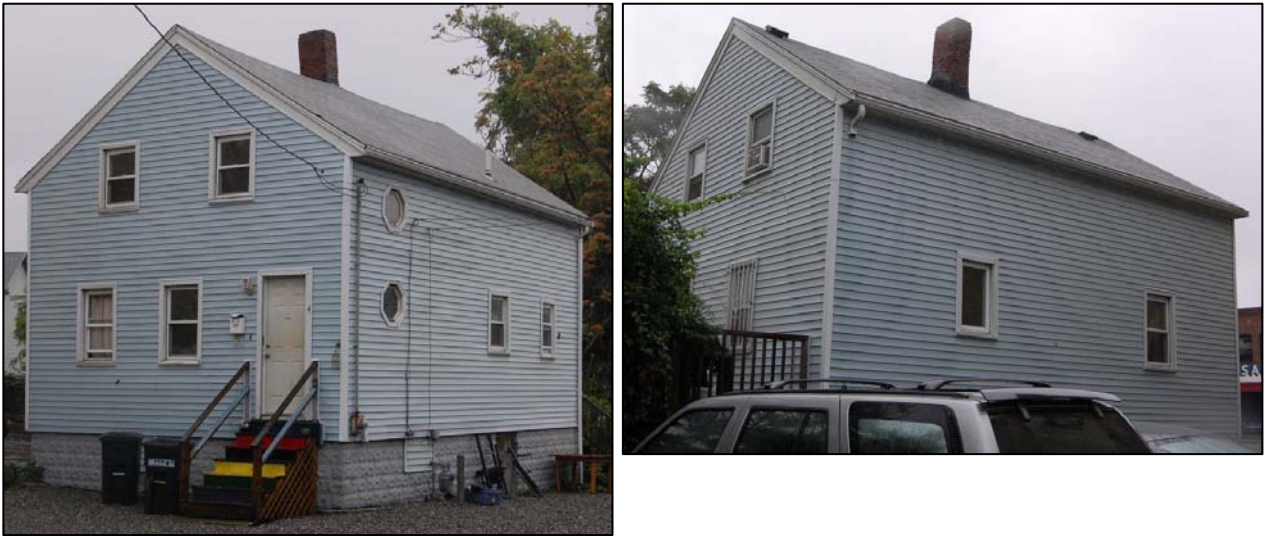
4 Milk Place, primary, right and left side façades

*The three-bay by three-bay, wood-frame, north-facing house has an ornamental concrete block foundation that dates to the 1926 addition of a cellar, vinyl siding, and an asphalt-shingled roof. A narrow entablature runs below the slightly overhanging eaves in the gable. A brick chimney rises from the ridge line.*

*The main entrance in the west bay of the facade (north) elevation is set within a simple rectangular vinyl surround with a modern panel door. Stairs extend directly onto the gravel driveway, and a secondary porch is located on the south (rear) elevation.*

*Fenestration consists of one-over-one, double-hung vinyl replacement windows with narrow wood trim. Two octagonal single-pane windows are located in the north bay of the first and attic stories of the west elevation.*

- b. **Design:** The original form, massing, and components of the original fenestration pattern are still evident. The three-bay primary façade is still understood, but the side elevations have been altered with regard to window placement and size. An entablature is still evident beneath the eaves and a brick chimney is located at the ridge.

- d. **Alterations:** The windows and doors have been replaced with vinyl. The structure was raised, but possibly also moved, and the fenestration on both side elevations has been altered. The form and massing remain intact as well as the primary façade fenestration pattern.

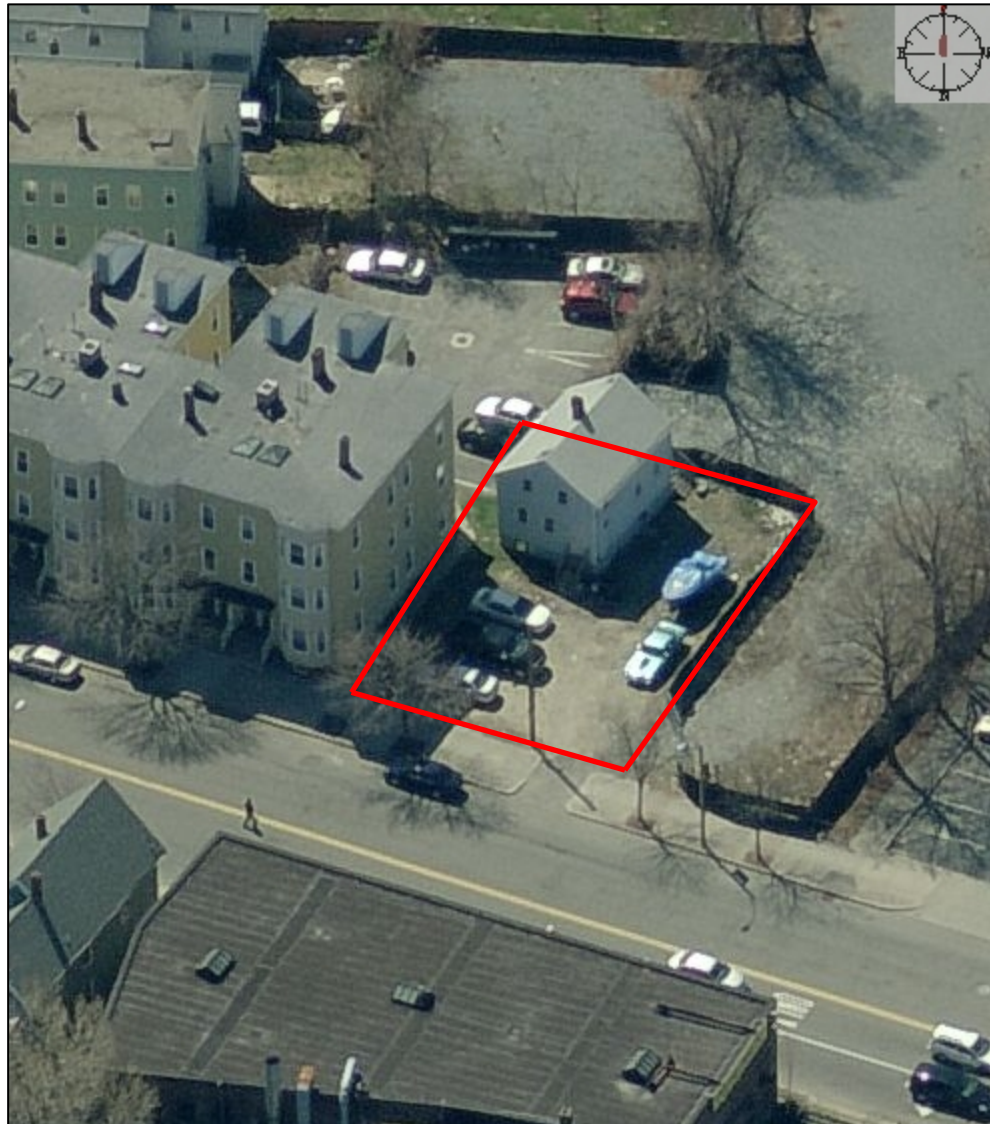
*4 Milk Place*

- c. **Materials:** The materials that compose this structure are predominantly wood with a concrete foundation and a shallow-pitched asphalt shingled roof.

The subject structure retains a low level of integrity due to the raised foundation or altered location. In addition, while the form and massing remain intact, and the three-bay primary façade, the structure does not display original fabric. In addition, this structure was once part of a collection of late nineteenth century income-producing buildings. The demolition of these four buildings removed the historic context to which this structure is directly associated.
