HISTORIC PRESERVATION COMMISSION

ALTERATION TO A HISTORIC PROPERTY STAFF REPORT

Site:	17 Mount Vernon Street	c.1845 Fritz-Curtis House
Case:	HPC 2016.053	Single Building Local Historic District Mount Vernon Street National Register District
Applicant Name:	Martin Scott, Owner	
Applicant Address:	17 Mount Vernon Street, Somerville, MA 02145	
Date of Application:	July 21, 2016	
Legal Notice:	<i>Replace two windows; Replace fence</i>	
Staff Recommendation:	Conditional Certificate of Appropriateness	
Date of Public Hearing:	August 16, 2016

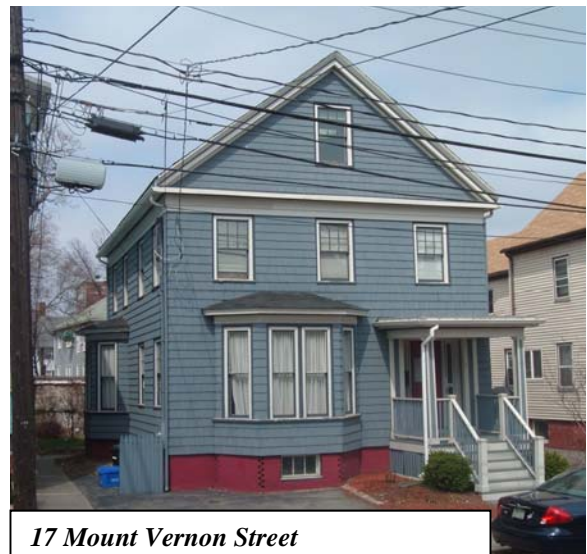
ARCHITECTURAL DESCRIPTION: From the Form B
The early suburban house at 17 Mt. Vernon Street was built 1845-1847 by an unknown housewright for Able Fitz and Edward Curtis a later owner. The house follows a traditional side hall plan of two stories with gable to the street and a rear kitchen ell. The design is of Greek Revival Style seen in the pedimented facade gable. However, the facade and side bay windows are set on a brick foundation, suggesting a latter remodeling ca.1910, matched by the beveled glass front door. A further remodeling is seen in the six/one sash windows that are likely of ca.1930 replacements, while the entry porch has been rebuilt ca.1970 with simple posts. The only original detailing is seen in the rear kitchen ell that retains a Late Federal form of the 1840s.

The Fitz-Curtis house is of note as an early suburban design on Mt. Vernon Street, likely remodeled in the early 20th century to its present form.

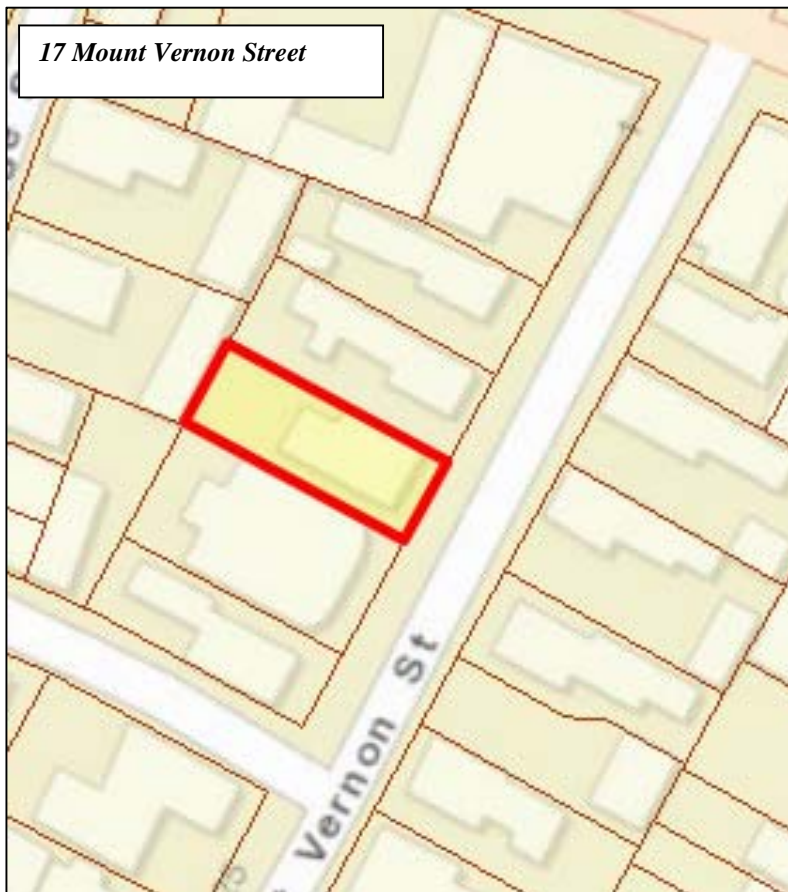
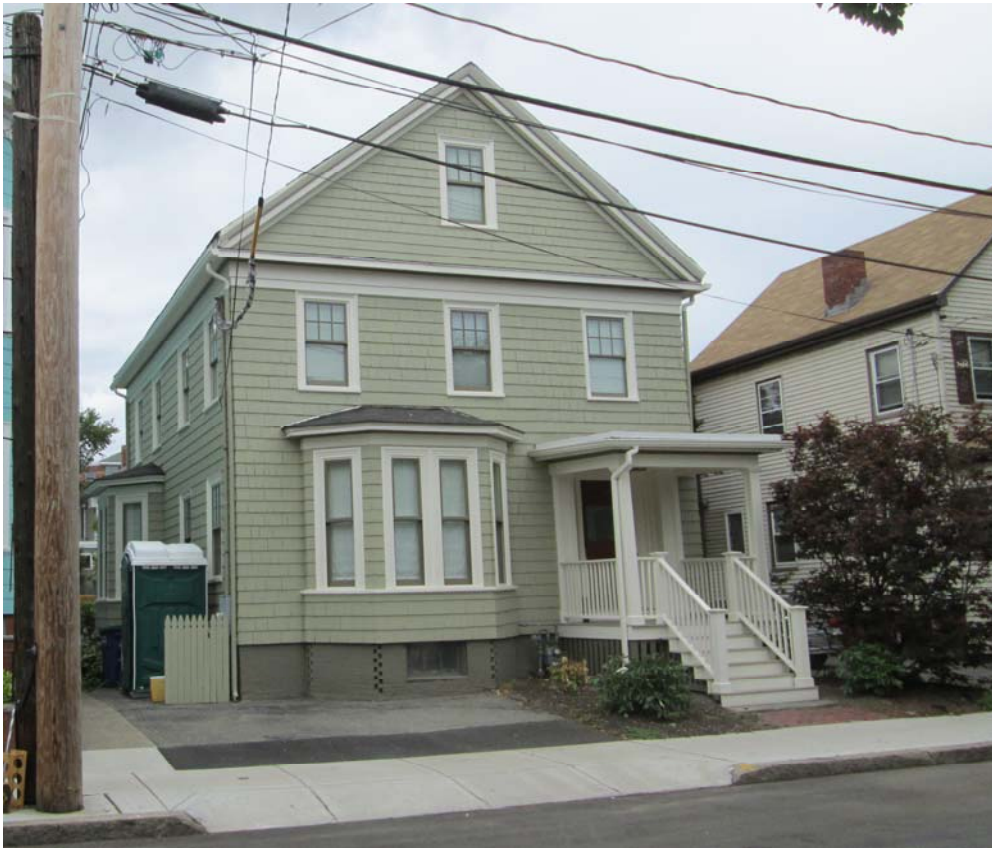
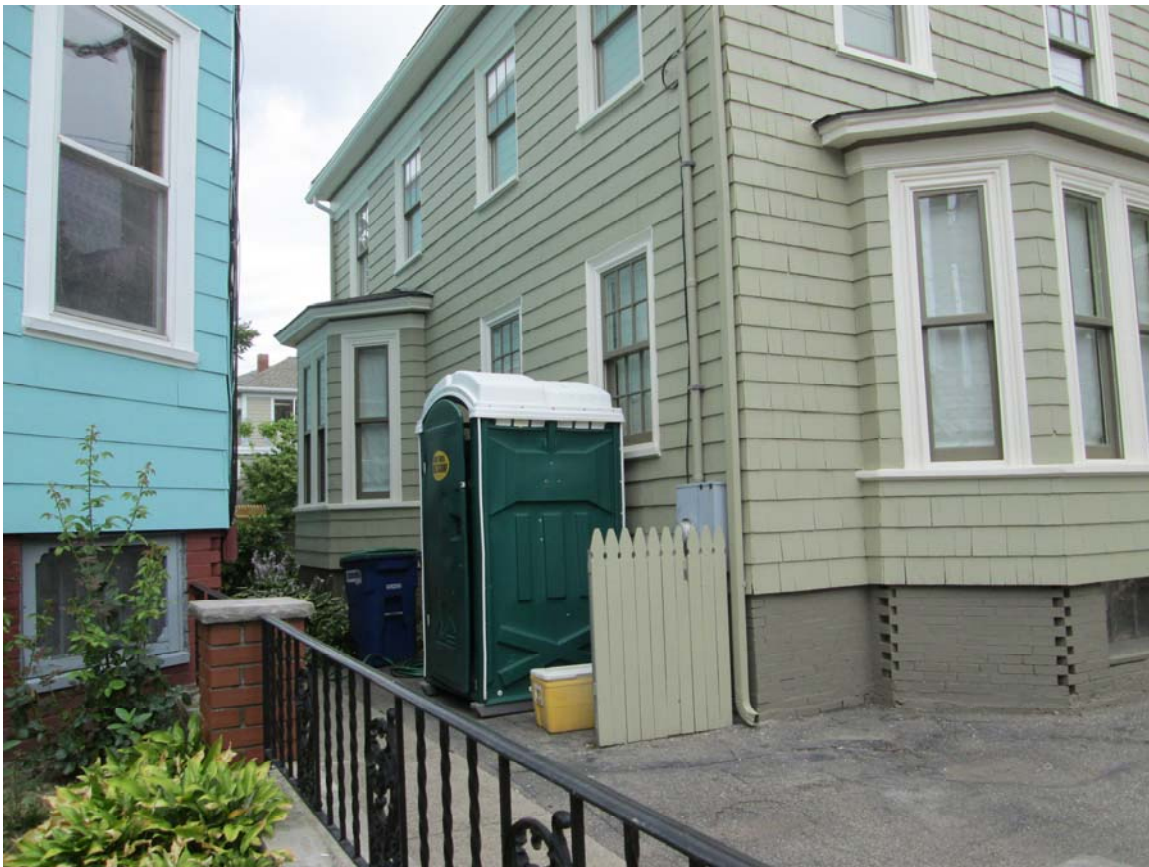
See the final pages for details and photos.

Two of the three replacement windows on the front of the building do not fit properly and are allowing air infiltration. These need to be fixed. As of September 14, 2016, the Contractor now plans to replace all three windows on the second floor front with Marvin replacement windows to match those existing on the side walls.

The existing 42" x 48" fence is falling apart and does not hide the garbage and the recycling carts, and utility meters adequately. They would like to make the fence a little larger to 54" x 60". The proposed fence is solid wood with a lattice top rather than the solid picket fence currently in place.

The existing windows leak due to the casing and windows not being fully square. This has resulted in some water infiltration and sill rot as well as air infiltration.

The fence is about 10 years old and is falling apart. It does not adequately hide the garbage carts and utility meters.

1. All appropriate building permits shall be obtained prior to the start of any work.
2. If changes are necessary to the proposed design for which this Certificate of Appropriateness was issued, new plans shall be submitted to Historic Staff prior to commencing the work.
3. The fence shall be 54" x 60" with a lattice top to be located on the south east corner of the house.
4. Historic Staff shall issue a sign-off upon completion of the project that this was done in accordance with the Certificate and approved plans.

1. The replacement window sash will match the existing top, bottom and meeting rails, stiles and muntins in size, shape, and installation details.
