HISTORIC PRESERVATION COMMISSION

ALTERATION TO A HISTORIC PROPERTY STAFF REPORT

Site: 46 Mount Vernon Street c.1885 George Poole House
Case: HPC 2013.089 Single Building Local Historic District

Date of Application: November 18, 2013
Legal Notice: Add 3rd floor egress, alter roofing material
Staff Recommendation: Conditional Certificate of Appropriateness
Date of Public Hearing: January 21, 2014

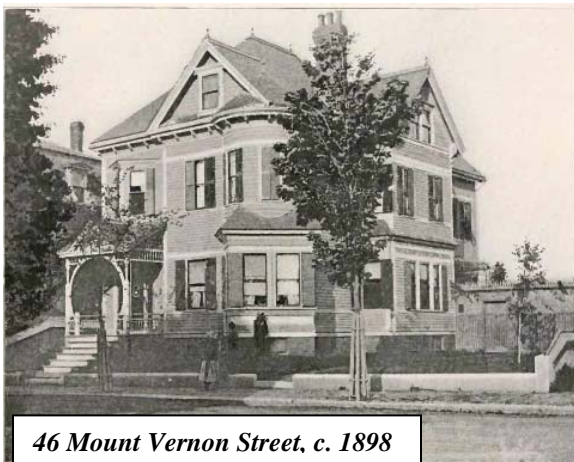
46 Mount Vernon Street, c. 1898

The large two and one-half story house has an asymmetrical plan typical of Queen Anne houses in the late 1800s. The decorative treatment starts on the brick foundation which has terracotta sunburst insets. The plan has square projecting bays and a round corner second story tower with a square base set on the diagonal to the main facade-s projecting bay. The entrance porch is elaborated with scalloped braces and has a pediment on a shed roof with spindle screening. There are cornice brackets and a high chimney other details found on many decorative Queen Anne houses. The house also has some Stick Style

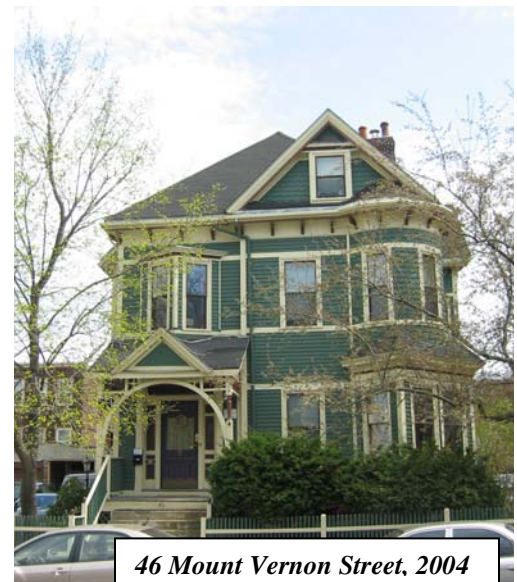
46 Mount Vernon Street, 2004

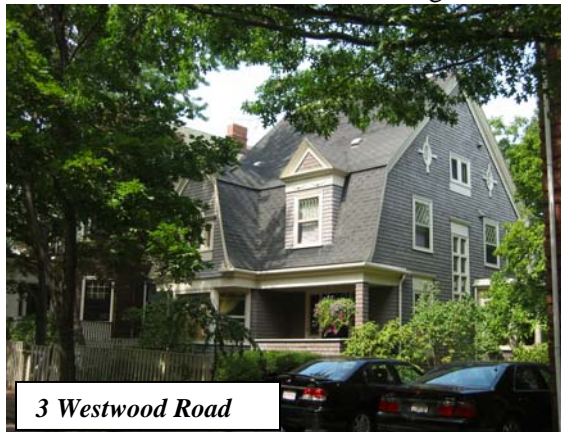
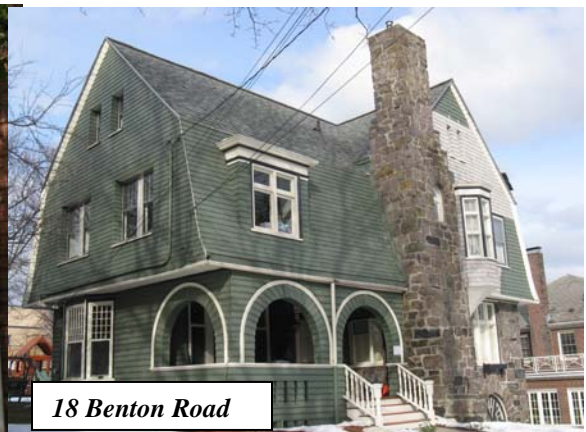
1. Replace 3-tab asphalt roof shingles on house and garage with Timberline® Prestique® Grandé® architectural roof shingles.

There have also been several cases of replacement of 3-tab shingles with architectural shingles. The appropriateness of the type of architectural shingle varies with style of the building. In replacing the roof of a Queen Anne Style house, the substitute roofing material should relate the original roof in form and shape if possible, of regular form and shape and of a scale similar to that of the original roof shingles. The Commission has not granted any Certificates of Appropriateness for the proposed Timberline shingle on a Queen Anne but has approved the following similar products for the Shingle style properties as noted below.

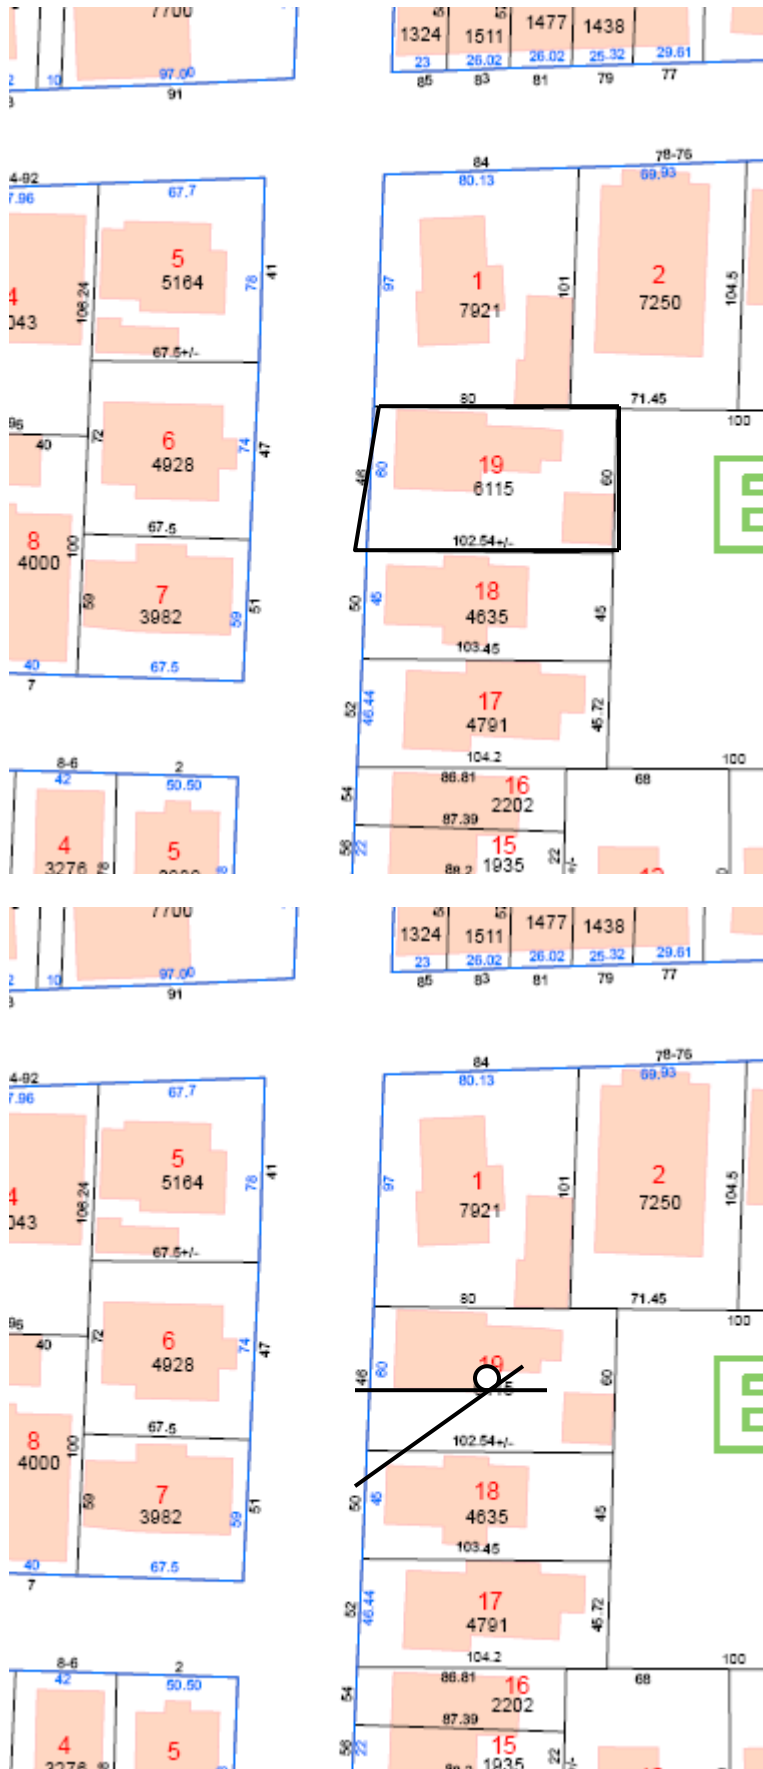
The enlarged window and egress platform will not be visible from the public right of way. The spiral stairway will protrude behind the cross gable edge of the building about 1' and will be partially more visible when the house is viewed from in front of 48 Mount Vernon Street.

46 Mount Vernon Street
showing sight-lines

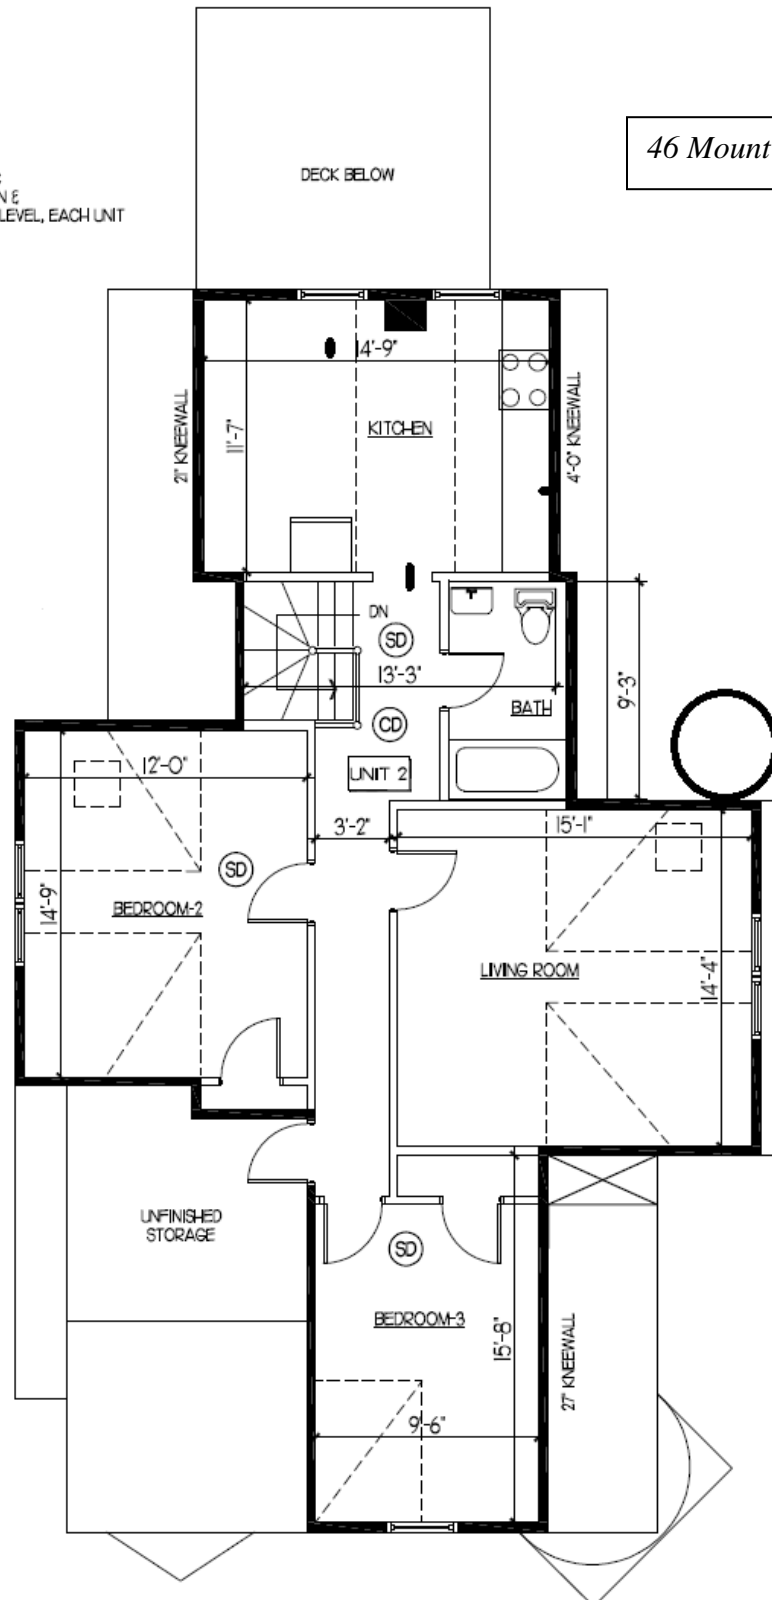
PROPOSED THIRD FLOOR PLAN
SCALE: 1/8" = 1'-0"
968 SF +/-

The owner proposes to enlarge the dormer window on the rear driveway side of the building to allow for access to a new spiral staircase to the ground level deck. This would be inserted into a corner of the building and would protrude 1' toward the driveway.

NOTE:
(SD) ADD HARD-WIRED PHOTOELECTRIC
SMOKE DETECTORS WHERE SHOWN &
(CD) CARBON MONOXIDE EACH FLOOR LEVEL, EACH UNIT

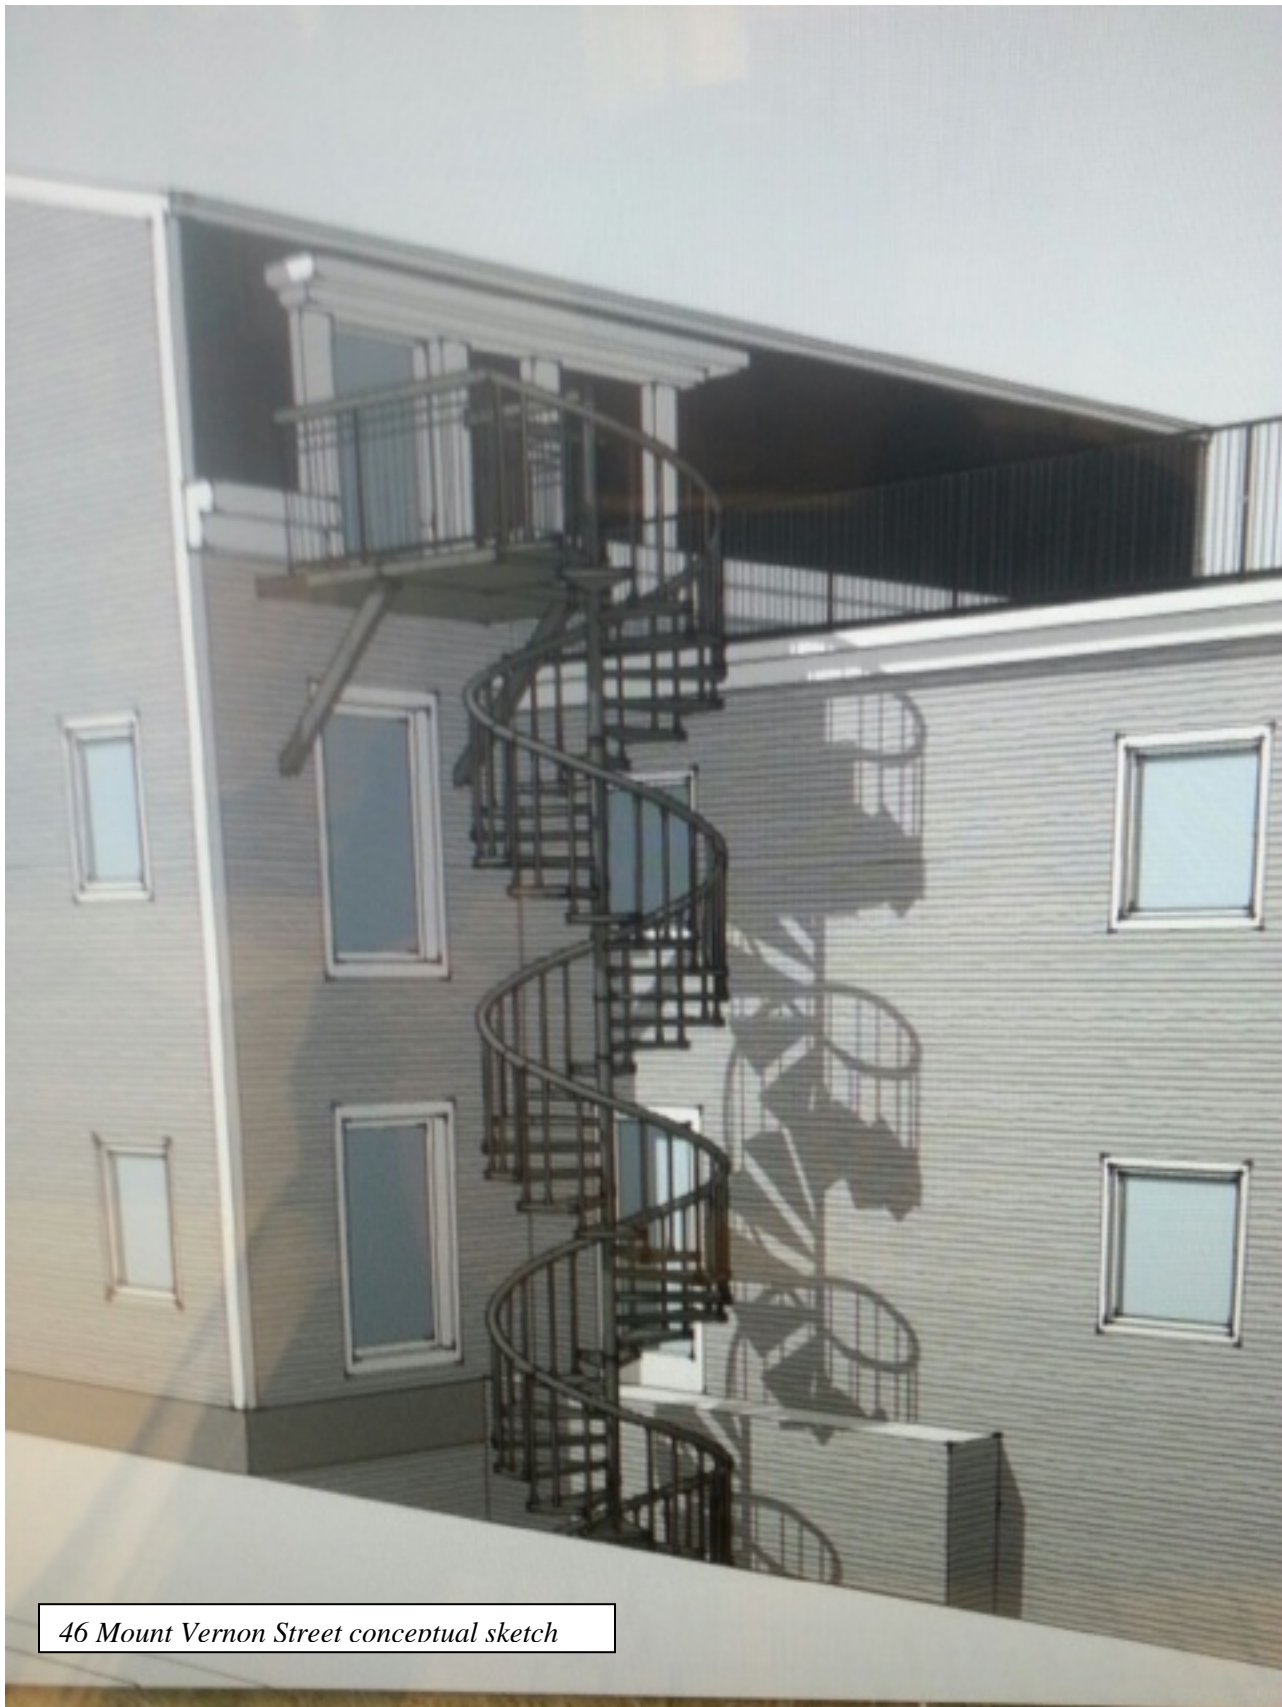
46 Mount Vernon Street conceptual sketch

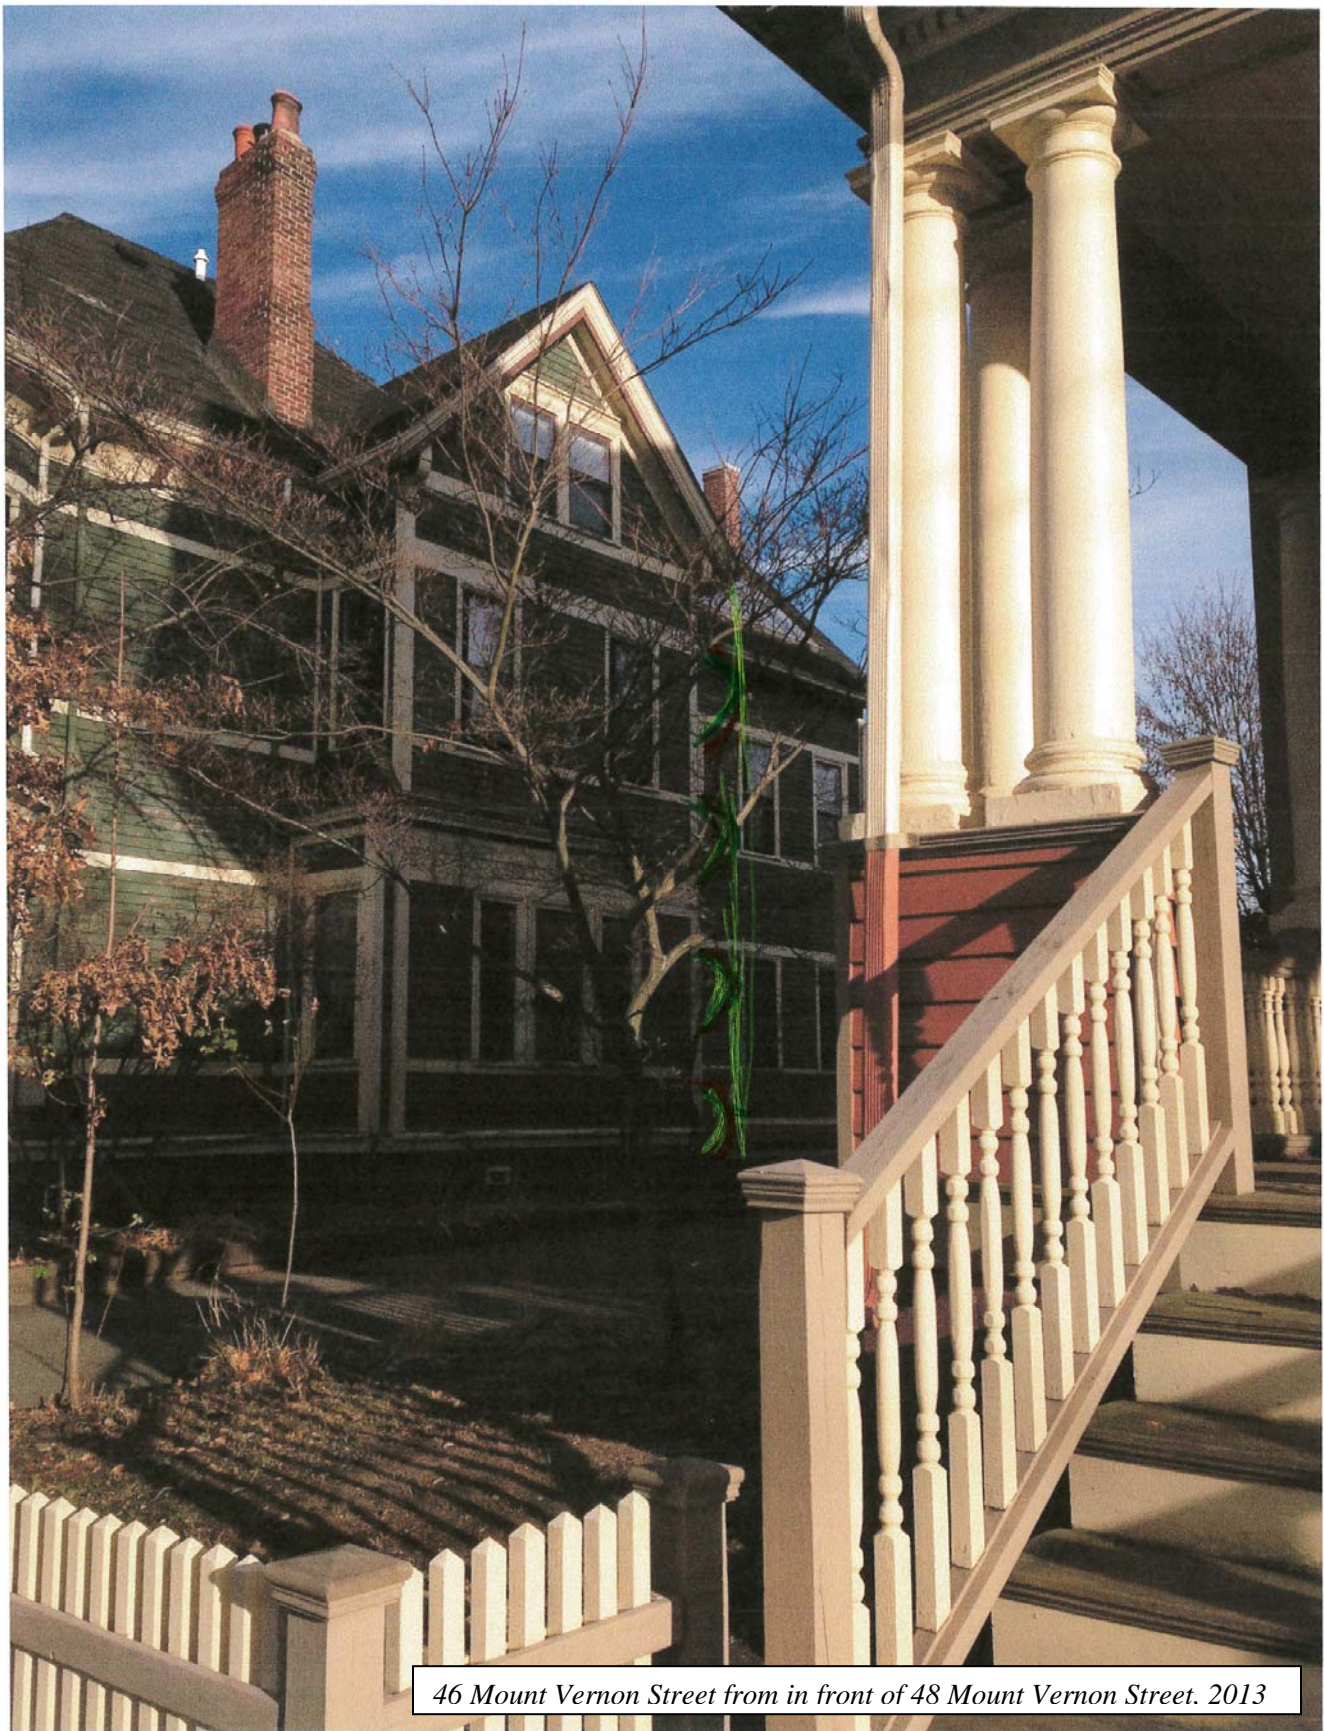
The fire escape/ second means of egress for the third floor apartment will be placed as inconspicuously as possible behind the cross gable and have as small a footprint as possible. It will protrude approximately 1' from the side when viewed from the front and will become more visible as one moves down to 48 Mount Vernon Street.

46 Mount Vernon Street from in front of 48 Mount Vernon Street. 2013

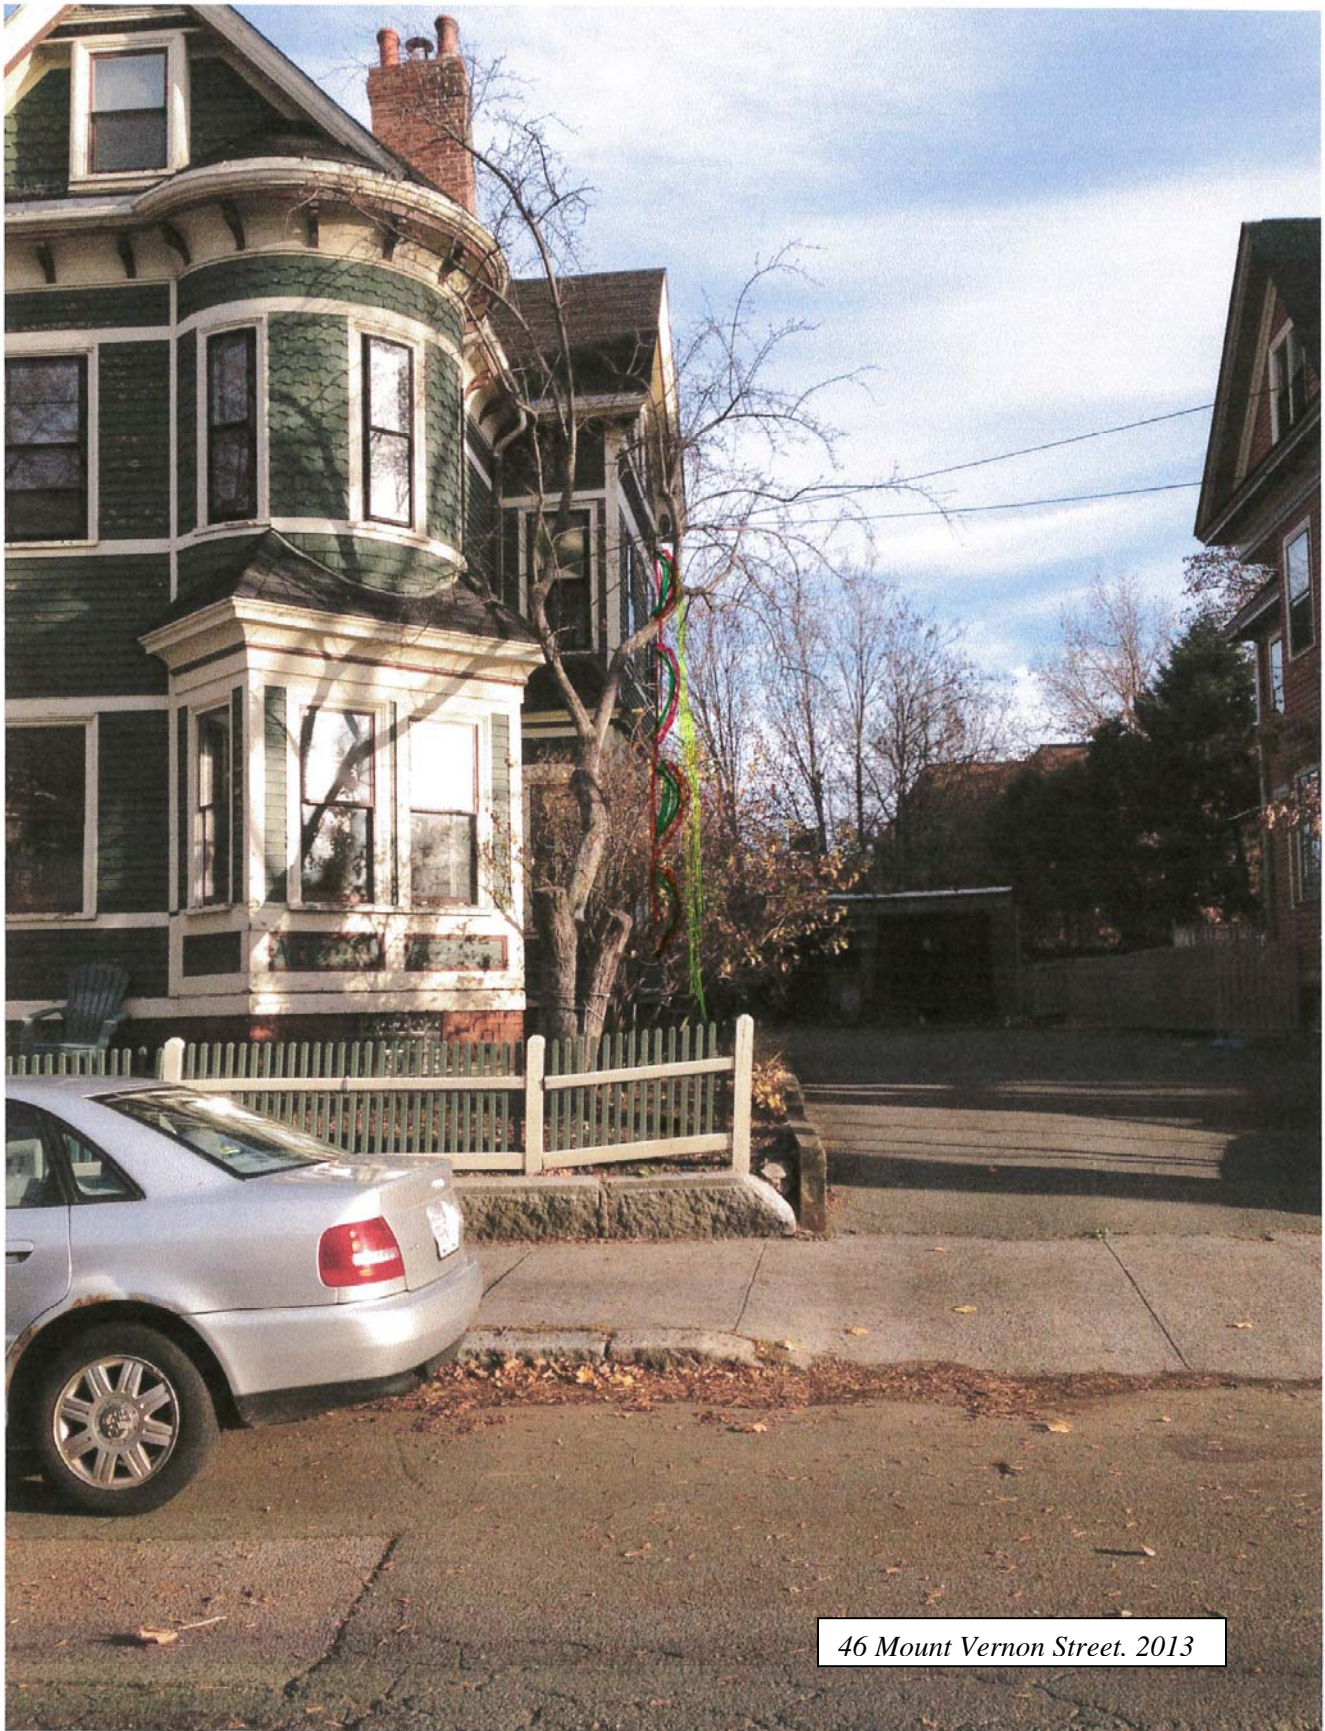
This roof is visible from Perkins Street and Mount Vernon Street.

46 Mount Vernon Street. 2013
