DETERMINATION OF SIGNIFICANCE STAFF REPORT

Site:	510 Somerville Avenue
Case:	HPC 2014.011
Applicant Name:	Douglas Beaudet
Date of Application:	March 5, 2014
Recommendation:	Not Significant
Hearing Date:	April 15, 2014

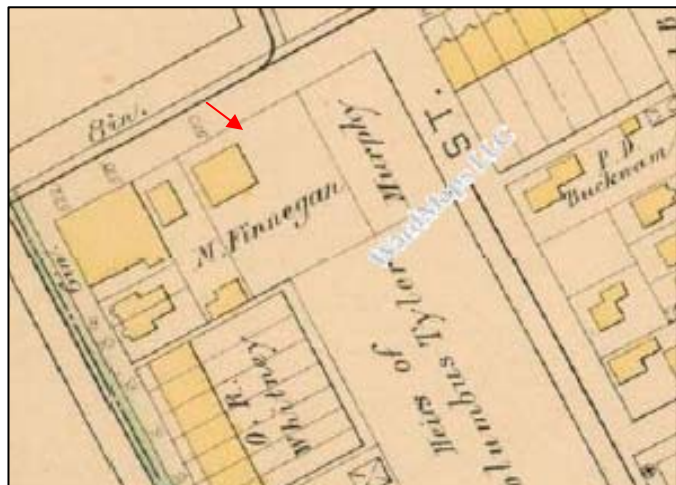
1884 Hopkins Map, Plate 8

Historical Description: The subject property is first illustrated on the 1884 Hopkins map as 510 Somerville Avenue and under the ownership of M.Finnegan. Directories from the late 19th century do not identify an M. Finnegan. However, the 1884 directory lists a dry goods store, J.M. Bradbury & Co., at 512 Somerville Avenue. Other references identify the boot/shoe retail establishment of James Lynch at #510; a carpenter, Joseph Tattan who boards at 512; and Michael Tattan, owner of a dry goods

was originally under the ownership of M.Finnegan. The 1895 Bromley map (Plate 4) illustrates that the parcel is owned by John Harrington with addresses of 510 and 512, and that the structure is divided in half, which often means different uses on either side. The 1900 Sanborn map (Sheet 55) illustrates the structure is divided into three stores and that the building is two-stories in height, while continuing to list the same two addresses. The 1903 directory lists Frank Borges, a hairdresser at #512, and Joaquin and Joseph Borges as residing at #508, which is not listed on the 1900 map. By 1915, there is a grocer on-site, Thomas Frizell, who also lives at this location, as well as Joaquin Borges and Frank Walsh, a driver. The property is under ownership of Evaline Razzaboni by the end of 1924, and by 1925, the property is used by Henry Razzaboni, a grocer. The 1930s list a butcher at #510, Napoleon Razzaboni; a laborer at #512, Dennis O'Connell; and Henry Razzaboni also continues to operate at this location. Various building permits for accessory structures were issued in the early portion of the twentieth century, all of which have since been demolished, and a permit for dormers was issued in 1929. The 1933 Sanborn map (Vol. 1/Sheet 10) notes the western half of the structure is a dwelling while the eastern portion is a store. A second two-story rear addition is also illustrated. The 1940 directory lists several members of the Razzaboni family as well as the Flaherty family as residing at #512. Henry Razzaboni continues to work as a storekeeper. The 1945 directory continues to illustrate a variety of residents which includes members of the Costa, Parachiso (also spelled Paradiso) and Razzaboni families. The storefront was most recently remodeled in 1983.

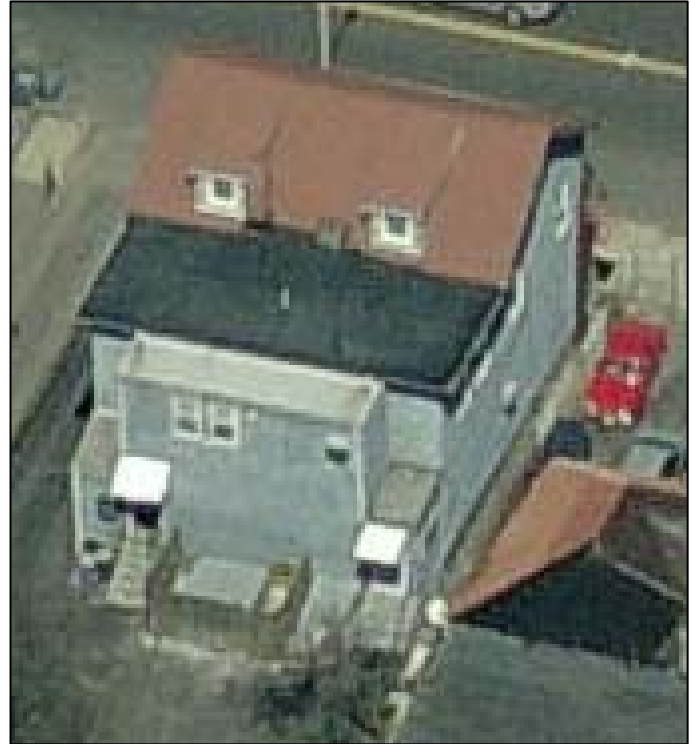
Architectural Description: The historically mixed-use building is c. 1884 and is a 2½ story side-gable structure with multiple rear additions that expand the width of the structure. The rear plane of the roof is comprised of two identical shed dormers (c. 1929) that are not visible from the street. The style is undetermined due to the number of changes and lack of architectural detail; however, the depth of the eaves and period of construction suggest the Italianate style. A brick foundation is visible on various façades of the main structure including the rear additions.

- b. Design: The original side-gable form, 2½ story massing, and second story fenestration pattern are still evident. Architectural details are only existent in the remaining window casings and depth of the eaves.
- c. Materials: The materials that compose this structure are predominantly wood, with a brick foundation. Windows, doors and the storefront have all been replaced over the years. Asphalt shingles were also added to the roof at a later period. The exterior is sheathed in wood shingles, which were likely wood clapboards originally.
- d. Alterations: Material alterations include the storefront, windows, doors, and rear additions. The first rear addition may have been constructed as early as c. 1884, while the second rear addition is c. 1933 and later additions are post 1950. The storefront was most recently modified in 1983 according to building permits.

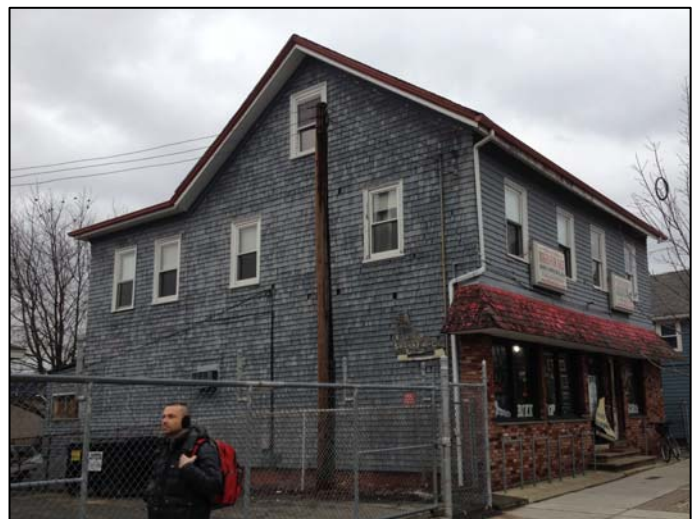
Windows and doors have all been boarded upon the rear façade; however

previously replaced and several windows appear several window casings still exist. The house is

entirely clad in shake shingles.

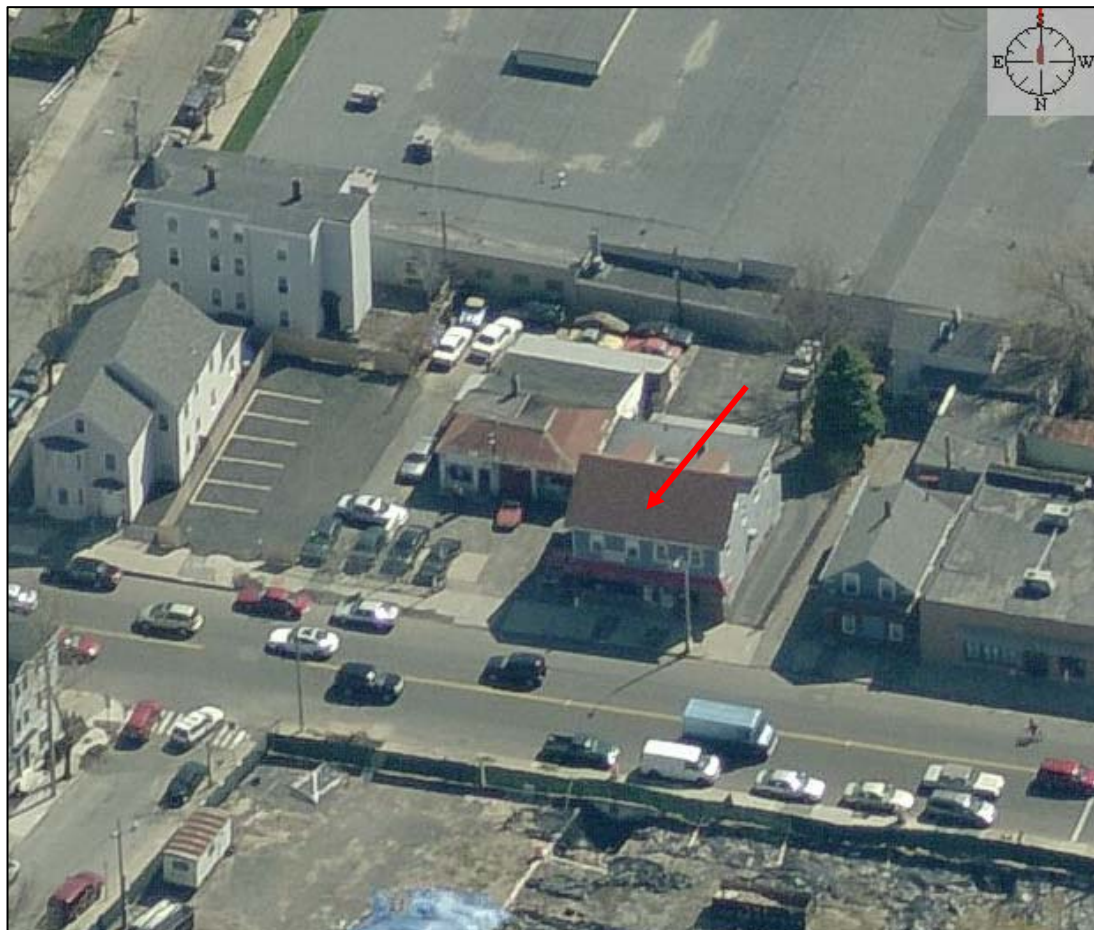
510 Somerville Avenue

The subject structure retains a low to moderate level of historical and architectural integrity due to changes in the surrounding streetscape which further remove historical context, lack of original materials and existent detail, and variety of alterations. The original side-gable form, 2½ story massing, and second story fenestration pattern are still evident.
