**DETERMINATION OF PREFERABLY PRESERVED STAFF REPORT**

Site:	589 and 593 Somerville Avenue
Case:	HPC 2013.011
Applicant Name:	Richard DiGirolamo, Agent for Owner, Vincent Pascale
Date of Application:	Wednesday, April 3, 2013
Date of Significance:	Tuesday, May 21, 2013
Recommendation:	Preferably Preserved (#589) NOT Preferably Preserved (#593)
Hearing Date:	Tuesday, June 18, 2013

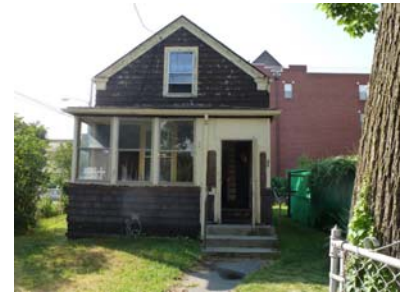
53 Kent St - 1848

Somerville, which is located on a major thoroughfare (53 Kent Street) and also associated with the Bleachery. Other houses from this era located on Somerville Avenue, Beacon Street or Broadway have been altered, demolished or moved. Worker cottage styles also vary.

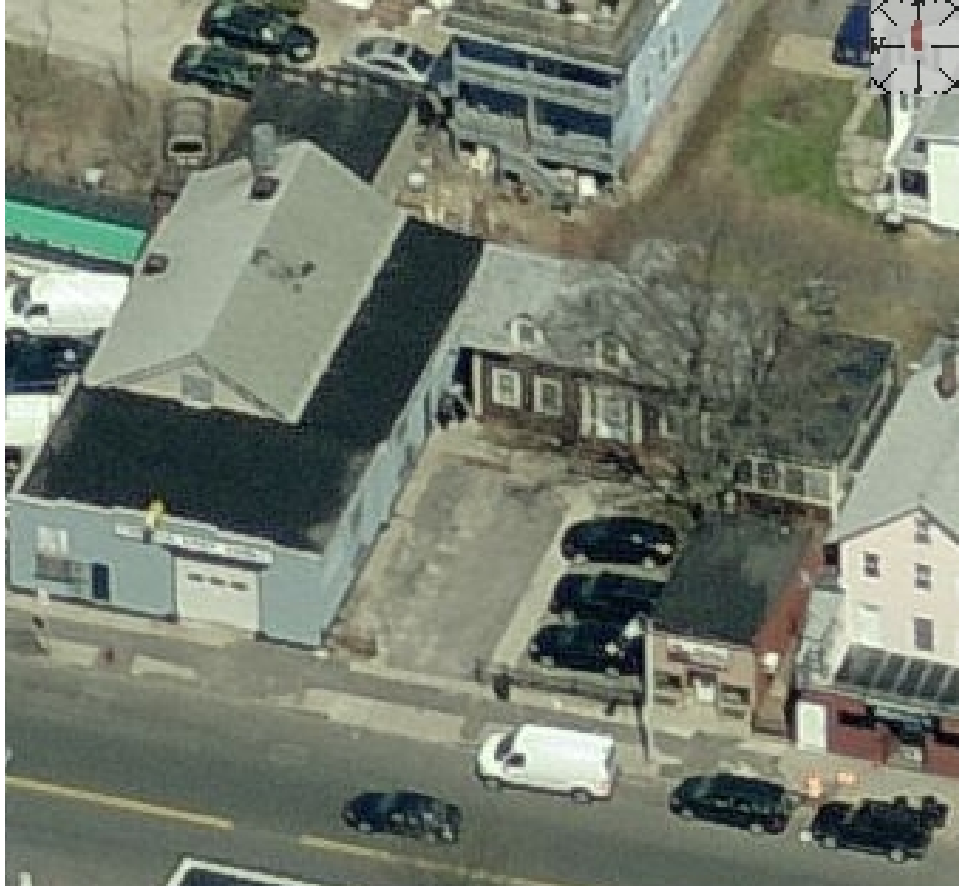
*587-589 Somerville Avenue aerial view*

The subject parcel is visible on Somerville Avenue with two buildings, a garage and a store located along the streetfront, while the house is set back and partially obscured by other buildings. Located on the former Middlesex Bleachery site, this parcel is across the street from Conway Park.
