ALTERATION TO A HISTORIC PROPERTY STAFF REPORT

Site / District(s): 170 Summer Street, c. 1865 – John Howie House, Central/Atherton/Spring Summer LHD
Case: HPC 13.007

Legal Notice: *Change 3-tab asphalt shingles on Mansard roof to architectural shingles or synthetic slates.*

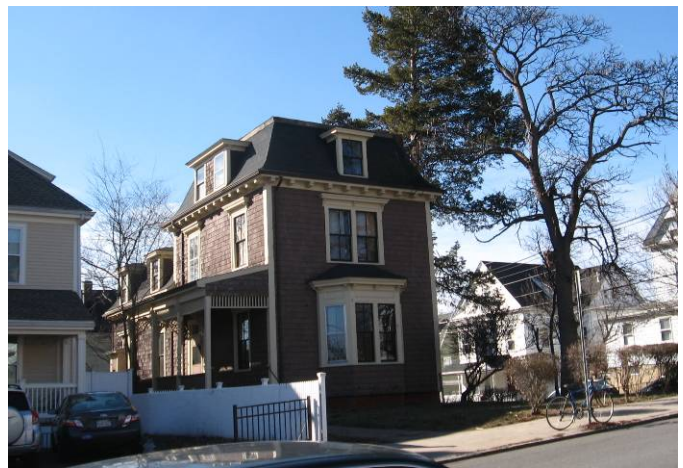
Both the edges of the main block and rear ell are accented by narrow corner boards. The narrow, one-bay Summer Street elevation exhibits a one-story bay. The windows of the bay surmount a flared wood shingle-sheathed apron and are surmounted by rectangular panels set off by raised moldings. The bay is enclosed by a bracketed hip roof. Above this bay is a double, fully-enframed window that culminates in a bracketed, cornice-headed lintel. Above the one-story bay is a double window that is fully-enframed and bracketed. Above the double window is the roof s

bracketed cornice. A single flat-roofed dormer is in evidence at the Summer Street roof slope. In general, windows of both the main block and rear ell are fully-enframed and cornice-headed.

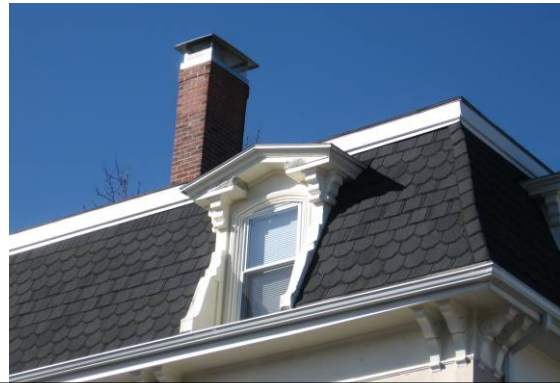
CertainTeed® Grand Manor™ and Carriage House™

The Applicant would like to replace existing 3-tab shingles with architectural shingles. His first choice is the CertainTeed® Carriage House® shingles which carry a strong shadow line although if he can afford them, he would like to install synthetic slates as a closer to real slate appearance.

Only 2 Mansard roofed designated houses have had their roofs replaced with architectural shingles. 53 Moore Street used Owens Corning Berkshire shingles with no color specified on the Certificate. 18 Summit Avenue used 2 kinds: CertainTeed® Grand Manor™ and Carriage House™ Black Pearl colored
