ALTERATION TO A HISTORIC PROPERTY STAFF REPORT

Site: 381 Summer Street, Rosebud Diner (c. 1940)

Case: HPC 2014.018

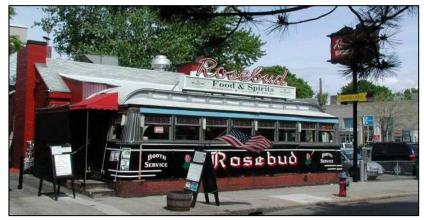
381 Summer Street, 2002 photo

Architectural Description: The Rosebud is a fine example of a streamlined diner produced by Worcester Lunch Car Company. The structure is 8 bays wide and 3 to 4 bays deep. Stylistically it resembles a traditional rail car diner form with a monitor roof and band of clerestory windows. The sloped end walls are considered character-defining features of the modern semi-streamliner form. It has a steel frame, a brick foundation, black porcelain enamel wall panels, and a metal roof. Small entries

are located in the narrow ends of the diner. Windows have leaded glass in the transoms

above the single-hung metal sash. There are fluted stainless steel jambs between the windows and at the rounded corners. The clerestory windows incorporate some colored glass, mostly visible on the interior. The prefabricated diner is attached at the rear to Jaunty Jack's, a one-story, side-gabled building (constructed in 1939) with brick veneer walls and two exterior end-wall chimneys and blinded windows. A much larger one-story, flat-roofed rear addition (ca. 1960s) also of covered with brick veneer, sits on the rest of the lot. Both the side-gabled building and the rear addition are visually subservient to the diner.
