HISTORIC PRESERVATION COMMISSION

DETERMINATION OF SIGNIFICANCE STAFF REPORT

Site: 197 Washington Street
Case: HPC 2012.134
Applicant: Anthony Cota

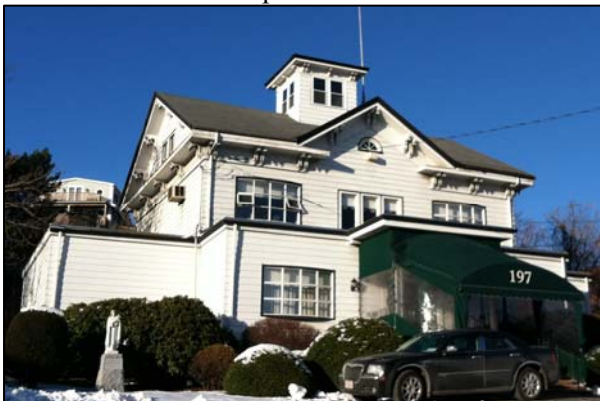
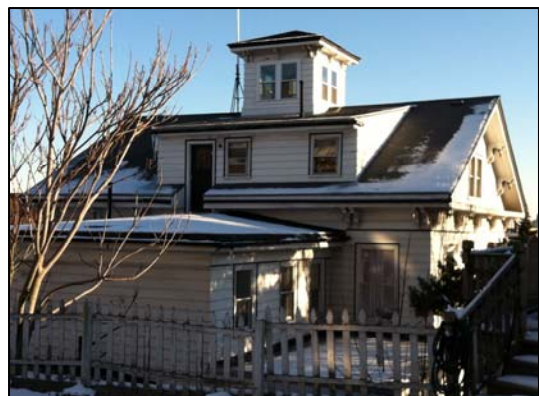
The subject property, c. 1860, is a 2½ story, single-family dwelling of the Italianate style that was converted for use as a funeral parlor as early as 1933. This structure was potentially three bays wide upon construction with a chimney at the east end and a deep front setback. A full cornice return is still visible at each gable end and an antennae is currently located on the roof. Remains of the Italianate style are illustrated by the centered gable on the primary façade, widely overhanging eaves supported by double brackets, and the square form of the cupola. The building has several additions; one is located along the entire front façade and a small wing has been added to both the east and west ends. Additionally, an eight foot dormer, constructed in the 1950s, is located on the rear plane of the roof with two windows and one door. Currently, a concrete foundation supports the front and side additions and is the only visible foundation material. The building is sheathed in synthetic siding with replacement bay and casement windows as well as replacement doors.

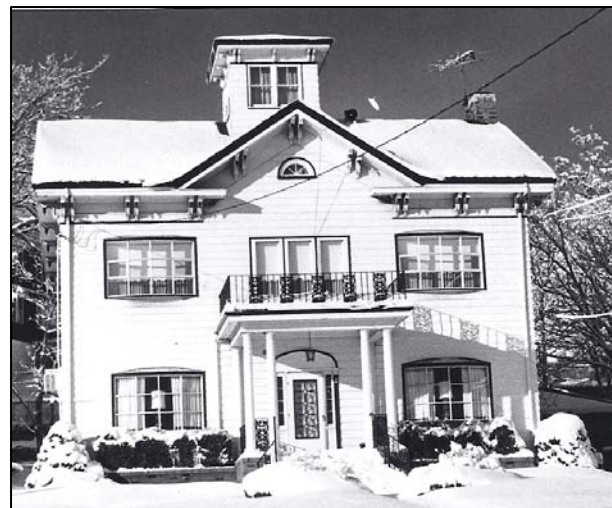
c. 1960

The property continues to be under the ownership of Cota, however, in the late 1950s and early 1960s, Salvatore Agresti, a steamfitter, and his wife Harriet, also reside at the property.
