CITY OF SOMERVILLE, MASSACHUSETTS
OFFICE OF STRATEGIC PLANNING & COMMUNITY DEVELOPMENT
JOSEPH A. CURTATONE
MAYOR

ALTERATION TO A HISTORIC PROPERTY STAFF REPORT

Site: 1 Westwood Road c.1929 Somerville Museum
Case: HPC 2012.019 R1 Westwood Road Local Historic District

Date of Application: June 19, 2014
Legal Notice: *Addition of short fence for ADA chair lift*
Staff Recommendation: Certificate of Appropriateness
Date of Public Hearing: July 15, 2014

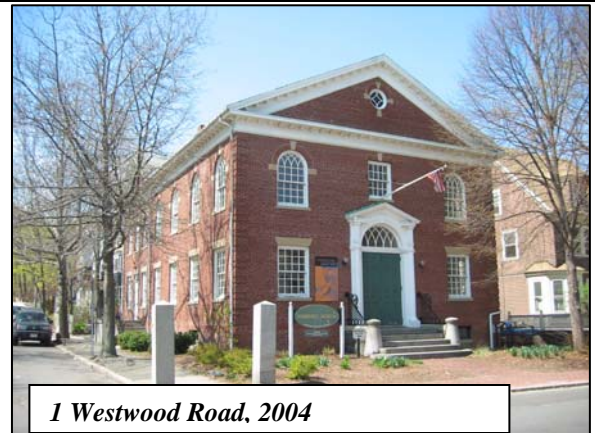
"The Museum building is a two-story Federal Revival building, executed in red brick, with brick quoins at the corners of the museum. A line of quoins defines a flat pavilion at the rear of the Westwood façade. This façade has its own enclosed pediment above the continuous cornice. A slate roof, whose ridge runs front to back covers the building. The front façade has an enclosed pediment, with a circular window in the middle. The centrally placed double entry doors on Central Street are surmounted by a fanlight with interlaced mullions and has a Federal Revival pedimented surround. Two square-headed 12/12 double-hung windows flank the entry. The second floor of the Central Street façade has an 8/8 double-hung window over the entry and is flanked by two round-headed double-hung windows with interlaced mullions. The two long sides have four bays of double-hung windows running back from the front façade. The upper windows have round heads, while the first floor windows have square heads. The rear of the northside wall is blank, while the rear pavilion on the Westwood façade has three bays. A single-leafed door is centered in the first floor of the pavilion and is flanked by two square-headed windows. Three square-headed windows are arranged above these openings on the second floor. The rear façade has an open pediment, with the main cornice returning across the rear quoins. There are six off-center, 8/8 double-hung windows on this facade. The lower windows each have a short transom.

"The main entry was changed to the Westwood Road door in 1986. Before this change, the first floor of the rear pavilion contained a door in the last bay and a small Palladian window to its right. The Palladian window was removed and the current configuration was built. The slate roof was replaced with new slates in 2012. The
