CITY OF SOMERVILLE, MASSACHUSETTS
OFFICE OF STRATEGIC PLANNING & COMMUNITY DEVELOPMENT
JOSEPH A. CURTATONE
MAYOR

HISTORIC PRESERVATION COMMISSION

ALTERATION TO A HISTORIC PROPERTY STAFF REPORT

Site: 1 Westwood Road c.1929 Somerville Museum
Case: HPC 2015.073 Westwood Road Local Historic District

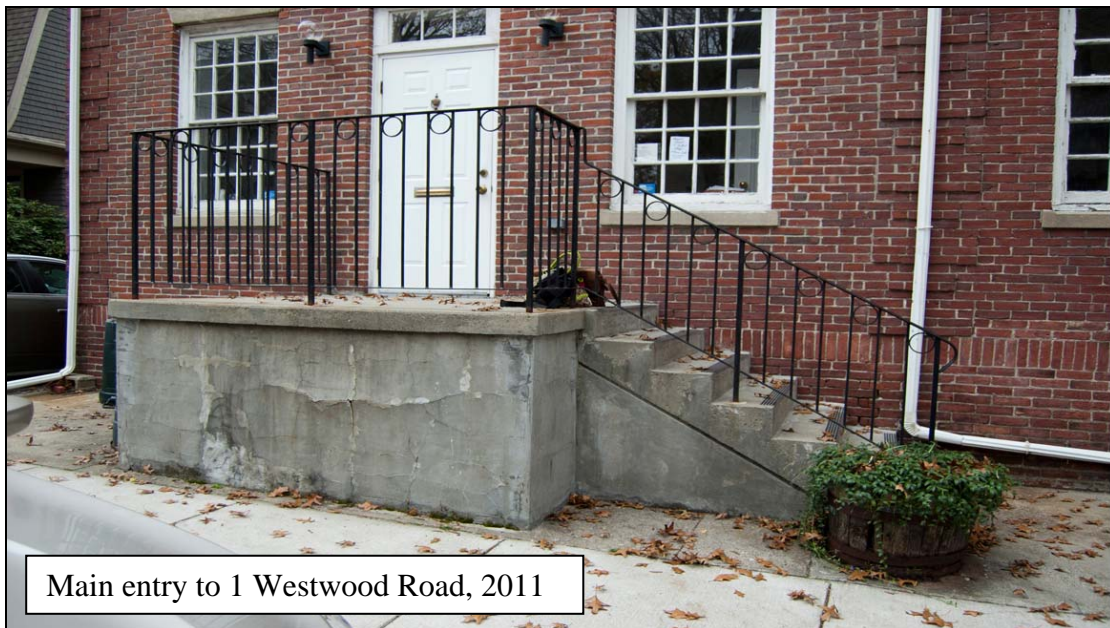
Main entry to 1 Westwood Road, 2011

The main entry on Central Street is not in service because its doors originally came from the Central Library, are fragile and should not be heavily used. The side entry on Westwood Road has become the principal entry. (This is not visually the prominent.) First-time visitors often don't realize that it is the main way into the building. The platform and stairs are cement and stucco with a simple iron railing; while meeting HPC Guidelines for being distinguishable from the historic building; they do not add anything to the building. In 2012, the Commission granted a Certificate of Appropriateness to alter the porch to meet ADA requirements along with issuing a Certificate of Non-Applicability for extensive repairs which have been completed. The Certificate was revised in 2014 to include a short railing to prevent a trip hazard. These plans were denied by the Architectural Access Board (AAB) who required that a more direct path be installed for wheelchair access than the one proposed by the original design. The AAB also required that all the museums floor needed to be accessible. This has resulted in a much larger addition than the one originally envisioned. See attached plans for the full proposal.

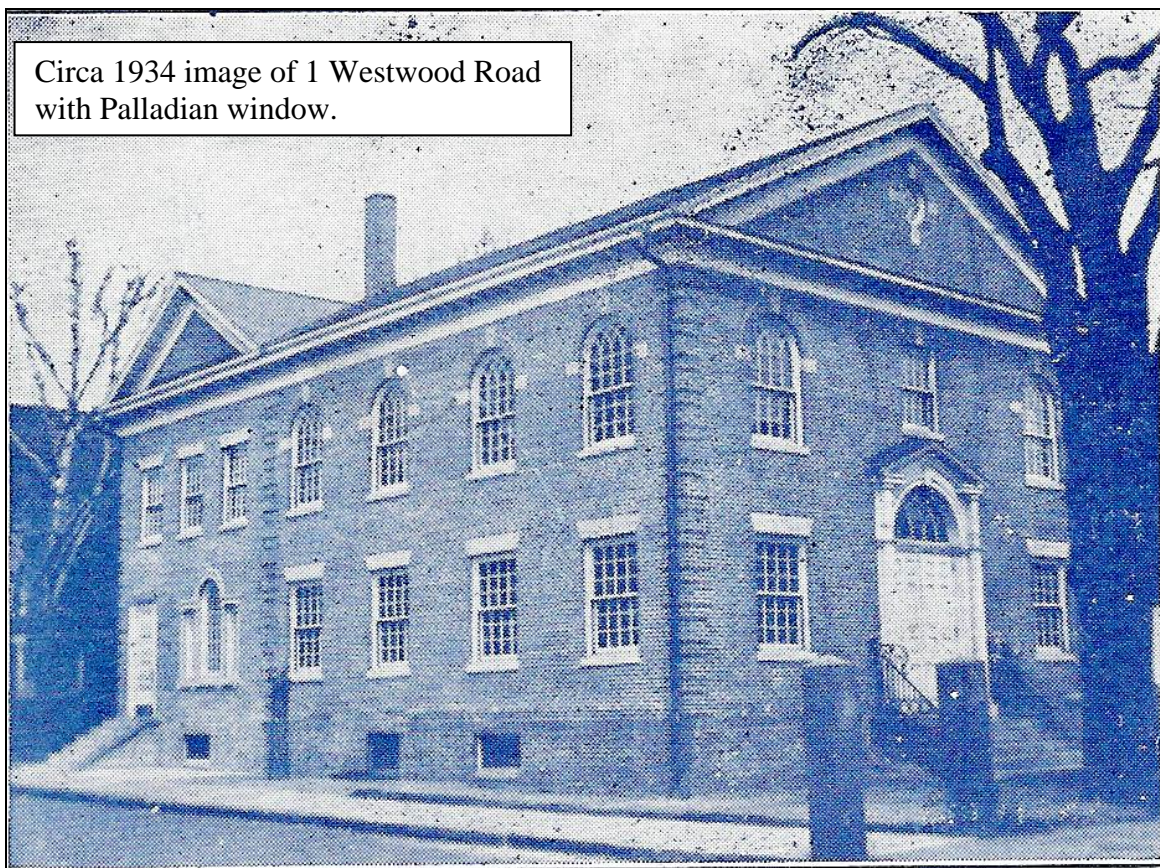
Circa 1934 image of 1 Westwood Road with Palladian window.

"The main entry was changed to the Westwood Road door in 1986. Before this change, the first floor of the rear pavilion contained a door in the last bay and a small Palladian window to its right. The Palladian window was removed and the current configuration was built. The slate roof was replaced with new slates in 2012. The

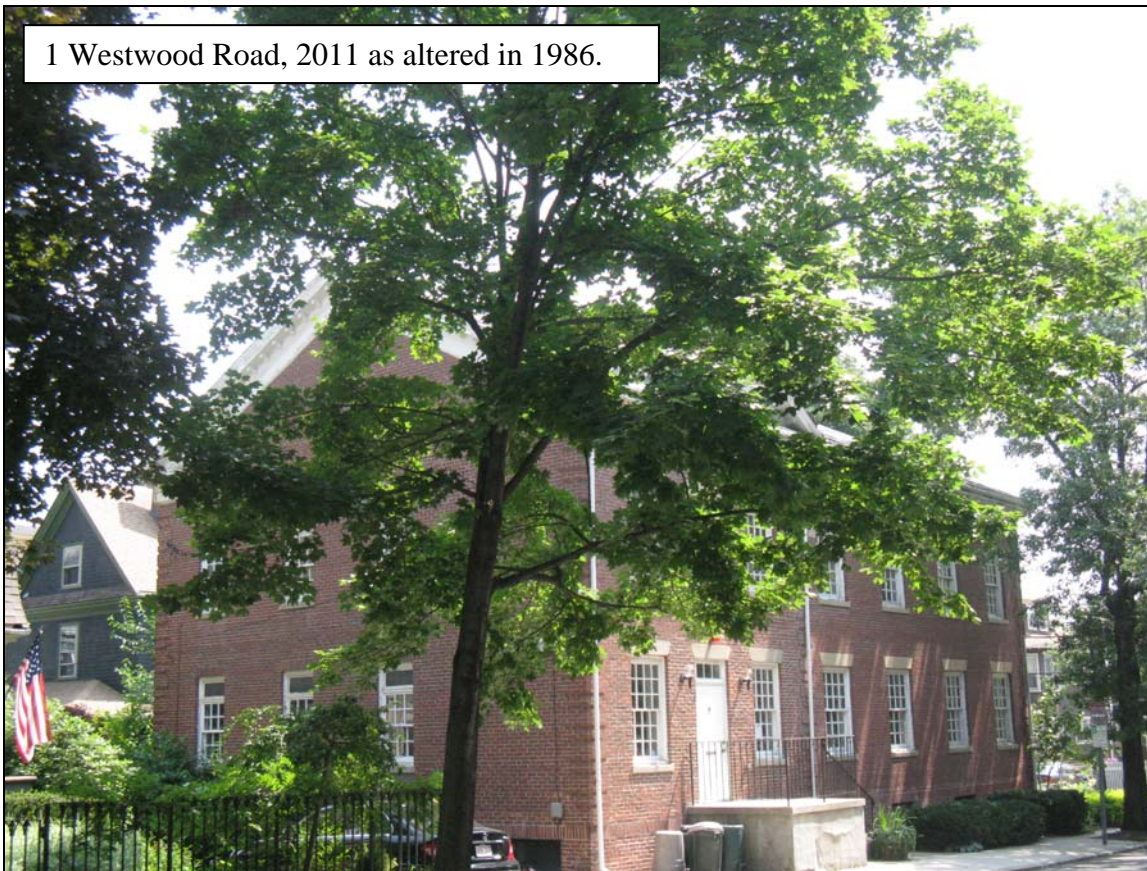
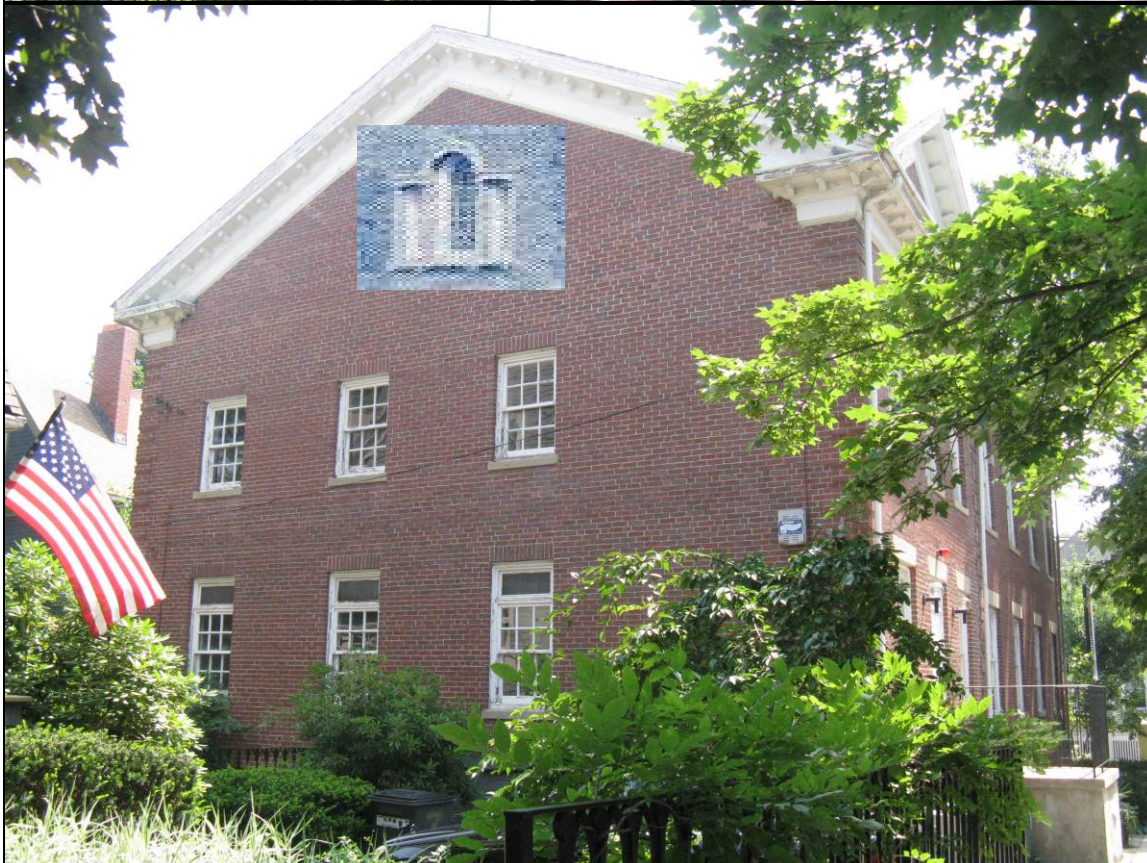
Rear of the Somerville Museum showing the approved location of the Palladian window as required by the MHC Preservation Restriction

There is no proposal at this time for the installation of the Palladian window which needs to be reinstalled at the time of the installation of an elevator. This does not meet with the MHC Restrictions.

5. Other Provisions: The Palladian window, which will be crated and stored is to be reinstalled in a location approved by the Commission on the rear wall of the Somerville Historical Museum. Reinstallation of the window will occur at a future date when and if an elevator is installed in the Somerville Historical Museum.

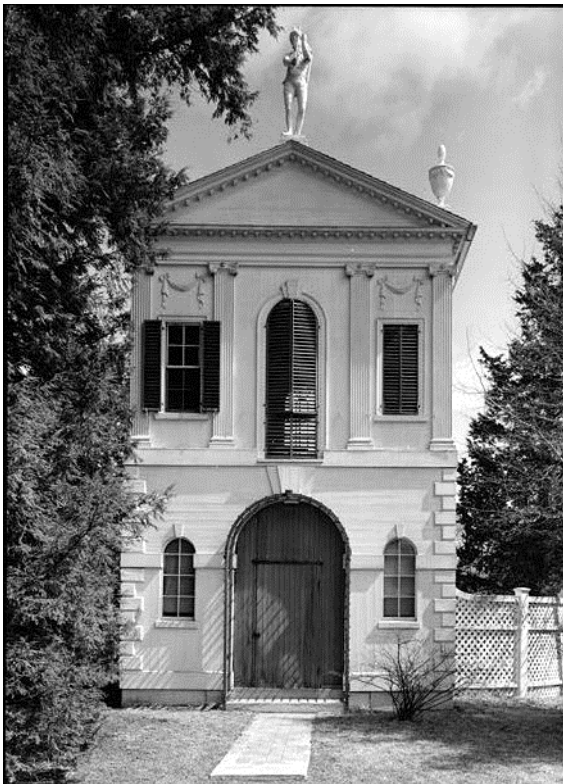
The 1797 Derby Summer House in Danvers served as inspiration for the proposed addition to the museum.

The proposal is more appropriate than the existing 1980s era steps and entry. At a meeting with Staff and an Architect from the Commission on February 4, 2016, a new design was reviewed and refinements made. The design, based upon a Colonial era building in Saugus with similar proportions, lends itself to the purposes of the Museum and compliments the original building.
