HISTORIC PRESERVATION COMMISSION

ALTERATION TO A HISTORIC PROPERTY STAFF REPORT

Site: 1 Westwood Road c.1929 Somerville Museum
Case: HPC 2015.073 Westwood Road Local Historic District

Date of Application: October 28, 2015
Legal Notice: *Alter Westwood Road entry to meet ADA.*

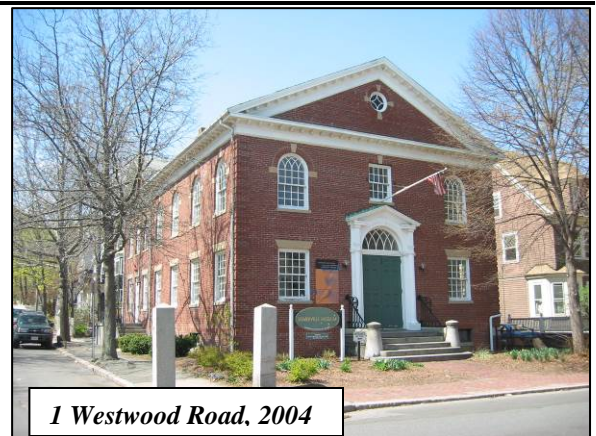
"The Museum building is a two-story Federal Revival building, executed in red brick, with brick quoins at the corners of the museum. A line of quoins defines a flat pavilion at the rear of the Westwood façade. This façade has its own enclosed pediment above the continuous cornice. A slate roof, whose ridge runs front to back covers the building. The front façade has an enclosed pediment, with a circular window in the middle. The centrally placed double entry doors on Central Street are surmounted by a fanlight with interlaced mullions and has a Federal Revival pedimented surround. Two square-headed 12/12 double-hung windows flank the entry. The second floor of the Central Street façade has an 8/8 double-hung window over the entry and is flanked by two round-headed double-hung windows with interlaced mullions. The two long sides have four bays of double-hung windows running back from the front façade. The upper windows have round heads, while the first floor windows have square heads. The rear of the northside wall is blank, while the rear pavilion on the Westwood façade has three bays. A single-leafed door is centered in the first floor of the pavilion and is flanked by two square-headed windows. Three square-headed windows are arranged above these openings on the second floor. The rear façade has an open pediment, with the main cornice returning across the rear quoins. There are six off-center, 8/8 double-hung windows on this facade. The lower windows each have a short transom.

"The main entry was changed to the Westwood Road door in 1986. Before this change, the first floor of the rear pavilion contained a door in the last bay and a small Palladian window to its right. The Palladian window was removed and the current configuration was built. The slate roof was replaced with new slates in 2012. The

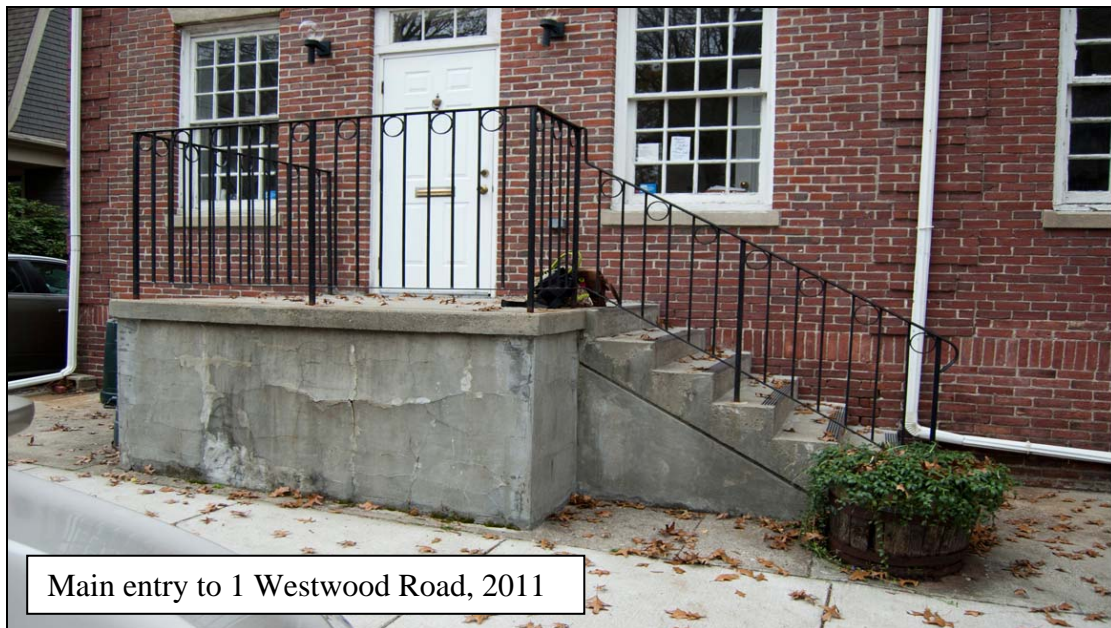
Main entry to 1 Westwood Road, 2011

The main entry on Central Street is not in service because its doors originally came from the Central Library, are fragile and should not be heavily used. The side entry on Westwood Road has become the principal entry. (This is not visually the prominent.) First-time visitors often don't realize that it is the main way into the building. The platform and stairs are cement and stucco with a simple iron railing; while meeting HPC Guidelines for being distinguishable from the historic building; they do not add anything to the building. In 2012, the Commission granted a Certificate of Appropriateness to alter the porch to meet ADA requirements along with issuing a Certificate of Non-Applicability for extensive repairs which have been completed. The Certificate was revised in 2014 to include a short railing to prevent a trip hazard. These plans were denied by the Architectural Access Board (AAB) who required that a more direct path be installed for wheelchair access than the one proposed by the original design. The AAB also required that all the museums floor needed to be accessible. This has resulted in a much larger addition than the one originally envisioned. See attached plans for the full proposal.

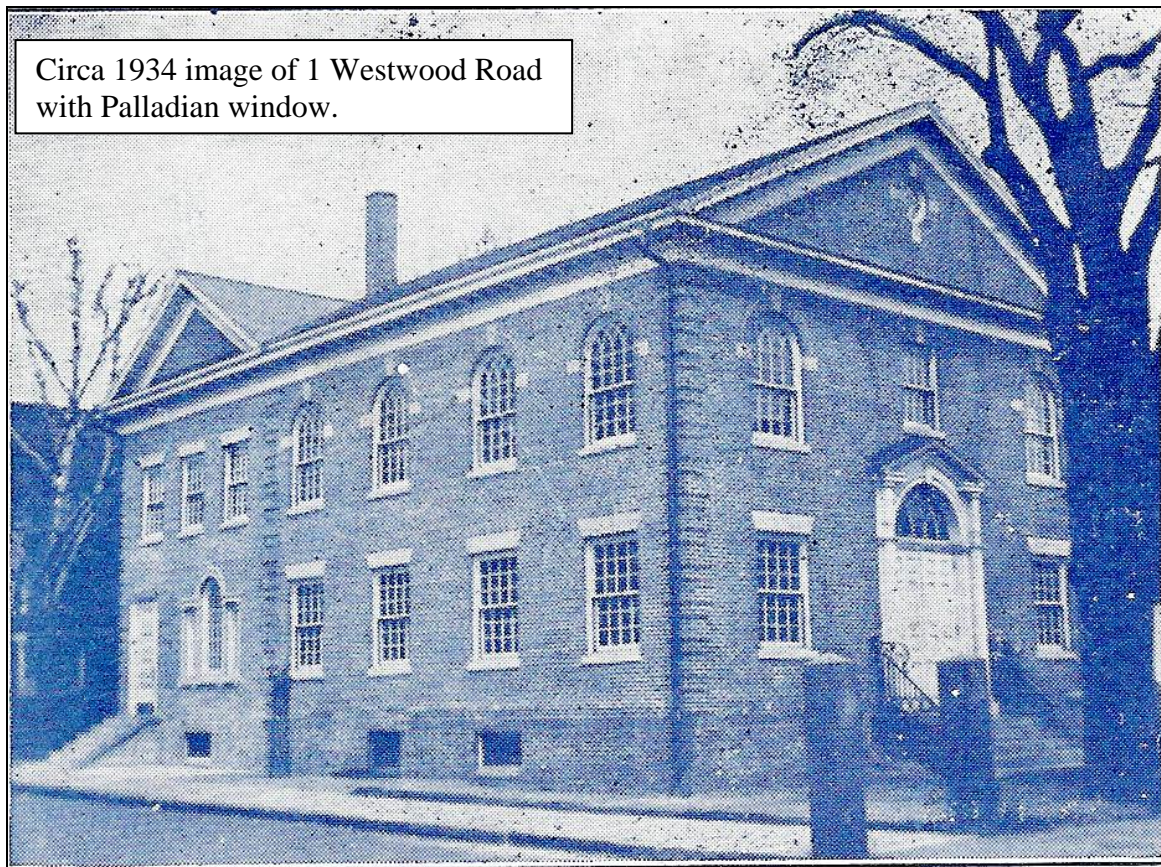
Circa 1934 image of 1 Westwood Road
with Palladian window.

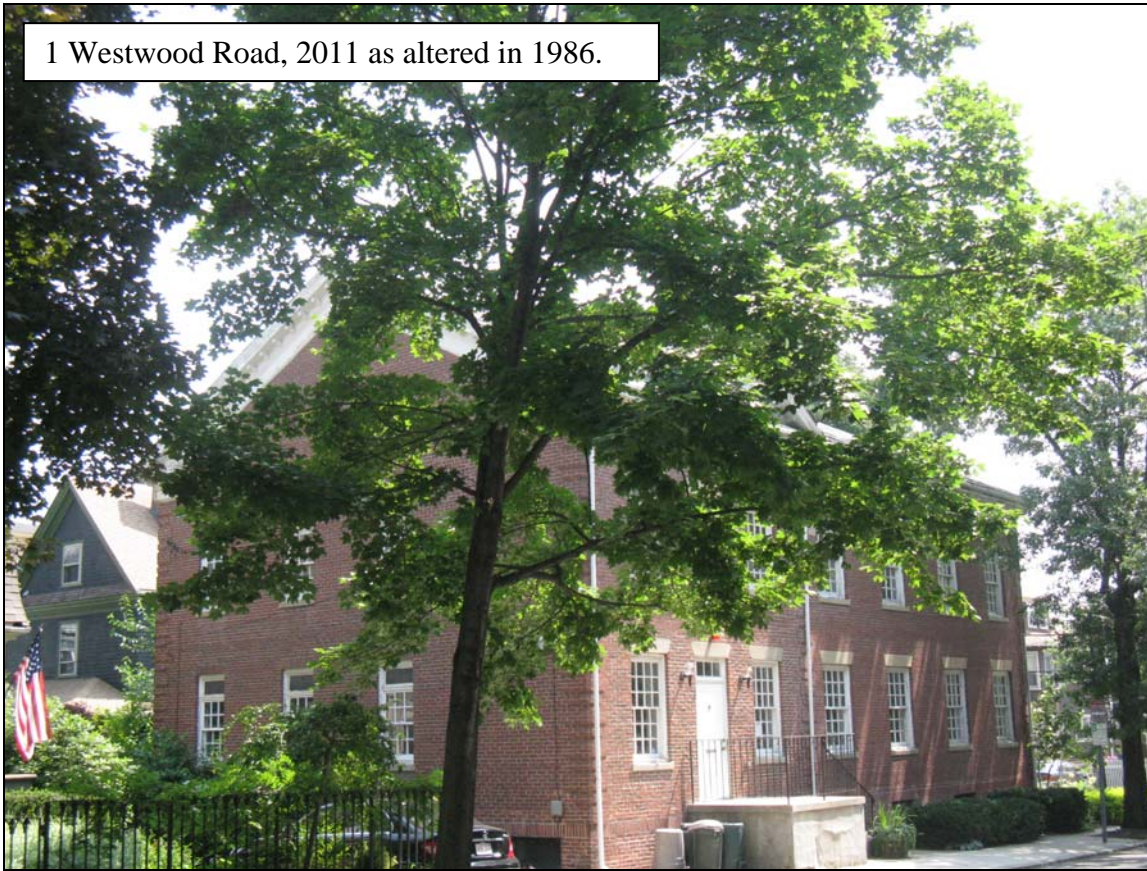
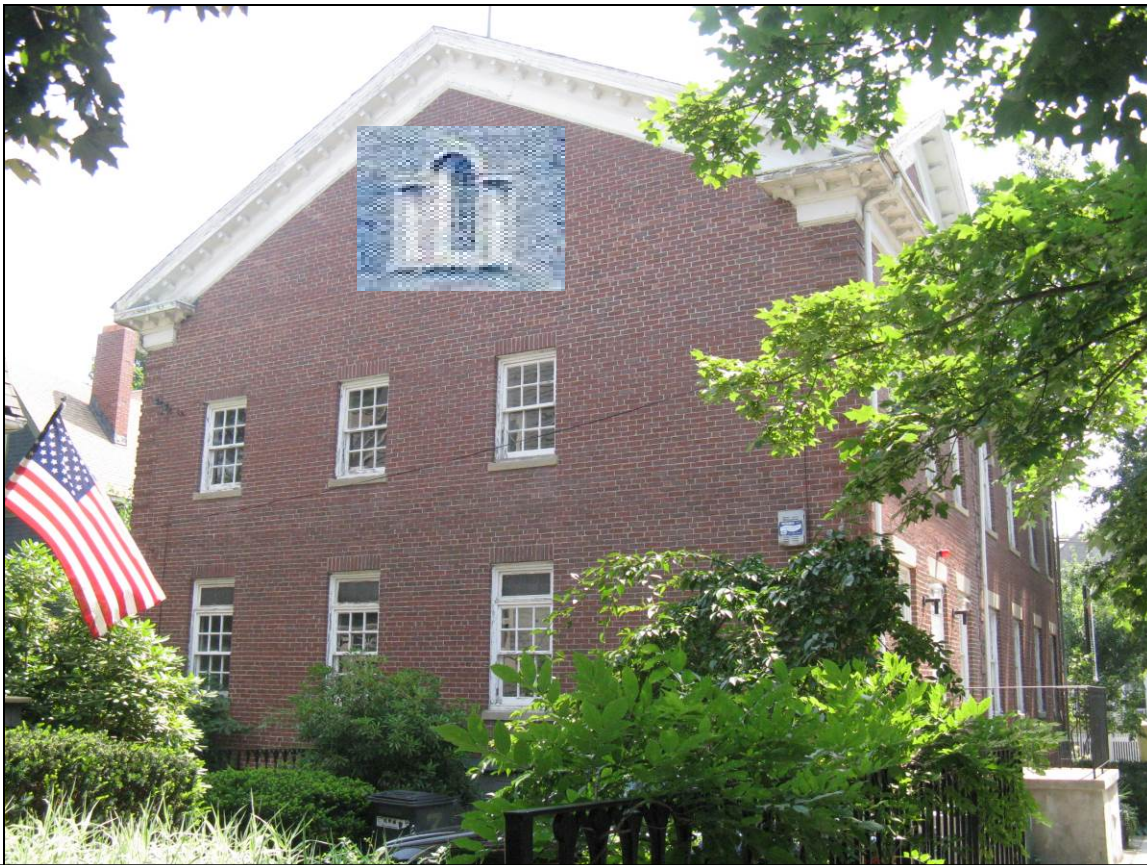
1 Westwood Road, 2011 as altered in 1986.

Rear of the Somerville Museum showing the approved location of the Palladian window as required by the MHC Preservation Restriction

The Palladian window will be reinstalled on the rear at the time as the elevator. This meets with the MHC Restrictions. *New additions or alterations should be done in a way that, if they were to be removed in the future, the basic form and integrity of the historic property would remain intact.*

6. The Palladian window shall be relocated to the rear of the building facing the parking area as per MHC Preservation Restriction.
7. Historic Staff shall issue a sign-off upon completion of the project that this was done in accordance with the Certificate and approved plans and prior to the Somerville Historical Society receiving Inspectional Service Division sign off.

5. Other Provisions: The Palladian window, which will be crated and stored is to be reinstalled in a location approved by the Commission on the rear wall of the Somerville Historical Museum. Reinstallation of the window will occur at a future date when and if an elevator is installed in the Somerville Historical Museum.

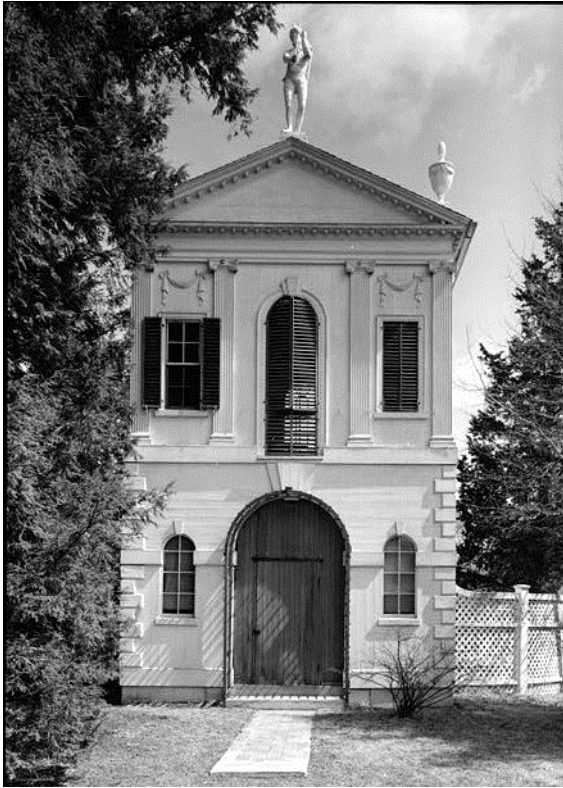
The 1797 Derby Summer House in Danvers served as inspiration for the proposed addition to the museum.

The proposal is more appropriate than the existing 1980s era steps and entry. At a meeting with Staff and an Architect from the Commission on February 4, 2016, a new design was reviewed and refinements made. The design, based upon a Colonial era building in Saugus with similar proportions, lends itself to the purposes of the Museum and compliments the original building.
