**ALTERATION TO A HISTORIC PROPERTY STAFF REPORT**

Site / District(s)      9 Westwood Road, Charles Lamb House, Westwood Road LHD  
Case:                      HPC 12.129

Applicant Name:        Sylvia and Arthur Shurcliff  
Applicant Address:     9 Westwood Road

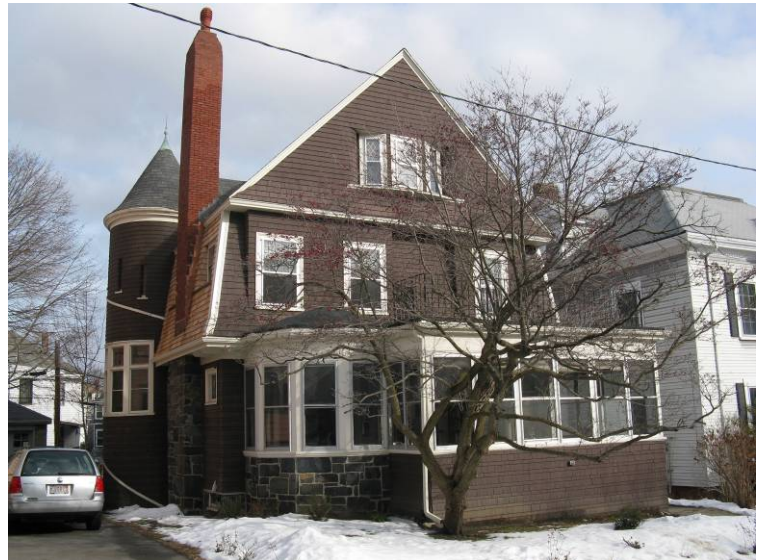
9 Westwood Road is one of the best preserved examples of the Shingle Style on Westwood Road. Rising from a prominent stone foundation and clad in wood shingles, this two and one-half story front gabled house is rectangular in plan. The facade is two bays wide with a one-story bay window on the first floor. The off center entrance has been obscured by an enclosed porch that also encompasses a portion of the bay. While the facade of this house has minimal architectural detailing, typical of the Shingle Style; the second floor exhibits unique variations in the wall plane. The building wall, which projects slightly over the first floor, is constructed at a slightly recessed angle, while the three second floor windows continue the vertical plane of the upper third story. This results in the appearance of shallow dormers under the projecting third floor. In the gable, a recessed semi-hexagonal bow window is framed by curved walls, a characteristic element of the Shingle Style. The west elevation is demined by a two-story round turret with conical roof. The turret consists of a four-part window with stained glass transoms on the first floor and a stepped series of narrow elongated rectangular windows recessed into the wall surface on the

second floor. The second story windows on this elevation are recessed into the angled wall, in contrast to the projecting windows on the facade. An exterior chimney, which is fieldstone on the first floor and brick above, completes the west elevation.

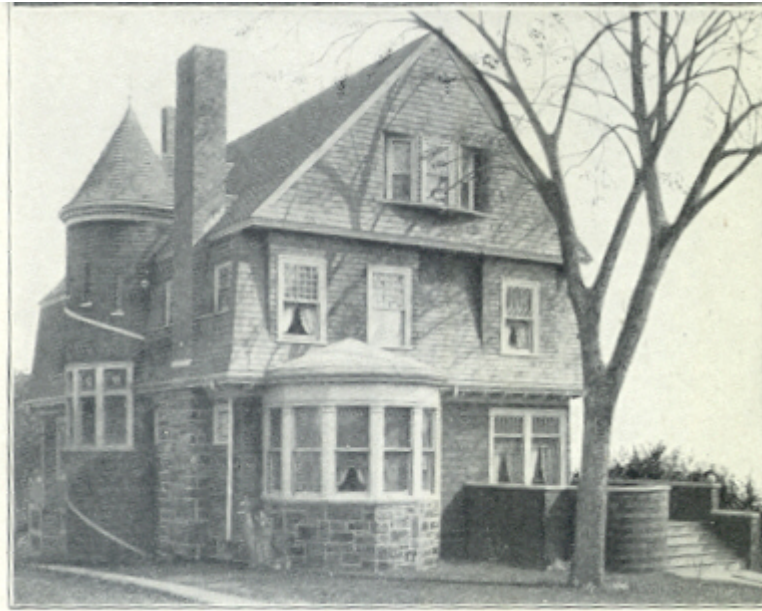
The windows are not described in Form B, however, the historic photo shows the original building as it looked in 1898. The proposed window is not visible in the photo and is located in the servants' portion of the building where simpler, less elaborate windows would have been the norm.

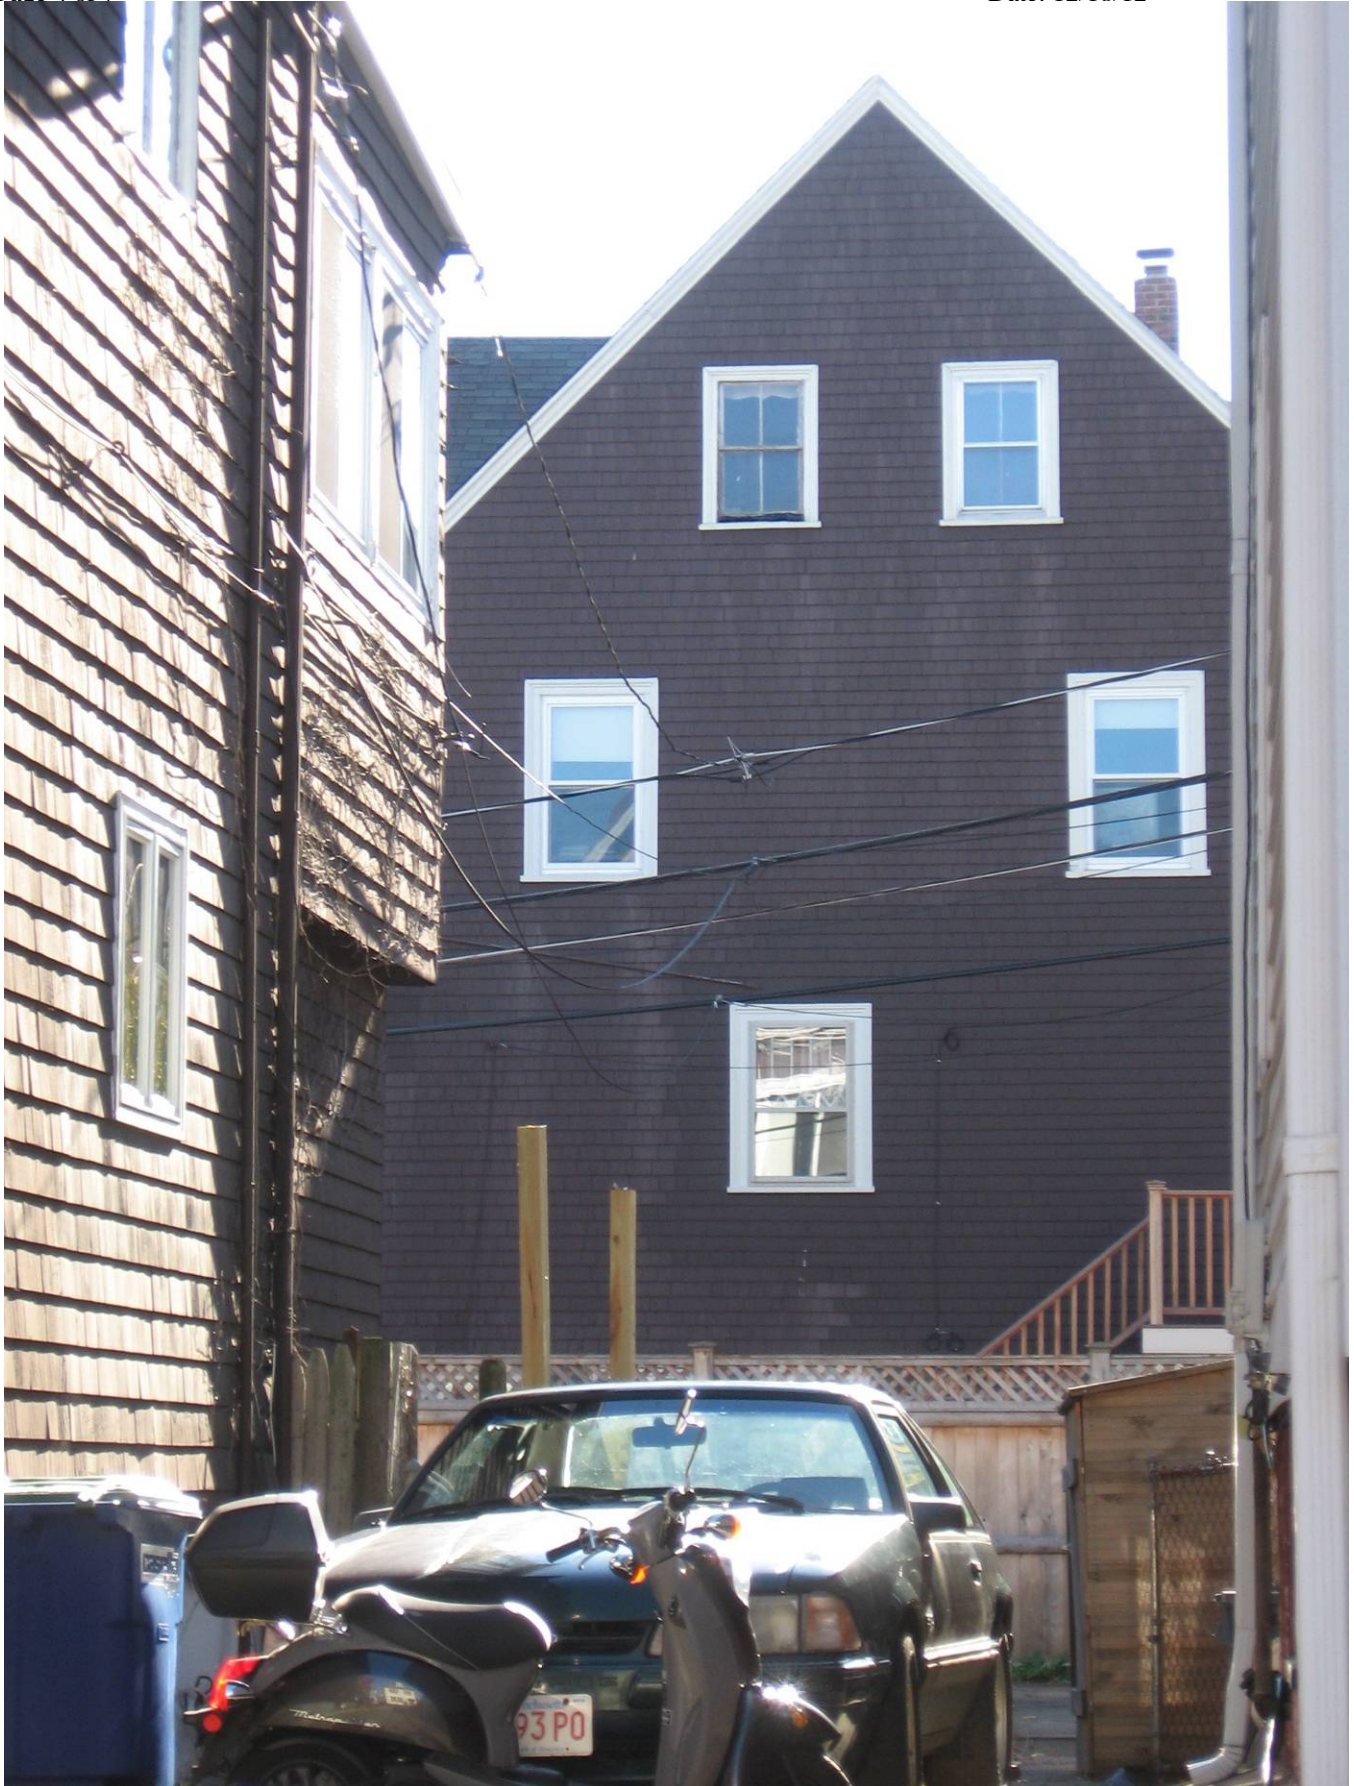
This house is located on Westwood Road, a district with multiple shingle style houses developed in the late 1890s. Decorative window treatments are found throughout the district. At some point, the decorative multi-pane second floor windows on the rear portion of the building were modernized with 1/1 sash. The existing windows on the third floor may be original to the building as they are located in the less formal section of the building.

The rear of the house is visible from Cambria Street. See photo.

- + Staff determines that the alteration for which an application for a Historic Certificate has been filed is appropriate for and compatible with the preservation and protection of the 9 Westwood Road, Charles Lamb House, Westwood Road Local Historic District; therefore **Staff recommends that the Historic Preservation Commission grant Sylvia and Arthur Shurcliff a Certificate of Appropriateness, with the condition that the windows have no Lo-E coating, a muntin and a spacer to match the existing historic window** because due to the distance from the street, it would not be “incongruous to the historic aspects or the architectural characteristics of the surroundings and of the historic district;” **and the windows be retained in storage for reinstallation at a later date, should a subsequent owner wish to do the needed repairs.**
