UST Closure Assessment

315-323 Broadway
Somerville, MA
IES Project # 2012-07-1072

Prepared By:
IES, Inc.
7 Kimball Lane – Building A
Lynnfield, MA 01940
617-623-8880

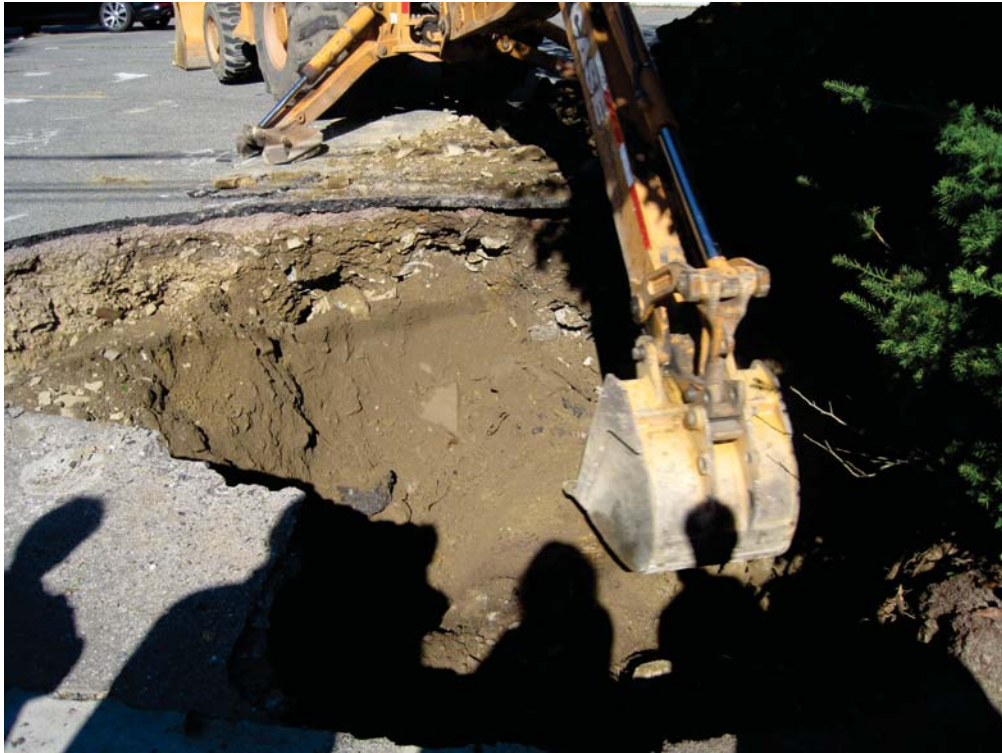
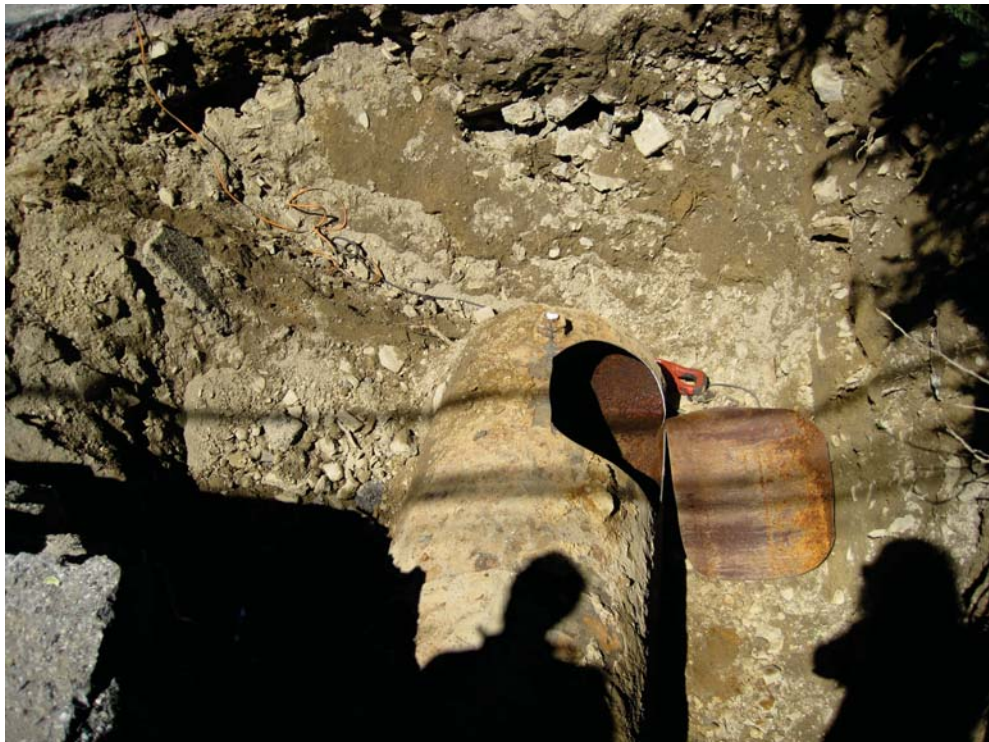
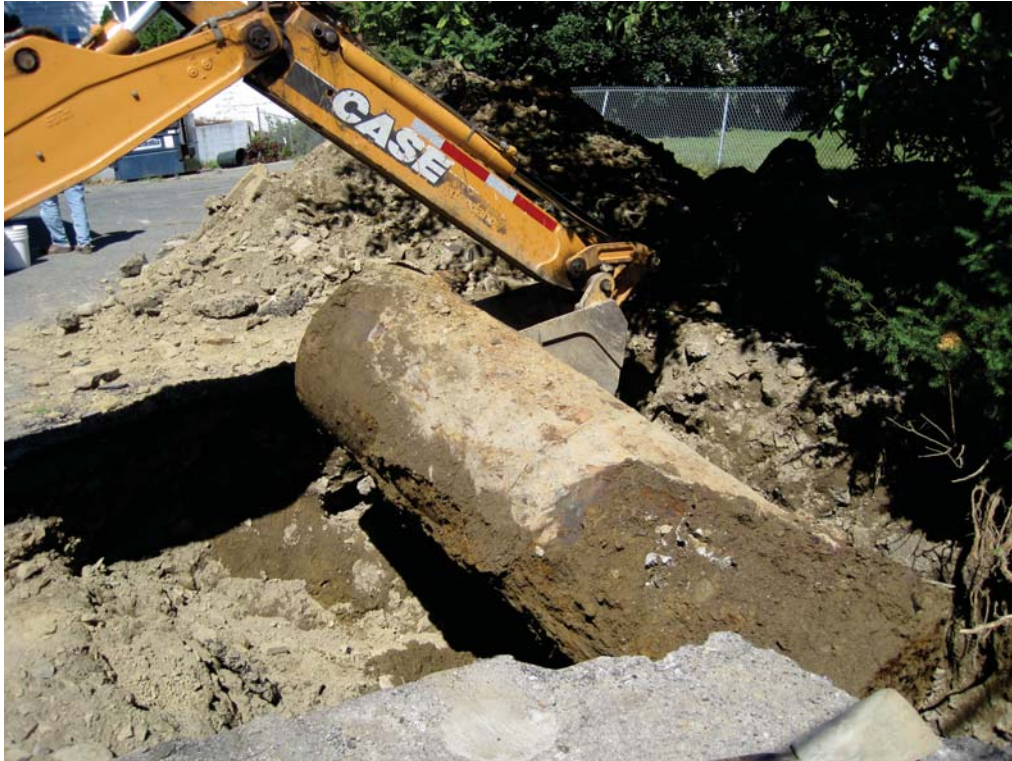
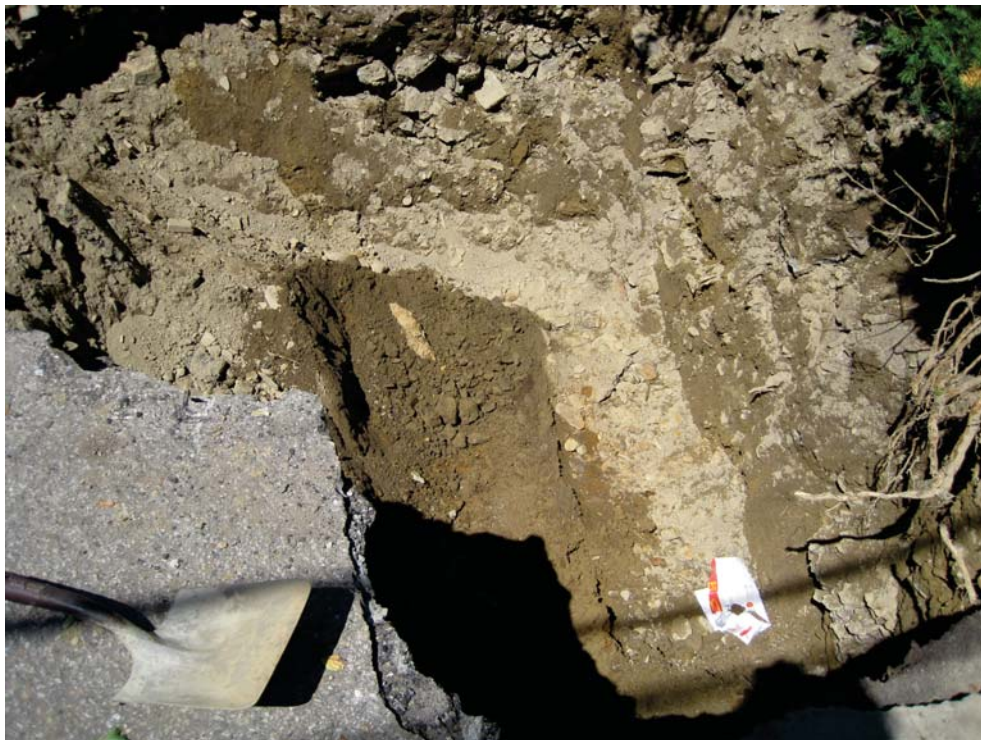
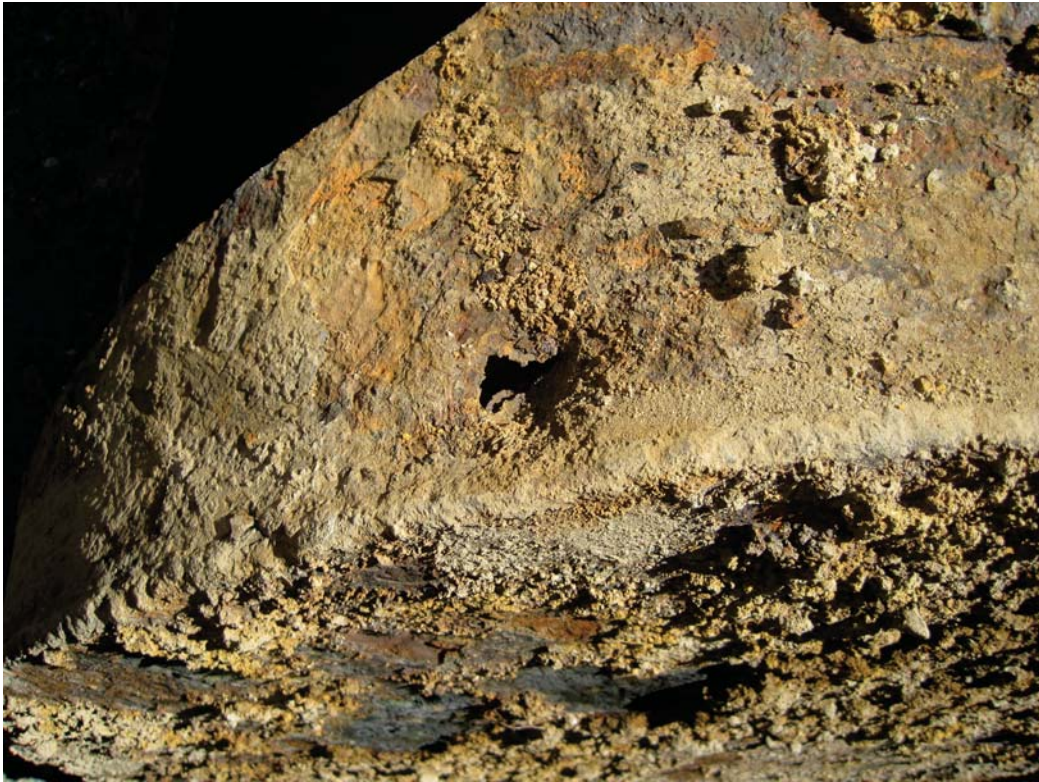
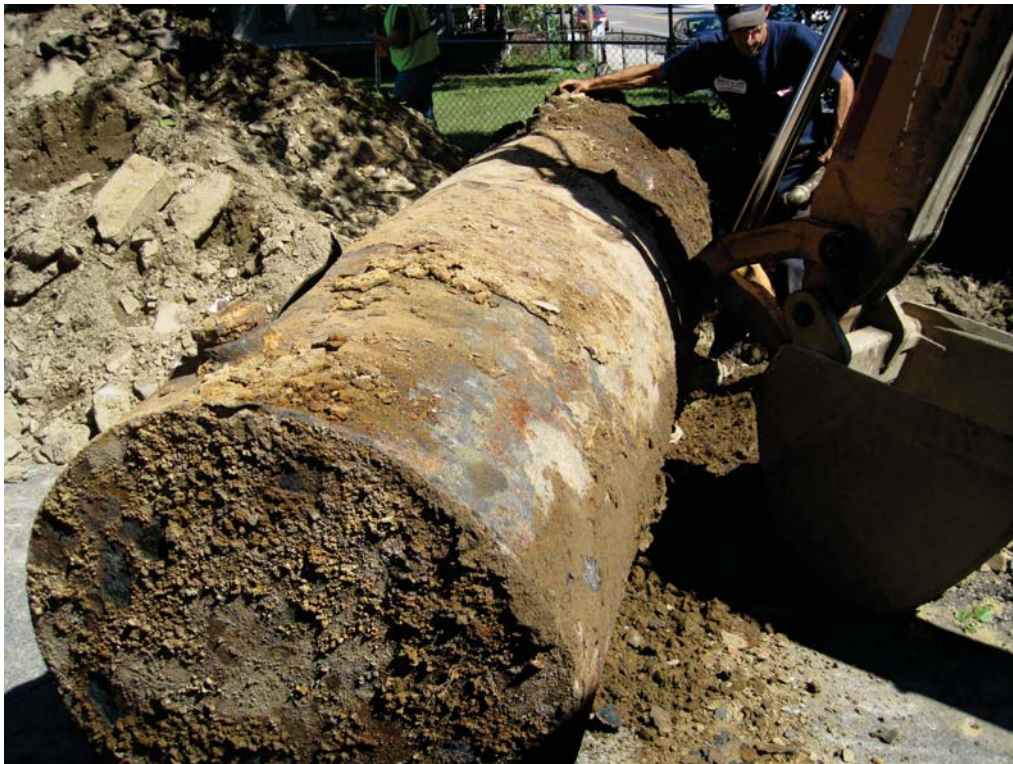
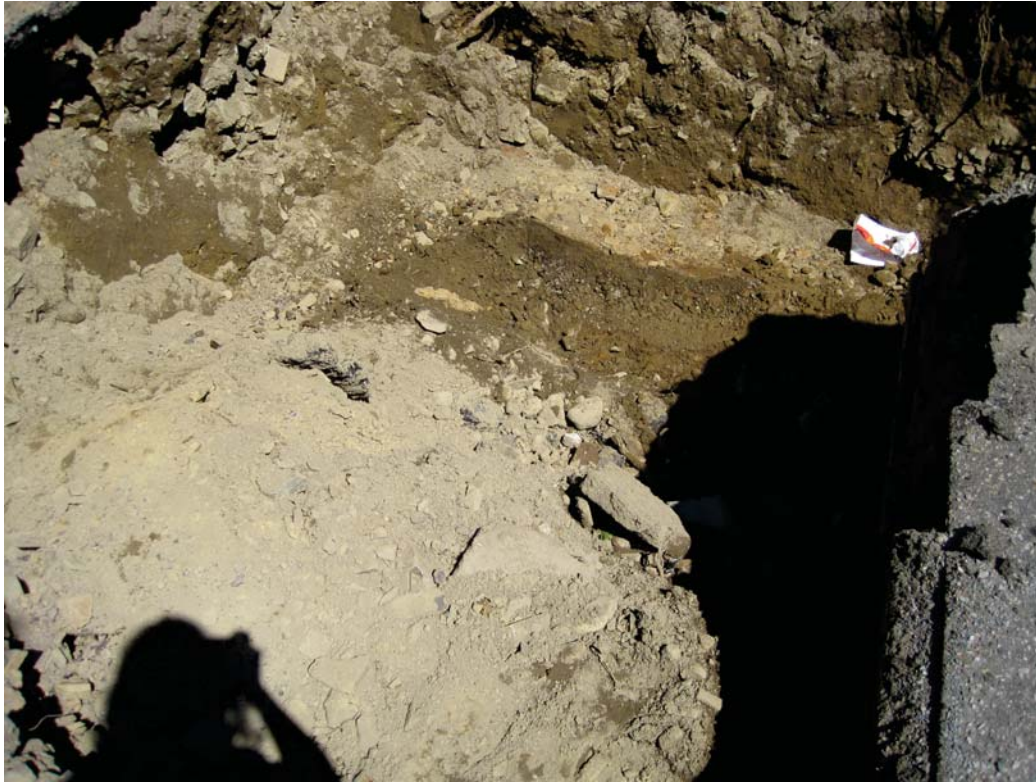
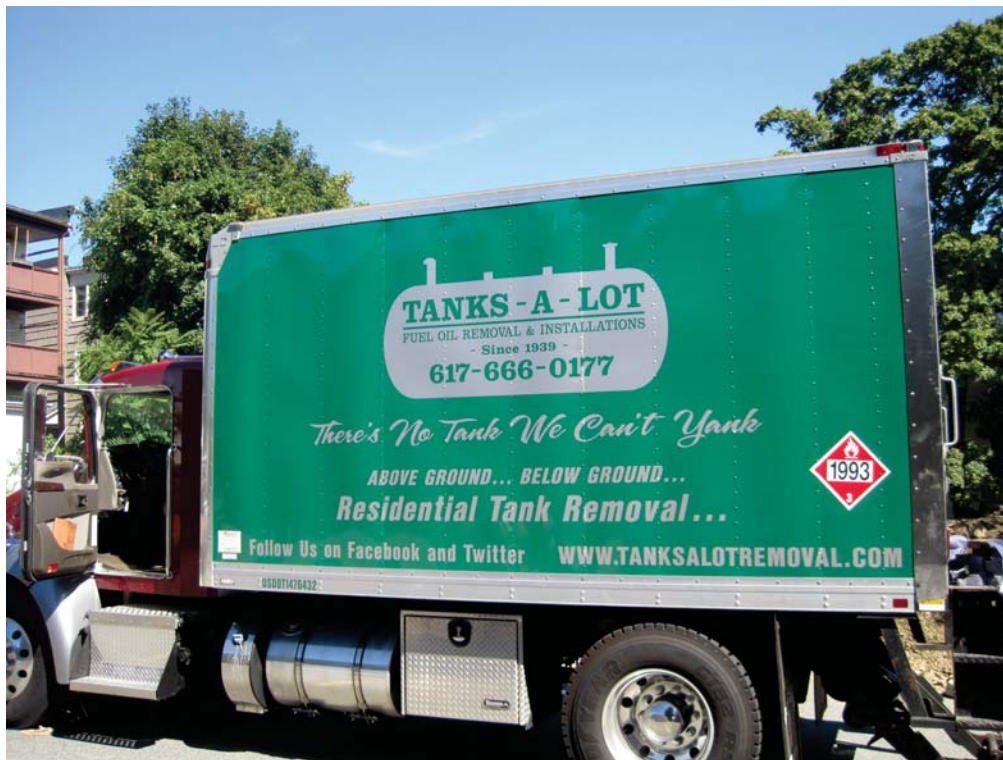
PHOTOGRAPHS

The tank was observed to be in fair to good condition, with one small hole noted near the top of the tank, and some rusting noted throughout the tank (see Photographs in **Attachment "A"**). Prior to the removal of the tank, a soil sample was obtained from the area in the immediate vicinity of the fill pipe. Upon the removal of the tank, a total of five other soil samples were obtained from the base (5-6 feet deep) of the four walls and from the center of the excavation. The samples were obtained pursuant to the requirements detailed in the DEP's "Underground Storage Tank Closure Assessment Manual" dated April 9, 1996 (DEP Policy #WSC-402-96).
