**CITY OF SOMERVILLE, MASSACHUSETTS**  
**OFFICE OF STRATEGIC PLANNING & COMMUNITY DEVELOPMENT**  
**JOSEPH A. CURTATONE**  
**MAYOR**

*HISTORIC PRESERVATION COMMISSION*

**ALTERATION TO A HISTORIC PROPERTY STAFF REPORT**

Site: 178 Central Street c.1840 Adams-Locke House  
Case: HPC 2014.014 Single Building Local Historic District

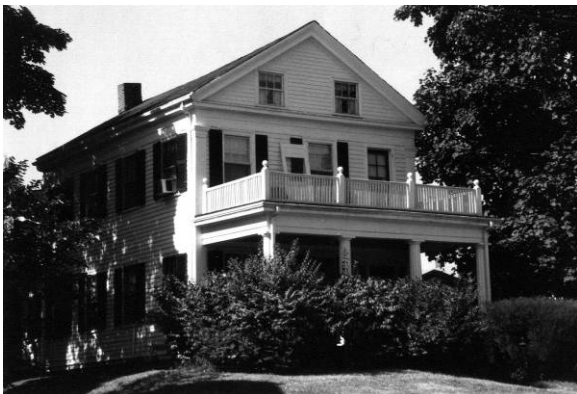
The Adams-Locke House is significant as one of the first non-vernacular houses built on Winter Hill. Built ca. 1840, this well-preserved grand sidehall plan Greek Revival-style house. It has a three-bay facade sited with its gable end to the street. Other notable features include the broad entablature at the cornice, wide corner boards, and full-width Doric porch (to which a ca. 1910 roof railing has been added). The entrance is flanked by full-length sidelights. The interior retains most of its original doors, door and window enframements, baseboard moldings, and decorative moldings. Recent interior demolition work for the kitchen has revealed post and beam construction

with brick nogging.

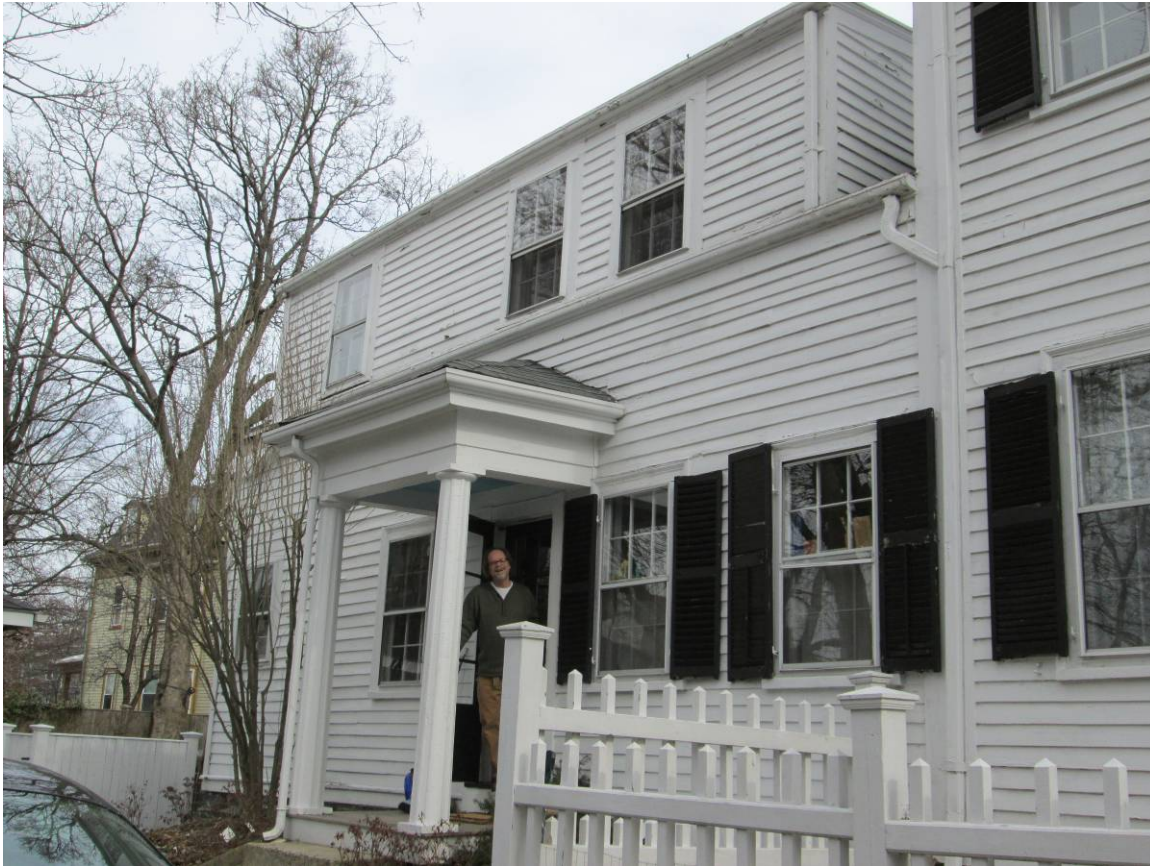
West facing windows (along driveway)  
have rotten sashes
