HISTORIC PRESERVATION COMMISSION

ALTERATION TO A HISTORIC PROPERTY STAFF REPORT

Site: 222 Morrison Avenue c.1873 William Shedd House
Case: HPC 2014.012 Morrison Avenue Local Historic District

Date of Application: February 9, 2016
Legal Notice:
Revisions to porch design, and driveway and walkway paving.

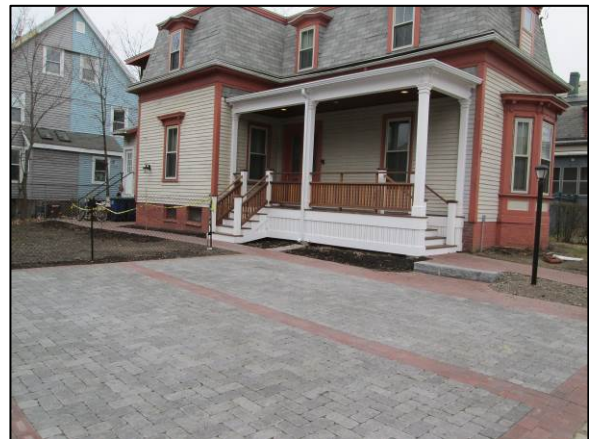
222 Morrison Avenue, 2016 photo

The porch was in poor condition with unsafe decking and broken balusters. As can be seen from the photos, the break in the porch floor and the sinking corner post coincided with the location of the original stairway. The walkways were uneven with broken asphalt. The driveway was dirt. The current fence at the end of the driveway is chain link.
