HISTORIC PRESERVATION COMMISSION

HISTORIC DISTRICT ALTERATION STAFF REPORT

Site / District(s) 8-10 Walnut Street / Single-Building LHD/NR
Case: HPC 2012.122

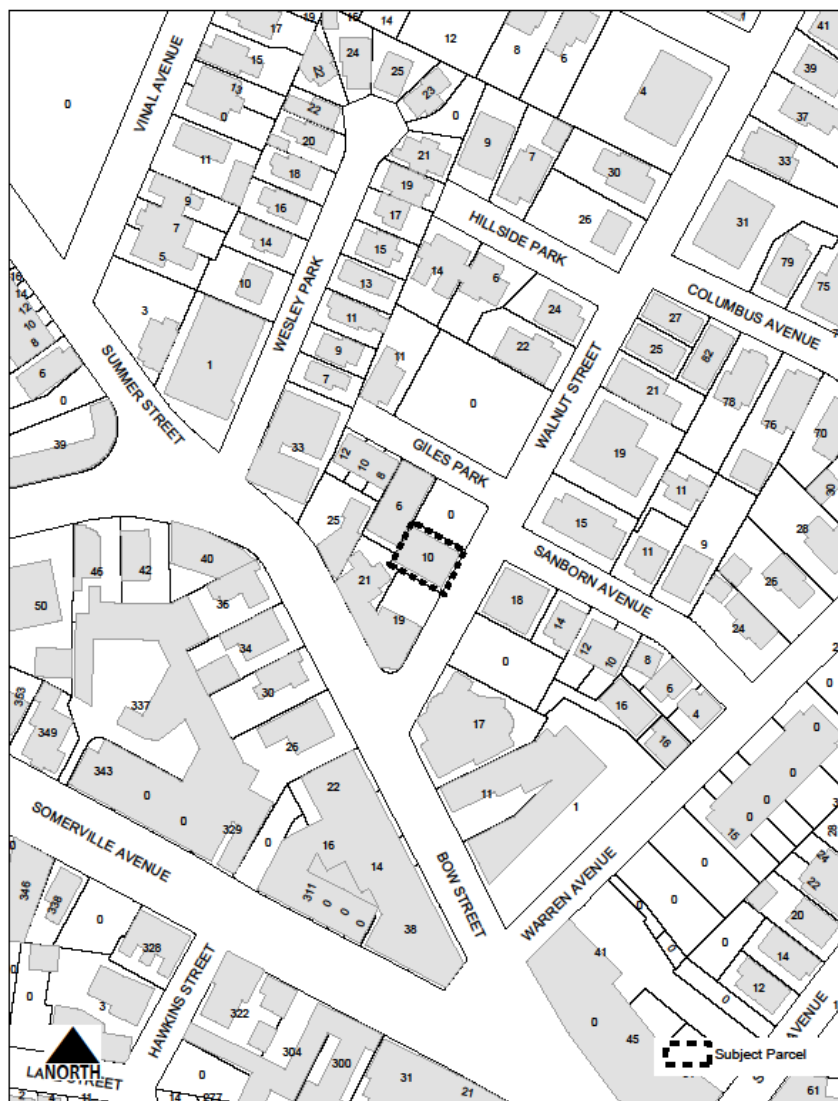
8-10 Walnut Street

The existing conditions were poor. Two of the six windows had already been replaced with vinyl; one window is only left with components of the upper sash, and the three remaining windows are in such bad condition that the wood components of the windows turned into dust as they were removed.

From photographs and statements by the tenant, Staff believes that the windows were likely not salvageable. Although the wood windows were replaced with aluminum, the feature still remains.

The newly installed aluminum windows do not match the material being replaced; however, the design is consistent and since the previous windows had been painted white, the color is consistent also. Although Low-E does alter the reflective quality of the glass, there are now six windows that are match.

Since the replacement windows have already been purchased and installed at the expense of the building owner, who thought the correct procedure had been followed, and since the previous windows were in such a poor condition that safety was an issue, **Staff recommends that the Historic Preservation Commission issue a Certificate of Hardship for the remaining three (3) windows that were originally wood. Staff also recommends a condition that upon the future replacement of these three aluminum windows, the Applicant shall replace them with Commission approved wood windows.**
