Re: Request for Qualifications (RFQ) #15-05 Design and Construction Administration Services for Renovations to the West Branch Library

**Addendum #1 – Response to Questions**

# Historic Structure Report

## West Branch Library

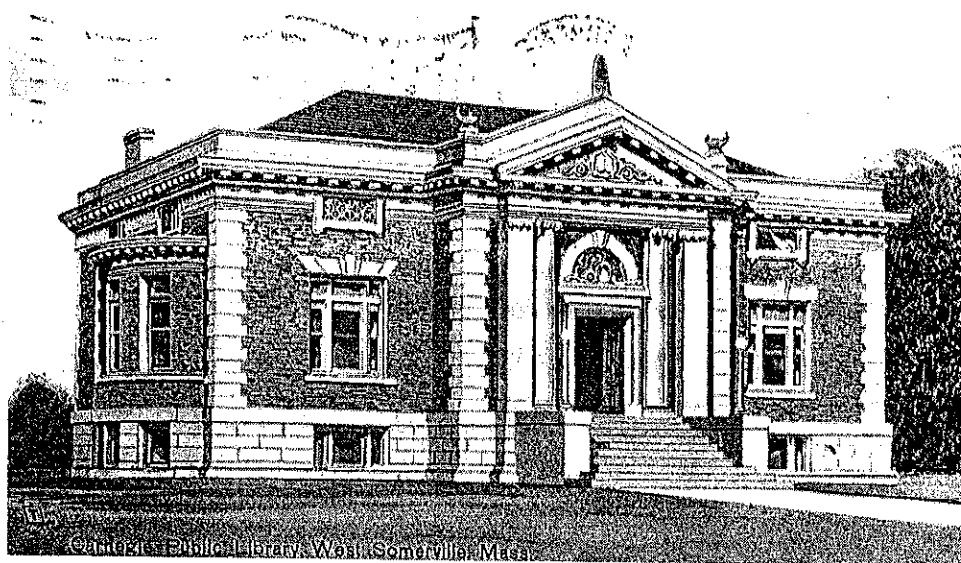
**Figure 1**

Early postcard of the library possibly from rendering by architect McLean & Wright. Note lampposts at entry.

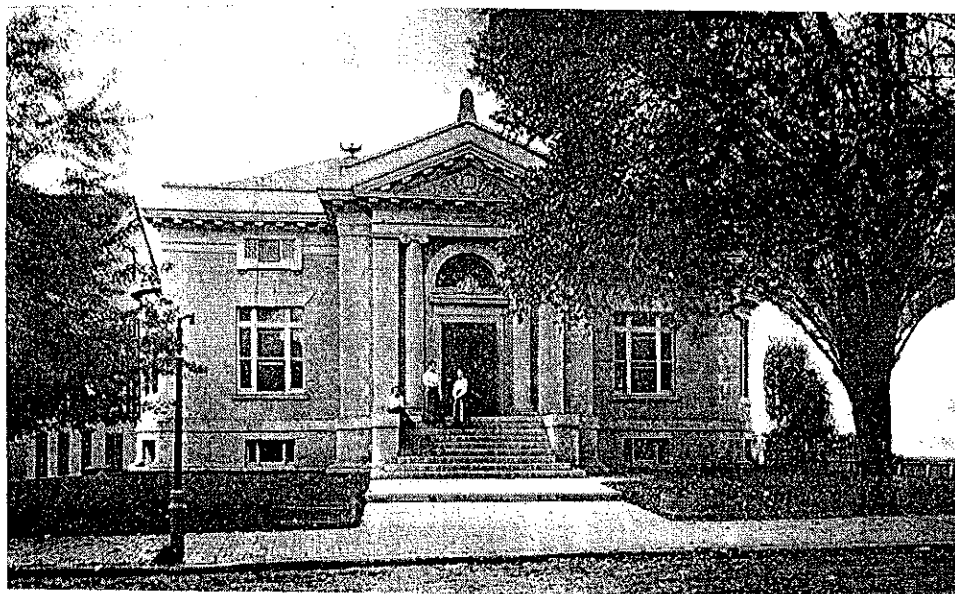
**Figure 2**

Photograph taken around the opening of the library. The three women are the librarians. Note the lack of construction to the northeast and no lamps on stairs.

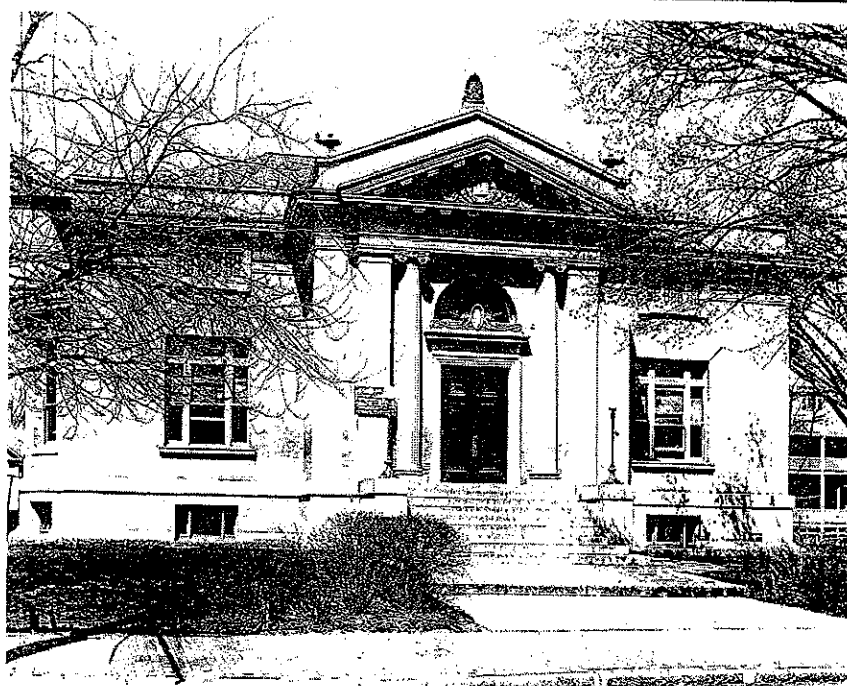
**Figure 4**

Photograph taken at a later date. Note visible construction to the northeast and lamps added not visible in 1909 view.

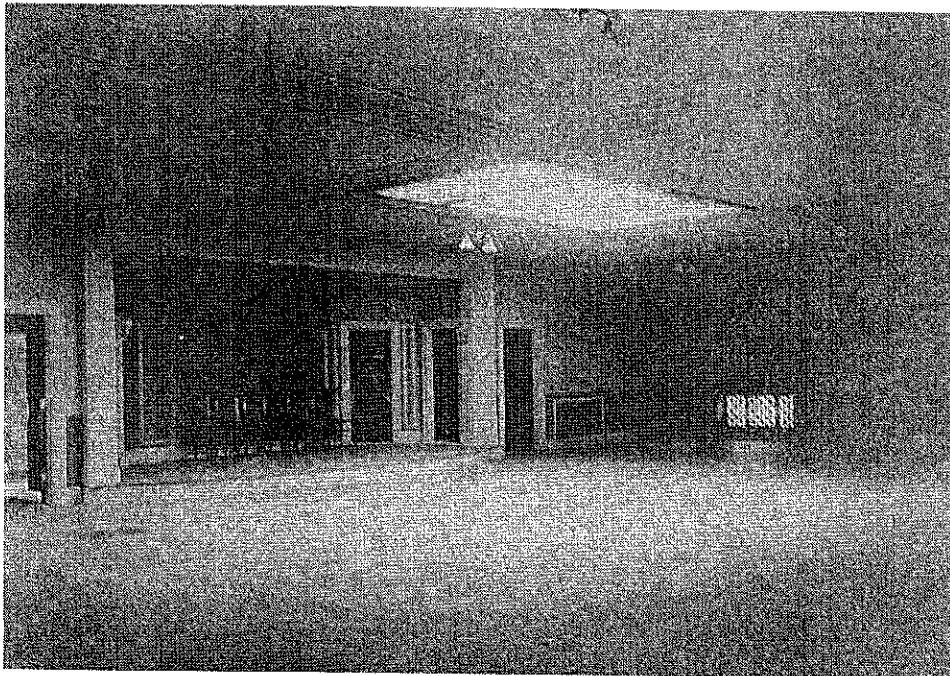
**Figure 6**

The roof skylight, which is shown on the original plans and is a significant element of the interior (Fig. 6), has been covered, the ceiling filled in and fitted with fluorescent lighting. The second floor Hall space has been converted to a reading room, possibly at the time of the 1974 feasibility study. The walls, which were finished in white wood according to the original drawings, were covered in plywood paneling and the hard pine floor was covered with yellow carpeting. All the original brown cypress doors by the stage still remain, except for the west door, which was converted to a fire door. Although there are no photographs showing the second floor entrance doors, the plans indicate that there were two glazed doors with glass sidelights on either side, the same as the current doorway configuration. The stage, another significant element of the second floor, remains intact and is not currently being utilized.

View of original second floor Hall space with ceiling stenciling, open skylight and stage area.

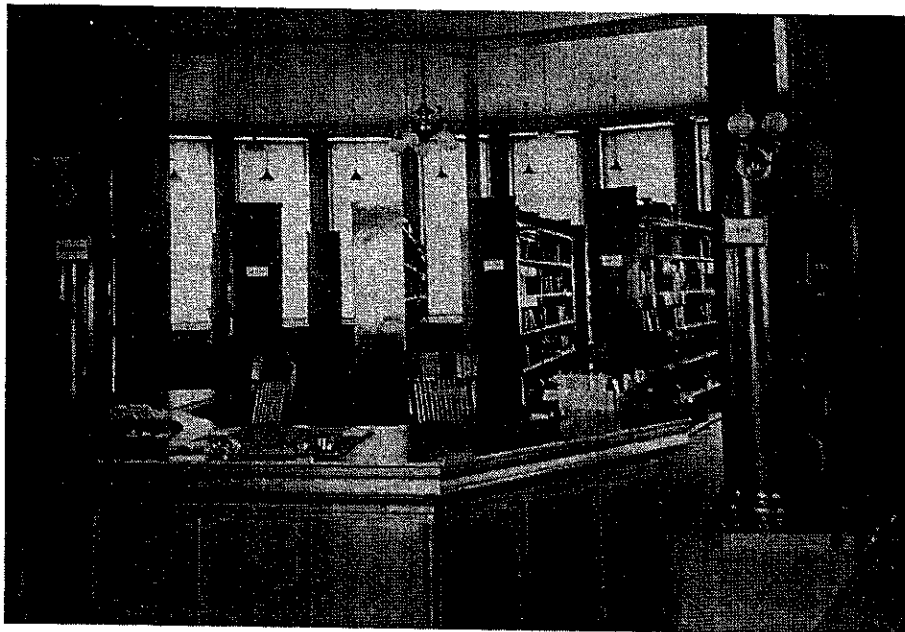
**Figure 11**

Interior view of reference desk and rear stack room. Note: columns with light fixtures still exist.

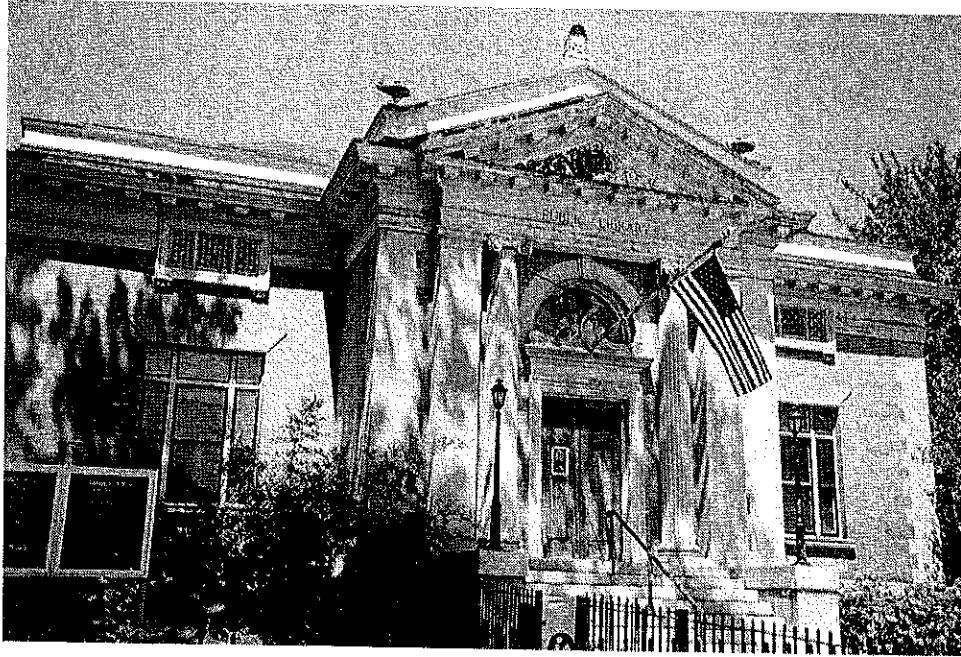
**Figure 12**

The exterior of the West Branch Library is a two-story Classical Revival (with Beaux-Arts influences) building of solid, multi-wythe load bearing construction (Fig. 12). It has not been significantly altered since its construction in 1909. The exterior cladding is composed of buff-colored Roman brick and limestone, which has become dirty and stained over the years (Fig. 13). All elements designated as terra cotta in the original drawings, such as window lintels and columns, were changed to limestone, as shown by the evidence of shells and other lime materials in the stone. The full-height basement is separated from the raised first floor by a limestone watertable line (Fig. 14). The base of the building is rusticated granite. The steps up to the first floor are granite and shifted, separated and spread outward due to the deterioration of the supporting brick below and behind them.

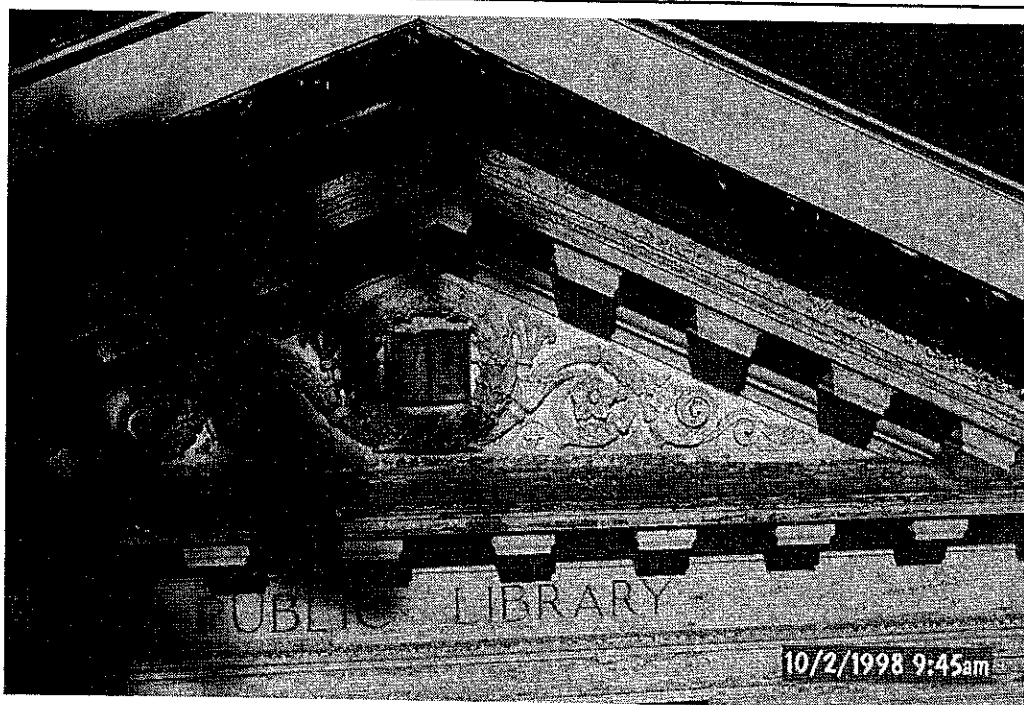
**Figure 17**

Detail view of wood ornament in tympanum, originally painted in polychrome colors.

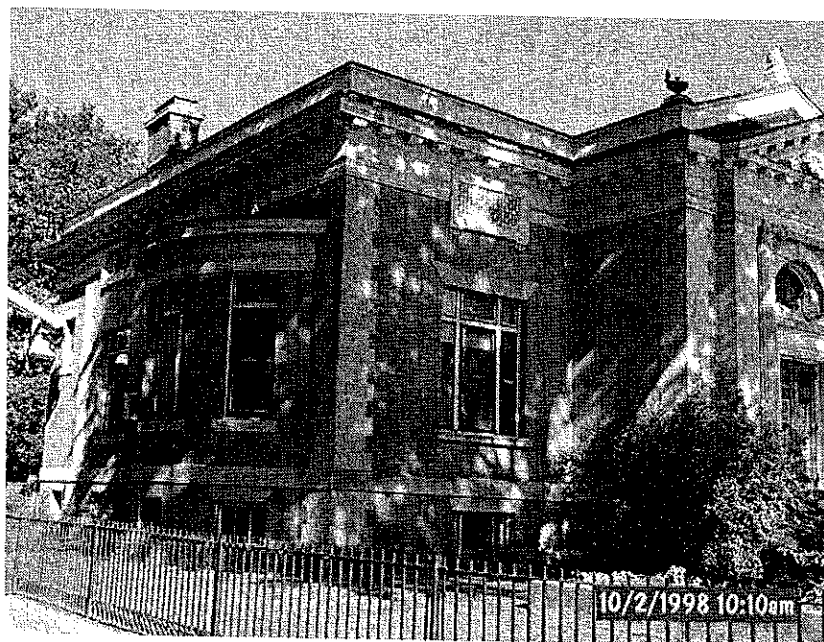
**Figure 21**

Typical water damage; Note existing original recessed bookshelves in Reading Room, Reference Room and Children's Room (Fig. 21)

South facade of West Branch Library, Somerville, MA. View looking northwest.

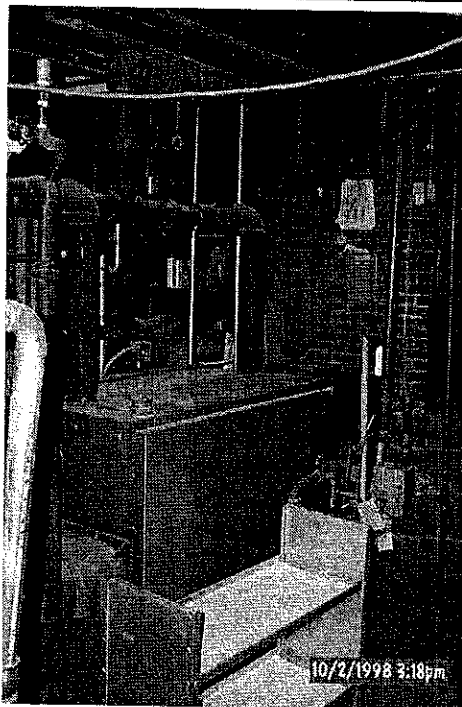
**Figure 33**

Original boiler room area in southwest corner of basement.

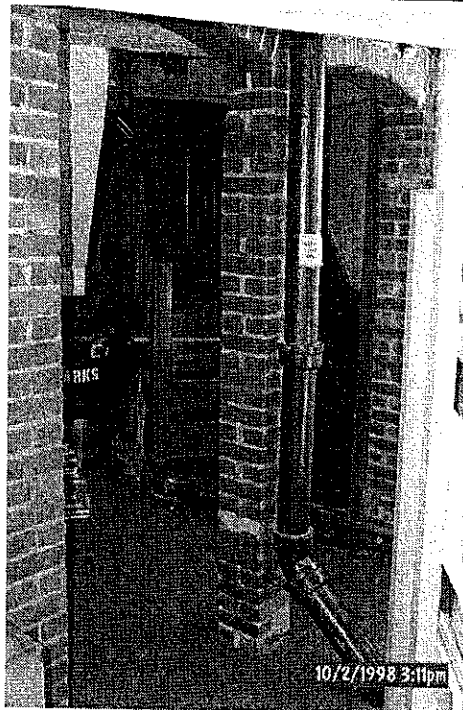
**Figure 34**

Original brick arch openings in southwest wall of basement. Note original stairway. View looking west.

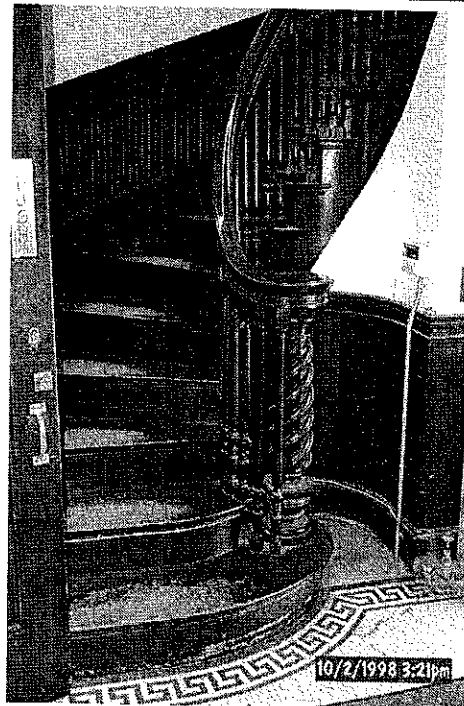
**Figure 37**

Original decoratively carved circular stair leading to second floor. Note original green and white floor tiles.

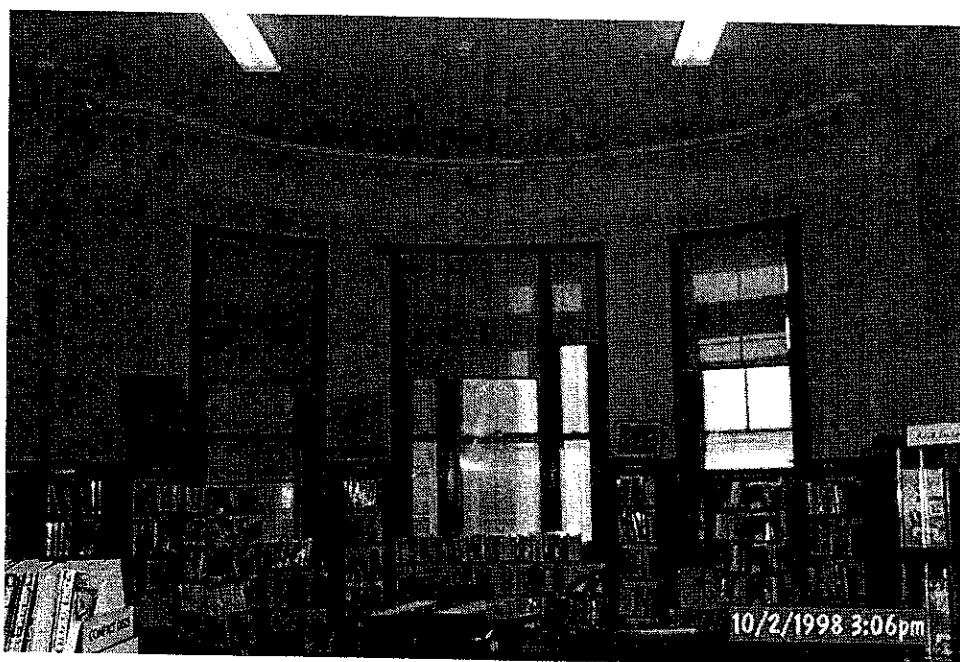
**Figure 41**

Original Stack Room, currently part of the reference area. Note original wood ionic columns and light fixtures. View looking northwest.
