To: SHPC
From: Kristi Chase, Preservation Planner and
Brandon Wilson, Executive Director,
RE: Staff Recommendations 10/18/11

HPC 11.98 – 50 Bow Street, 1874 Bow Street Police Station (continued)

Applicant: Danielle Bennett, Condo Owner, Urbanica 50 Condominium Trust, Owners

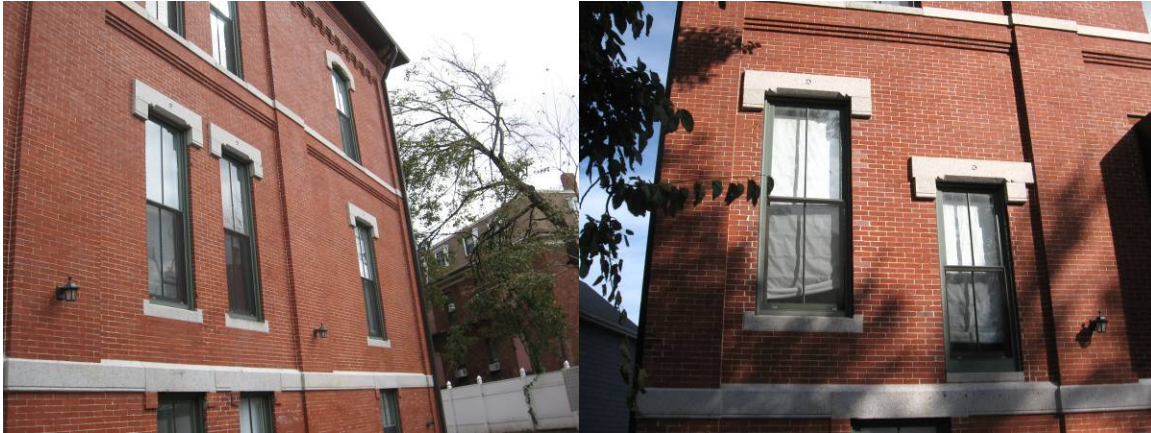
In 2003, Urbanica bought the building and began the rehabilitation of the Police Station which wasn't completed until 2005 and turned into condominiums. The Historic Preservation Commission gave the developers a Preservation Award in 2006 for the replication of the mansard roof, the chimneys, the cresting, the brackets and the windows, all of which was based on documentary and physical evidence.

The current owner purchased the unit in September 2005. The windows on the building are all new construction replicating exactly the historic casings and sash. Because modern wood is not as dense as the historic old growth wood from which windows were constructed, a few windows have been replaced with identical windows by the same manufacturer. The windows are insulated double-pane construction. Due to the nature of the brick mold casing, there are no exterior storm windows and are considered unnecessary with double glazing.

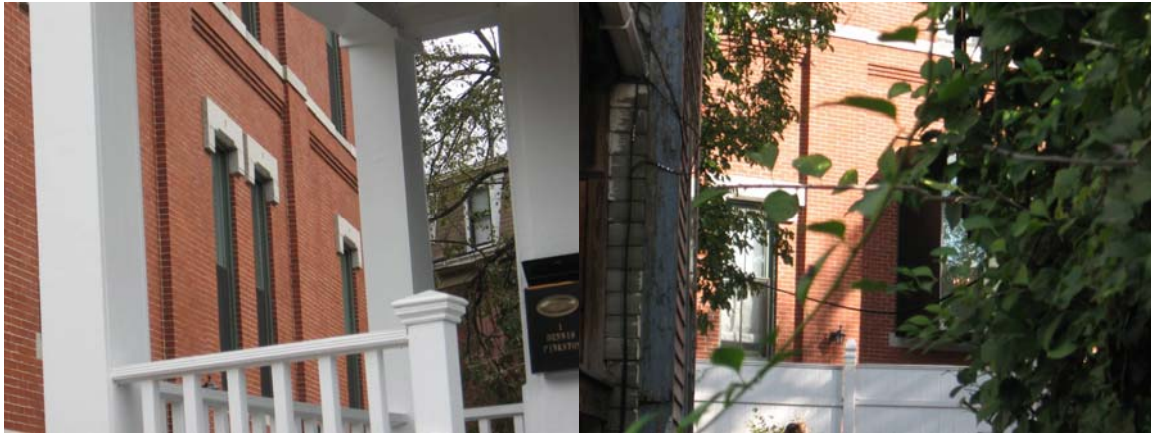
One of the two rear windows does not appear to be at all visible from a public way. The other rear window, while technically visible from Somerville Ave, requires looking between the altered brick mansard and the Indian grocery. The Guidelines and Ordinance do not consider fences or plantings to be considered as permanent obstructions to a view shed. The windows along the driveway are, of course, visible from Bow street albeit very obliquely, while the front window is completely visible.

The proposed window replacement on the wall facing Bow Street would be very obvious. The front window is part of the main façade and is grouped with other windows that will be remaining. The existing window should be either repaired or replaced with a JB Sash unit identical to the unit that is in place. It is most important that the one window along Bow Street be either kept or replaced with a match of the existing JB Sash window. A commission member suggested that the owners contact Kim Cleary of Cleary Window Restoration about corrective weather stripping options for this window that might solve the air infiltration problem prior to buying a new JB Sash window.

The extreme oblique angle from which the public will view the windows along the driveway may keep most of the dimensional differences from being obvious. At this angle, the most likely "noticed" difference would be the difference in new / existing shadow lines on the window sash that result from the thicker glass and shallower recess of the glazing in the new sash and a difference in the height of the lower rail.

Only one of the two windows on the back wall is visible. The other is visible at a distance between 2 buildings.
