To: SHPC  
From: Kristi Chase, Preservation Planner and  
Brandon Wilson, Executive Director,  
RE: Staff Recommendations 8/16/11

**HPC 11.62 – 396-398 Broadway, 1874 Second Empire Double Houses**

6/30/11

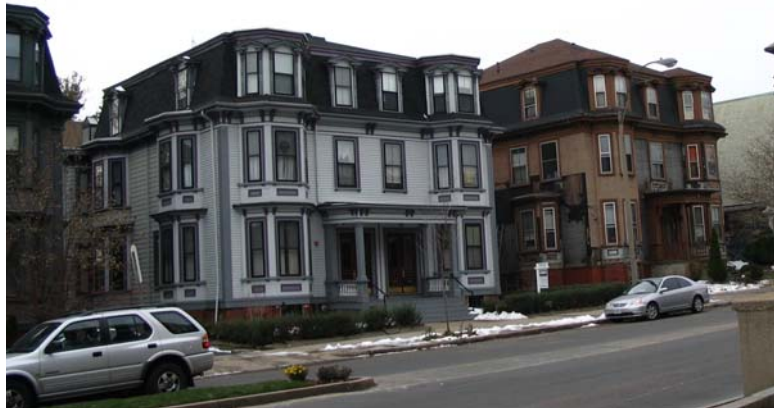
This is the center building in a grouping of three similar Second Empire double houses constructed by Cutler Downer. For several years, the owners have been trying to find the source of a leak that has damaged the wall and ceiling on the second floor.
