CITY OF SOMERVILLE, MASSACHUSETTS  
OFFICE OF STRATEGIC PLANNING & COMMUNITY DEVELOPMENT  
JOSEPH A. CURTATONE  
MAYOR

**ALTERATION TO A HISTORIC PROPERTY STAFF REPORT**

Site:	53 Columbus Avenue	c.1874 Second Empire House
Case:	HPC 2015.008	Columbus Ave. / Warren Ave. Local Historic District
Applicant Name:	RCG Columbus Renewal LLC, Owner	
Applicant Address:	17 Ivaloo Street, Somerville, MA 02143	
Date of Application:	February 25, 2015	
Legal Notice:	<i>Alter rear ell and windows.</i>	
Staff Recommendation:	Certificate of Appropriateness	
Date of Public Hearing:	March 17, 2015

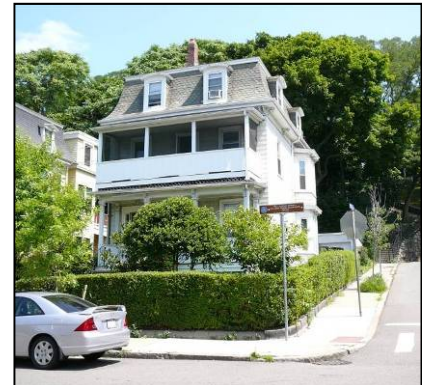
**53 Columbus Avenue 2014**

*One of the most popular building styles in the Prospect Hill area during the 1870s and early 1880s was the Second Empire style for large center-hall or side-hall entrance dwellings. The concave Mansard roof retains its decorative hexagonal slates. There are two segmental arched dormers on each side exposed to the corner intersection.*

*In spite of the asbestos shingled siding the house retains some of its Second Empire characteristics including its most distinctive feature of a decorative slate roof, paired cornice brackets, a two-story octagonal side bay and squared porch columns with capitals and brackets with drop finials.*

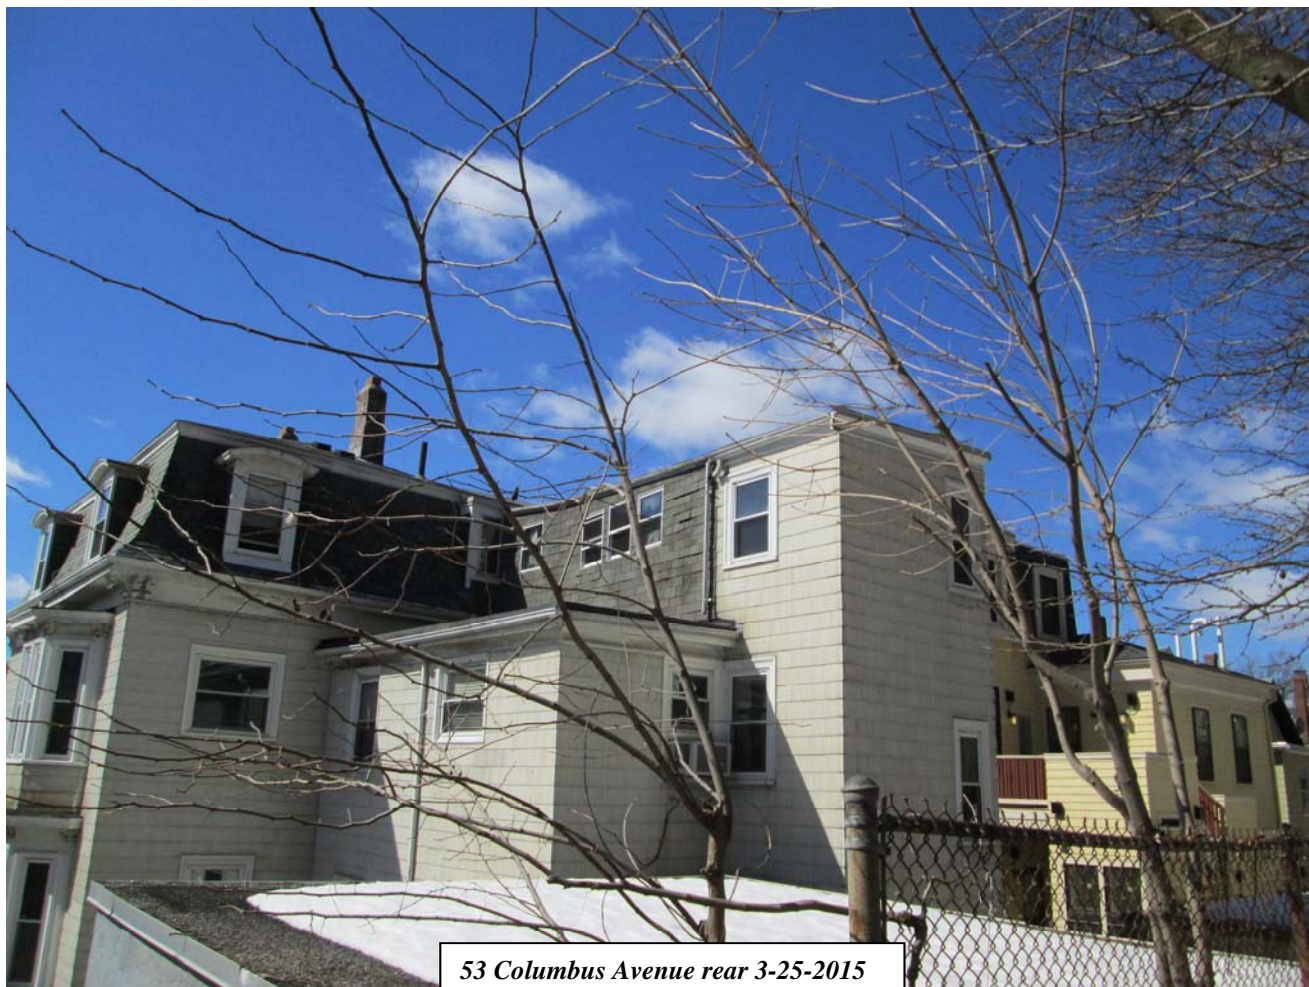
*53 Columbus Avenue rear 3-25-2015*

On the second floor they propose to replace four disproportionate existing windows, one on the rear elevation of the main building, one on the east elevation of the rear ell, two on the west elevation of the ell, with windows that are sized proportionally to match the typical existing windows in the building. These windows would be white vinyl to match the existing.

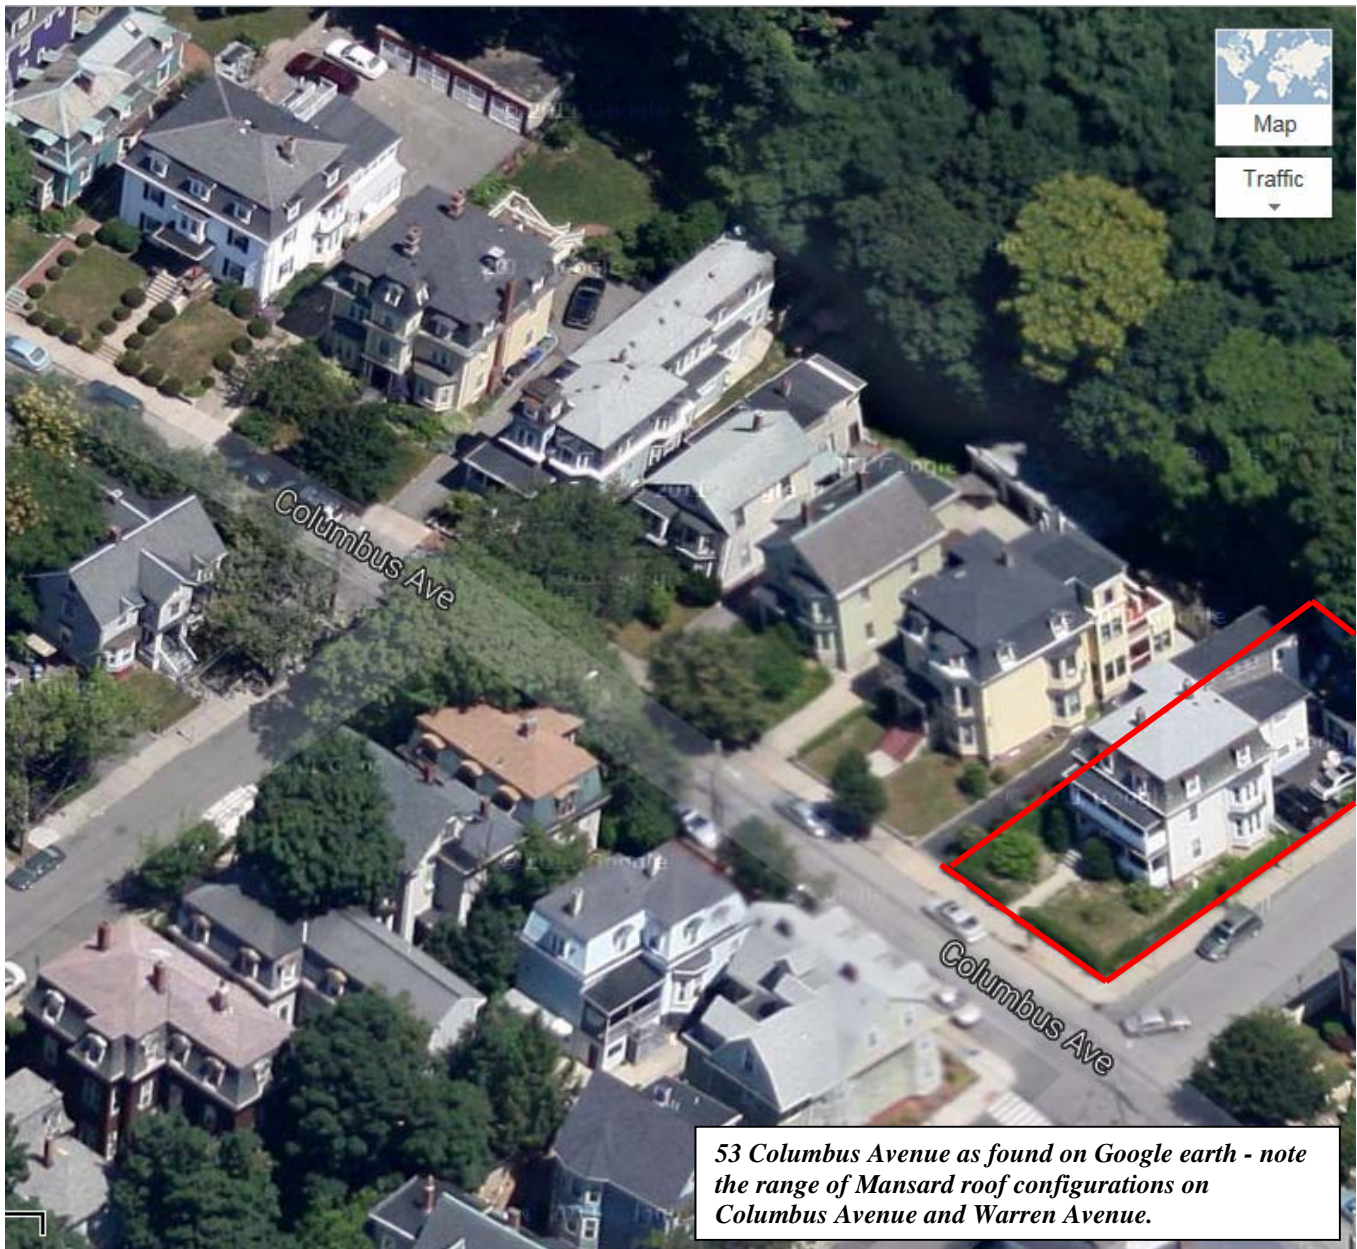
*53 Columbus Avenue as found on Google earth - note the range of Mansard roof configurations on Columbus Avenue and Warren Avenue.*

There are several buildings in the Columbus Avenue Warren Avenue Local Historic District with Mansard ells that continue the roof line. These are 56, 61 and 71 Columbus Avenue, and 26, 27, 29 and 31 Warren Avenue. In other cases, the rear ell terminates with a flat roof of the second floor on the ell just below the Mansard eave. As noted above, the ell on 55 Columbus Avenue was altered extensively to allow for ADA access and a second means of egress from the third floor.

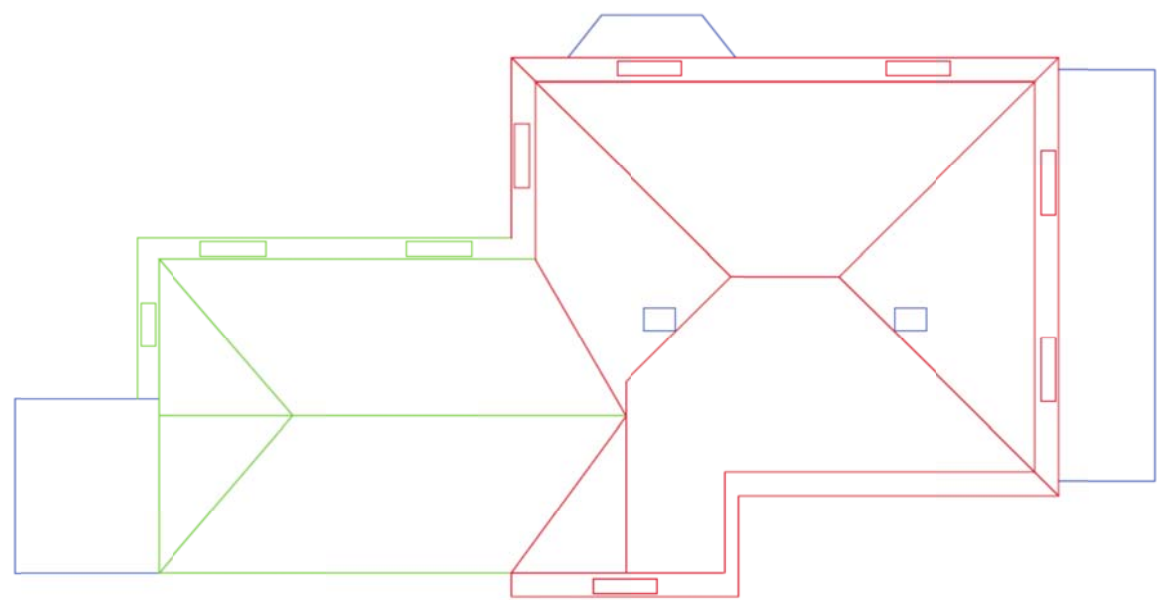
53 Columbus Ave  
Somerville, MA  
Proposed Roof Plan

Proposed Third Floor  
Roof Alterations  
↑

1. Remove and rebuild the existing third floor continuing the eave line and with a Mansard roof to meet the existing wall line on the rear ell; and
2. Replace four altered second floor windows visible on the rear and ell near Prospect Hill Parkway to match the original openings
