CITY OF SOMERVILLE, MASSACHUSETTS
OFFICE OF STRATEGIC PLANNING & COMMUNITY DEVELOPMENT
JOSEPH A. CURTATONE
MAYOR

HISTORIC PRESERVATION COMMISSION

ALTERATION TO A HISTORIC PROPERTY STAFF REPORT

Site: 381 Summer Street, Rosebud Diner (c. 1940)
Case: HPC 2014.018
Applicant Name: Rosebud Restaurant Inc.
Applicant Address: 219 Elm Street, Somerville, MA 02144

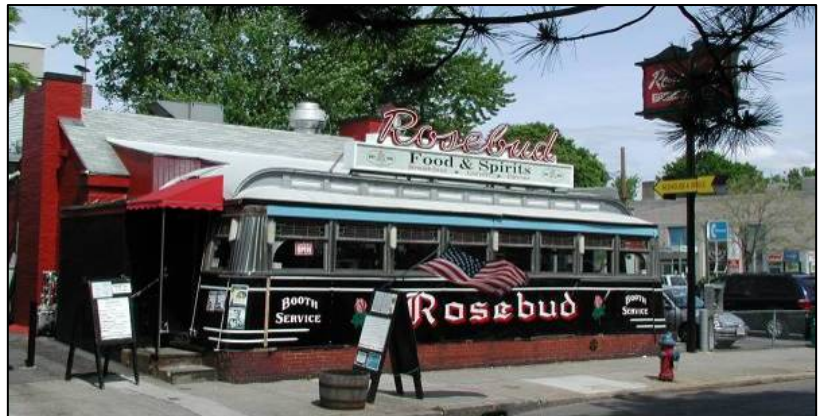
381 Summer Street, 2002 photo

Windows have leaded glass in the transoms above the single-hung metal sash. There are fluted stainless steel jambs between the windows and at the rounded corners. The clerestory windows incorporate some colored glass, mostly visible on the interior. The prefabricated diner is attached at the rear to Jaunty Jack's, a one-story, side-gabled building (constructed in 1939) with brick veneer walls and two exterior end-wall chimneys and blinded windows. A much larger one-story, flat-roofed rear addition (ca. 1960s) also of covered with brick veneer, sits on the rest of the lot. Both the side-gabled building and the rear addition are visually subservient to the diner.
