HISTORIC PRESERVATION COMMISSION

ALTERATION TO A HISTORIC PROPERTY STAFF REPORT

Site: 141 Central Street c.1889 William Veazie Row Houses
Case: HPC 2016.077 Single Building Local Historic District

Date of Application: September 29, 2016
Legal Notice: *Alter/repair front porch (posts and corbels will be milled as-needed). Replace bottom step with granite or concrete step.*

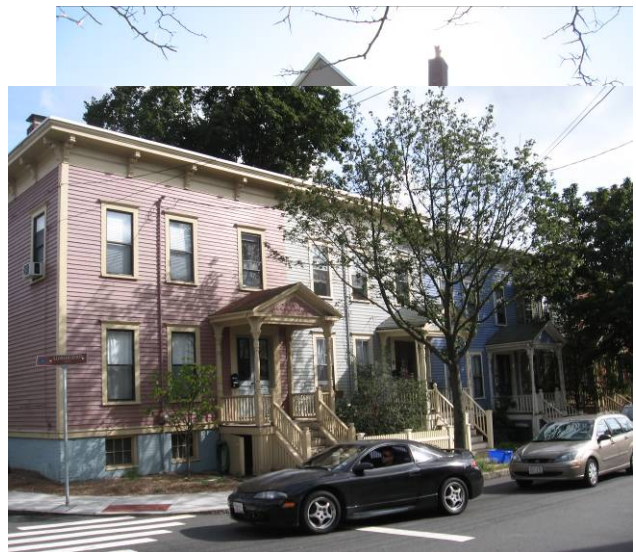
This is one end of a set of 5 wood Italianate rowhouses with bracketed eaves. They are all side-hall plan with a small pedimented porch. Simple window hoods cap the casing. The brick foundation of #145 has been painted. The rear entries have all been altered in various ways. #145 has an enclosed porch and small kitchen window overlooking the yard and Medford Street.

141 Central Street has a full set of wood steps. The porch and steps need to be repaired and are in fair to poor condition. The bottom riser is rotting. The other rowhouses have a concrete bottom step.

The stairs, porch and handrails visible from the public right of way were not discussed in the Form B. The deteriorated steps would be replaced to match the others in the row. Porch columns and other damaged and rotting details would be replicated to match the existing.

1. The wood replacement porch columns shall match the existing in form, shape, and size.
