ALTERATION TO A HISTORIC PROPERTY STAFF REPORT

Site: 17-19R Aldersey Street c. 1869 Adoniram Taylor House and Stable Case: HPC 2014.053 Aldersey Summit Local Historic District

Legal Notice: Demolish garage, install new fencing and bike racks

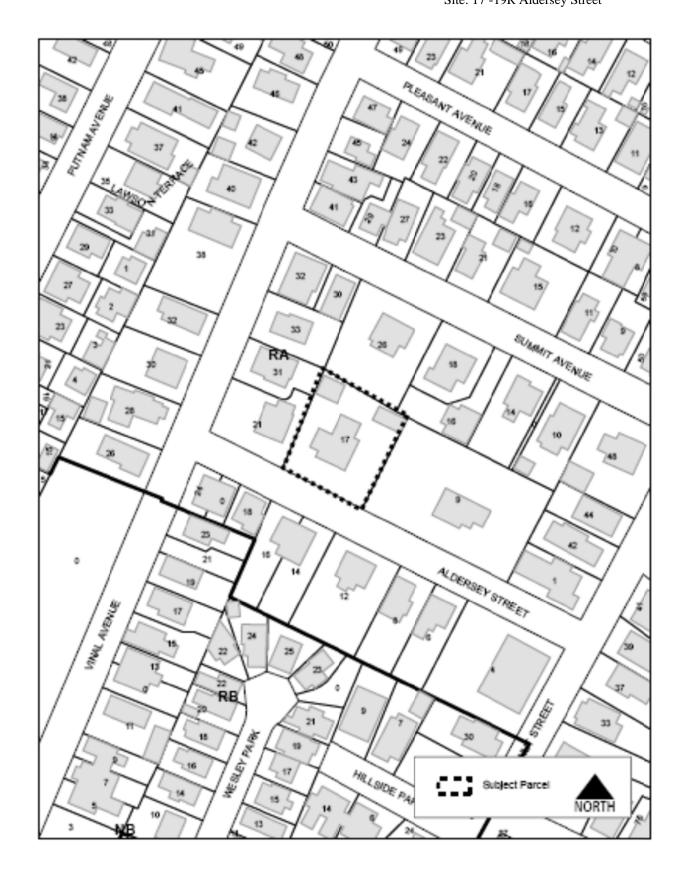
The garage is located at the northeast corner of the lot. It is in poor condition but does have its original doors. The garage is typical but less ornamented than many garages of the 1920s. See **Carriage House to Auto House** by Reed and Hardwicke for a typology of popular styles. It is significant as a characteristic structure of the vintage automotive era when the Model T and Model A Fords were the car of choice for many.

- 1. The 1927 garage shall be demolished to grade, retaining the portions of the garage that act as a retaining wall;
- 2. A 4' solid wood fence along driveway entry shall be installed to the edge of the front yard setback
- 3. A 6' wood and vertical lattice fence shall be installed along the parking area and the rear wall of the property;
- 4. Trellises shall be installed in a planting area along the rear portion of the fence to encourage climbing vines;
- 5. Seven bike racks shall be installed along the east side of the parking area along the 6' lattice fence; and
- 6. Eight *arbor vitae* or similar shall be pante4d to obscure and protect the bicycle racks along the east side of the parking area.
