ALTERATION TO A HISTORIC PROPERTY STAFF REPORT

Site: 331-333 Broadway 1914 – The Princeton
Case: HPC 2013.075 Single Building Local Historic District

Date of Application: April 9, 2015
Legal Notice: *Install cell equipment & antennae*
Staff Recommendation: Certificate of Appropriateness; Certificate of Non-Applicability
Date of Public Hearing: May 19, 2015

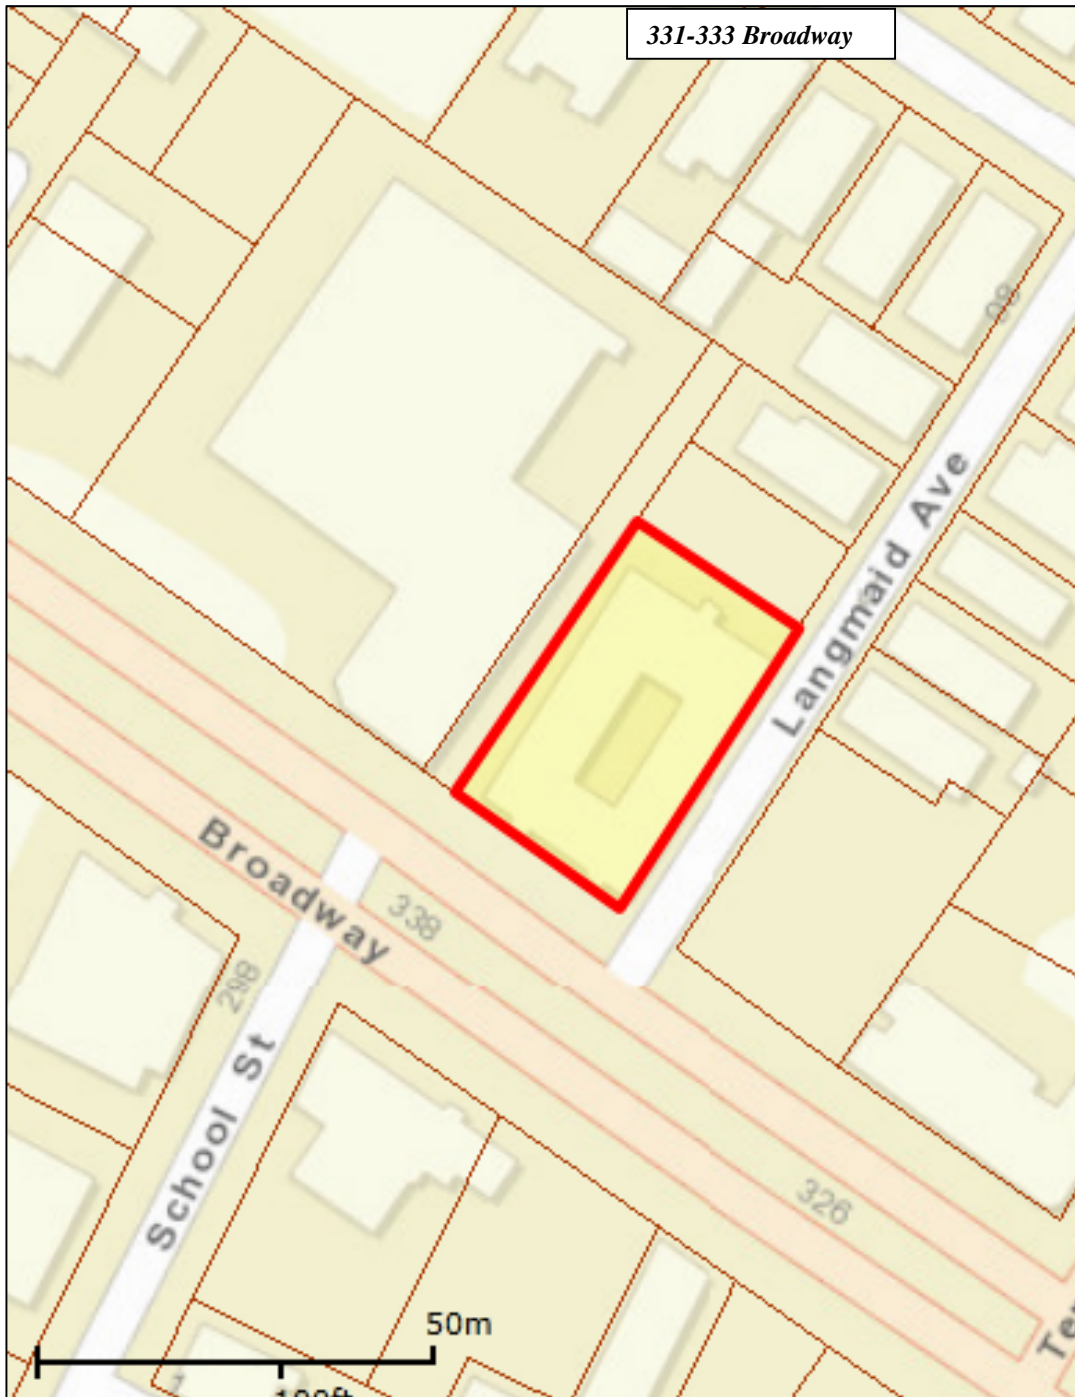
331-333 Broadway showing penthouse with visible antennae.

The penthouses currently have cell antennae. Additional equipment is located centrally on the roof of the building and not visible from the public right of way. See photos at the end of the document.

The penthouses on the front side of the building are visible from Broadway on the uphill (west side) of the building and from School Street.

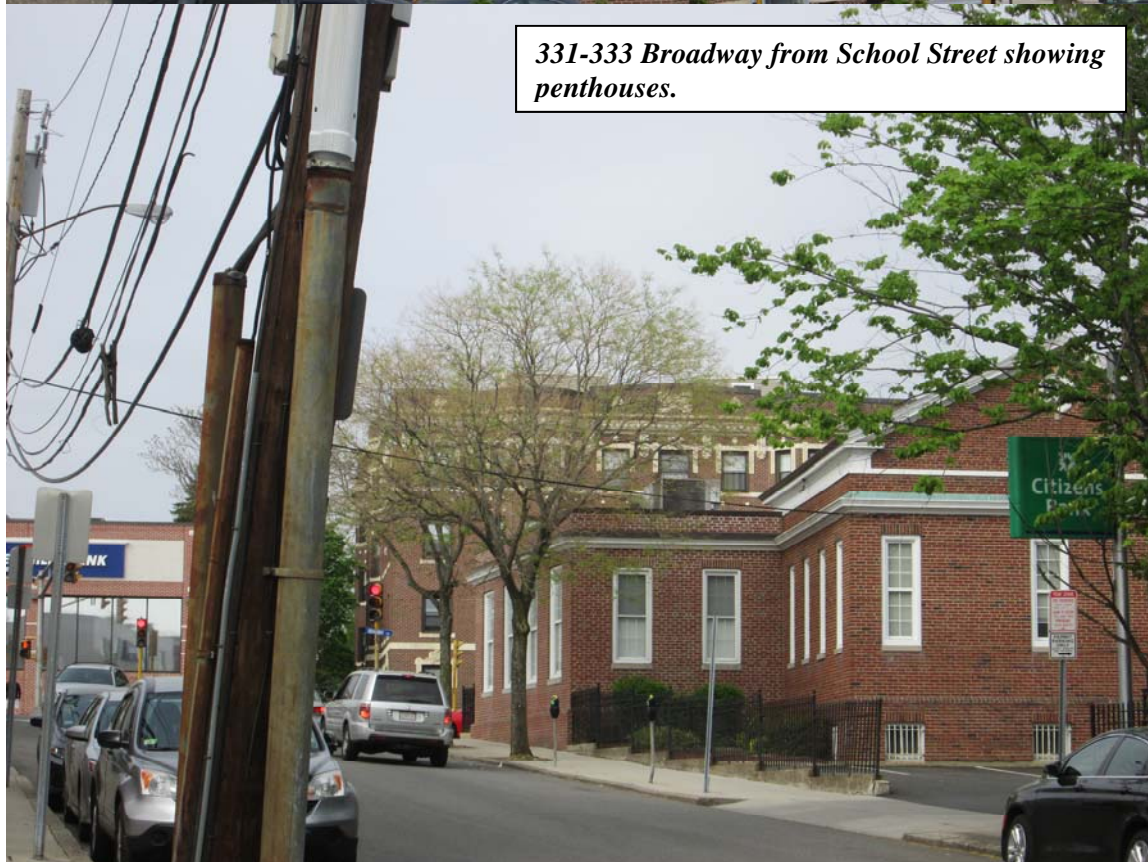
331-333 Broadway from School Street showing penthouses.
